Inspection Report

Property Address:
4444 Tall Hickory Trail
Gainesville, GA 30506

Superior Home Inspections

Date: 4/16/2005	Time: 10:05 AM	Report ID: 041605
Property: 4444 Tall Hickory Trail Gainesville, GA 30506	Customer: Joe Sample Jane Sample	Real Estate Professional:

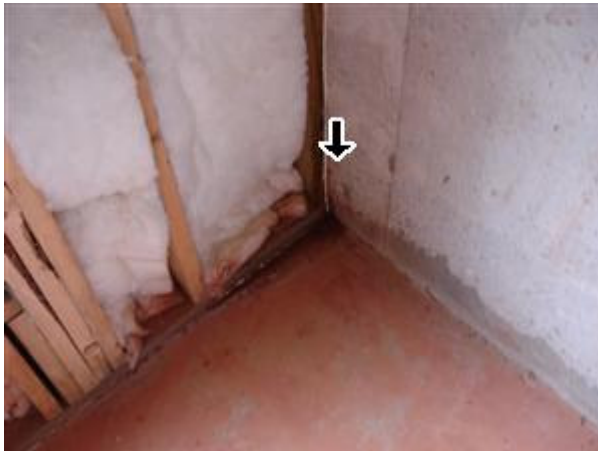
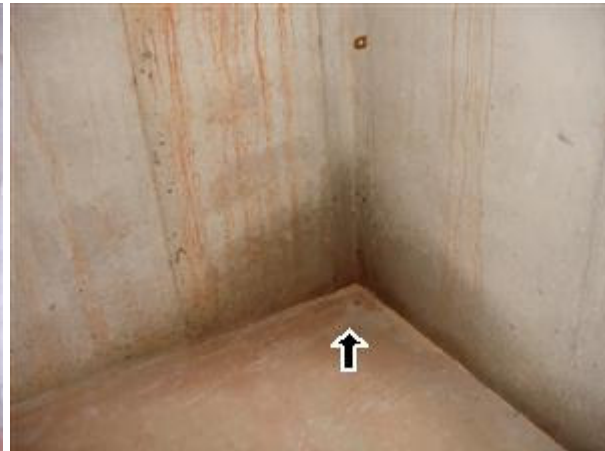
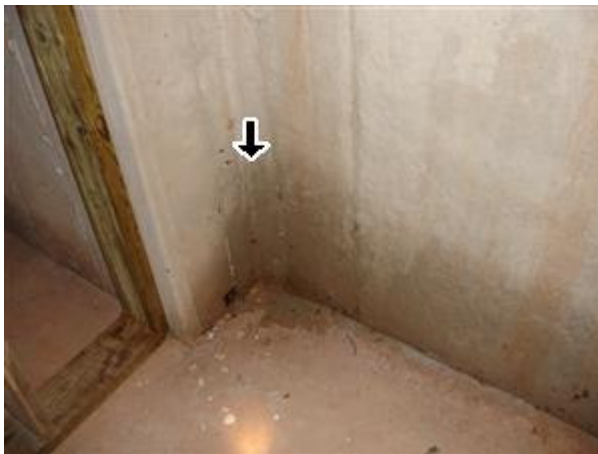
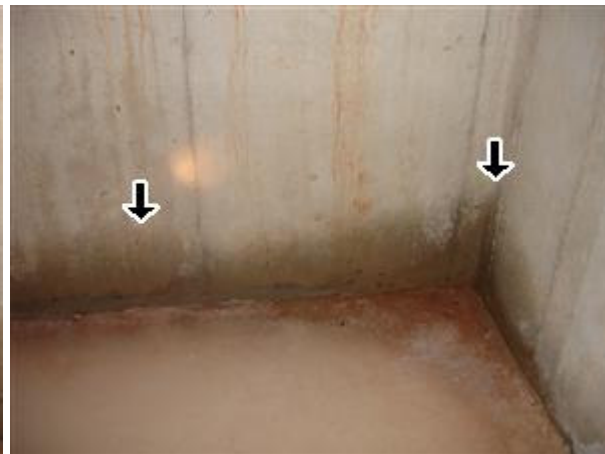
Visible signs of water intrusion in basement (along front of home) , (along rear of home) and in several various other areas also visible are mold, and dampness. Water intrusion can lead to more costly repairs and increase damage if not corrected. Unable to determine the extent of intrusion or how often it occurs. Water intrusion if not corrected can lead to other problems including mold and cause excessive moisture to floor system that can lead to deterioration and increased repair cost. Recommend further investigation or correction by a qualified licensed contractor or water infiltration specialist.

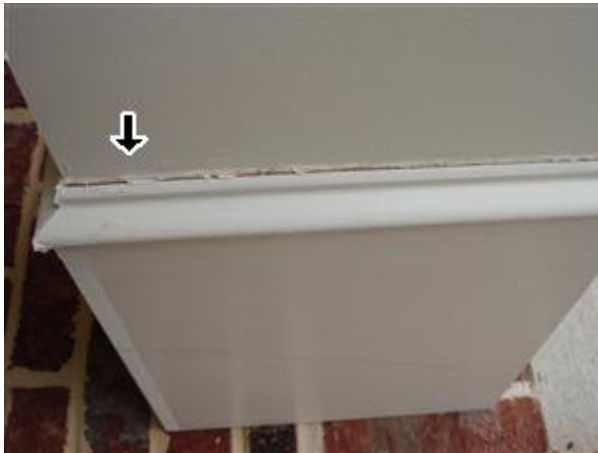
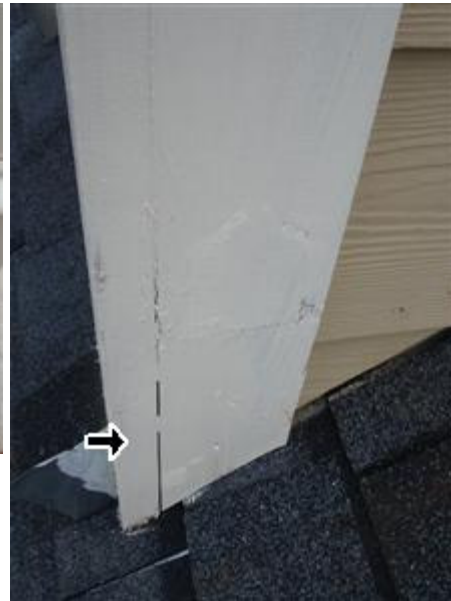
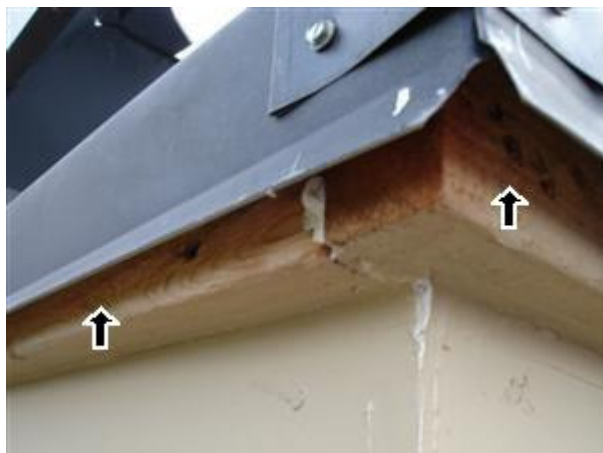
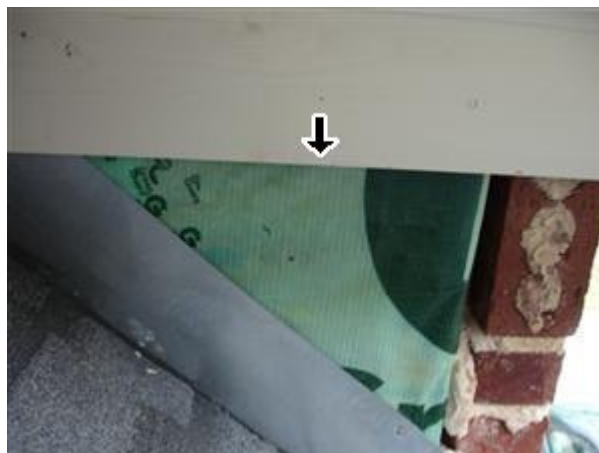
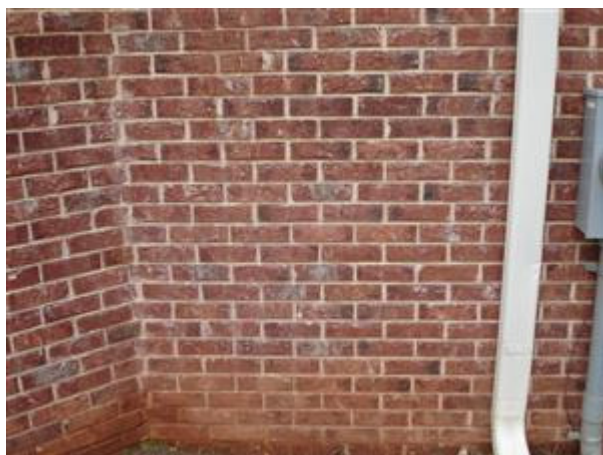
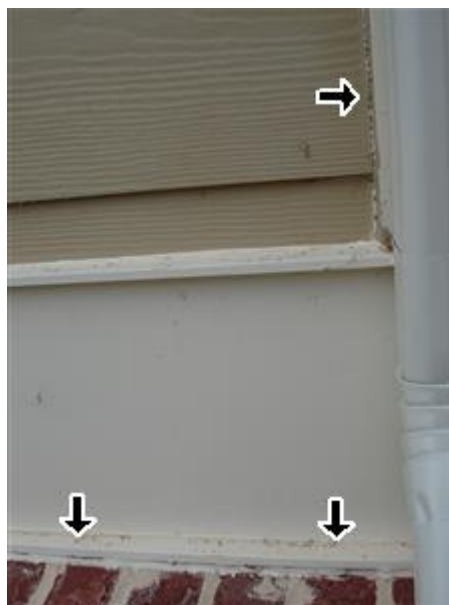
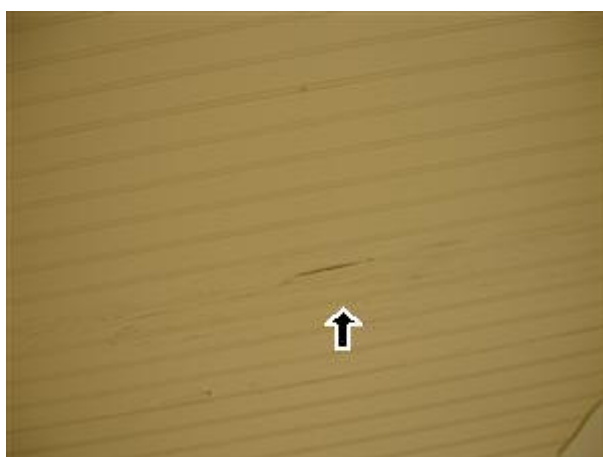
Wood trim and Masonite siding at "All of exterior in areas is missing/improper sealant/caulking. Further deterioration can occur if not corrected. Recommend repair as needed using a qualified person.

Specific areas include chimney bottom right corner, and chimney cap edge(unprimed wood).

Front porch columns at base needs caulking.

Right of main entry on roof missing siding exposed/open framing.

Right side of exterior no noticeable weep hole in brick cladding.

Right side of exterior back bottom corner needs sealant.

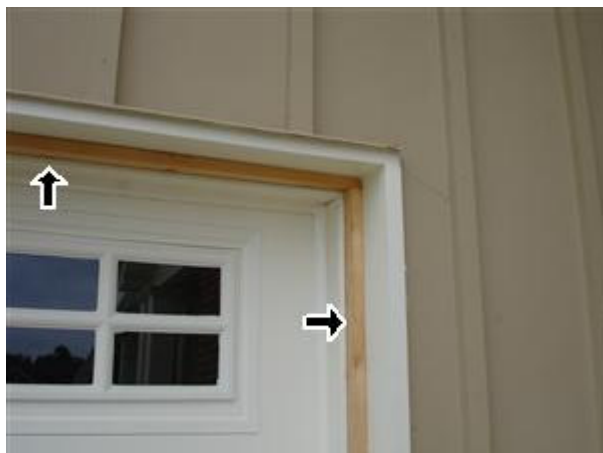
2.1 Picture 1

Garage door trim at front of home needs prep and paint (both doors). Recommend repair as needed using a qualified person.

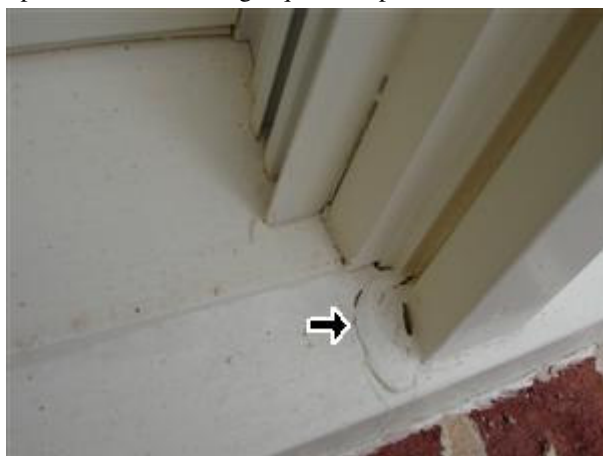
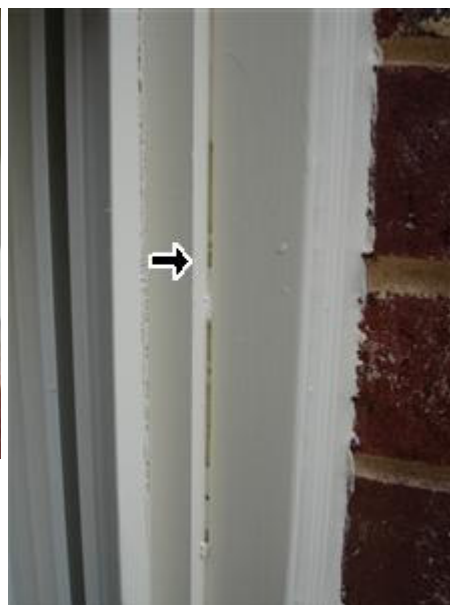
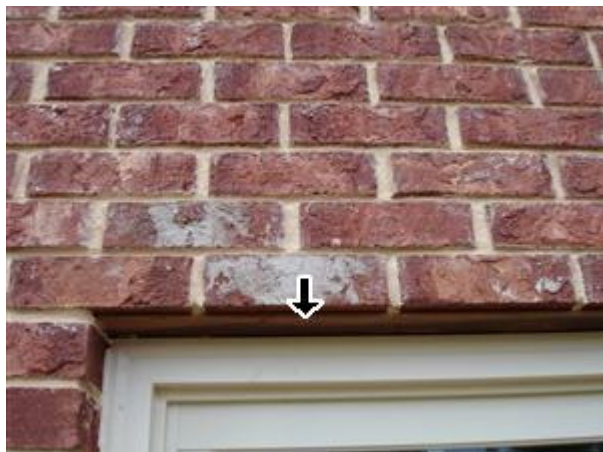
Brick-mold and Window frames/sills missing sealant at most windows. Further deterioration may occur if not repaired. Deterioration can allow water to enter behind siding or wall cavity and more damage could result. Recommend repair or replace as needed using a qualified person.

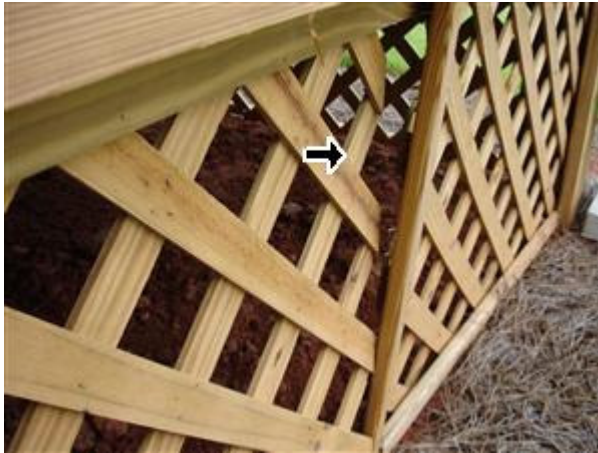
2.4 Picture 1

Lattice on Covered porch at rear of home in several areas is loose and needs tighten or repair. Recommend repair or replace by a qualified contractor.

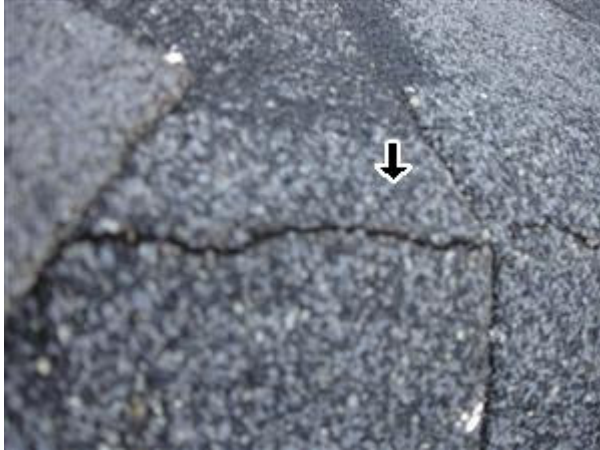
3.0 Picture 1

Roof covering has hairline cracks in various areas mainly along the ridges. This is possibly from a manufacturer defect. Roof could leak. Recommend repair or replace.

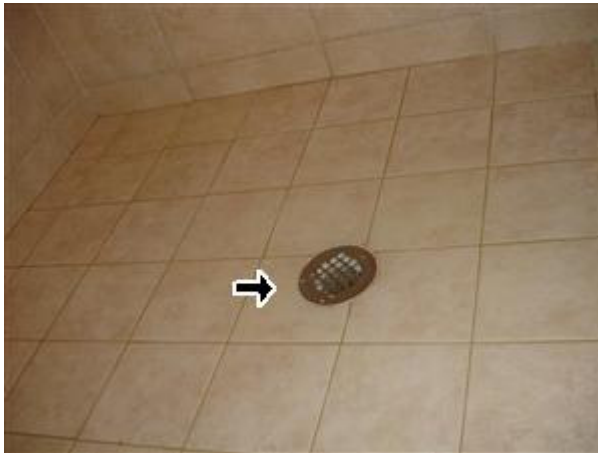
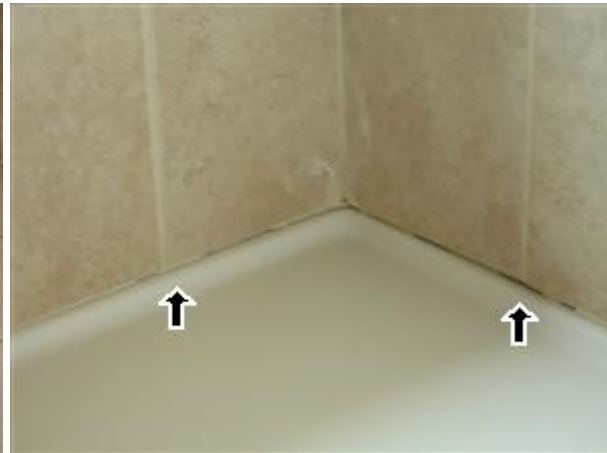
Shower stall does not drain properly at Master Bath. Recommend a qualified licensed plumber repair or correct as needed.

Fiberglass Jacuzzi Tub does not work properly at Master Bath. Recommend a qualified licensed plumber repair or correct as needed. Also missing grout sealant along top edge.

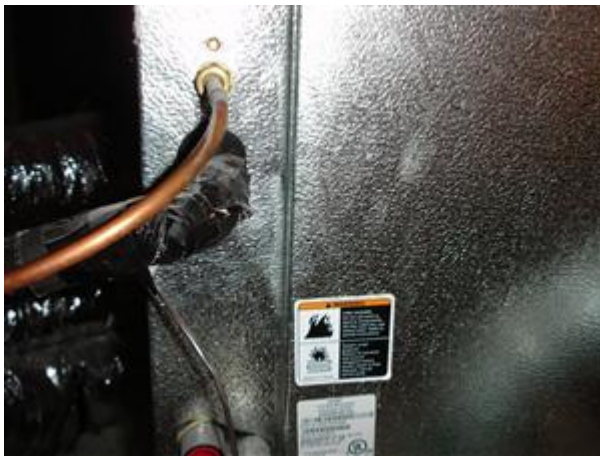
6.0 Picture 1

Service doors on both attic units will not shut properly and is loose. This is a maintenance issue and should be repaired. Recommend service or repair unit using a licensed HVAC contractor. Also recommend making sure unit is sealed properly (air leakage).

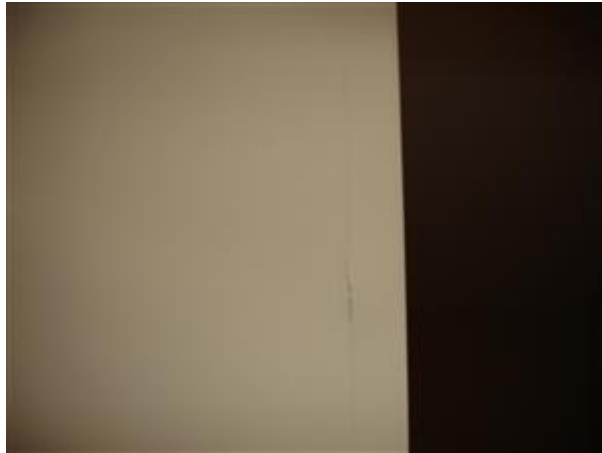
8.1 Picture 1

Sheetrock on wall has several hairline cracks (cosmetic) in bonus room. This damage is considered cosmetic. Recommend repair or replace as needed using a qualified person.

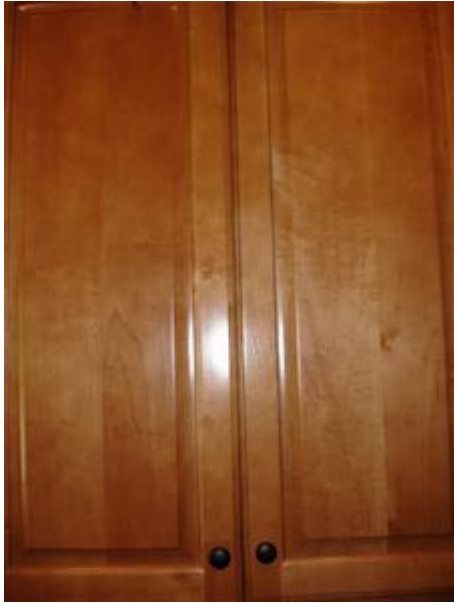
8.4 Picture 1

Cabinet door (s) needs adjustment or repair at some cabinet doors. This is a cosmetic issue for your information. Recommend repair or replace as necessary.

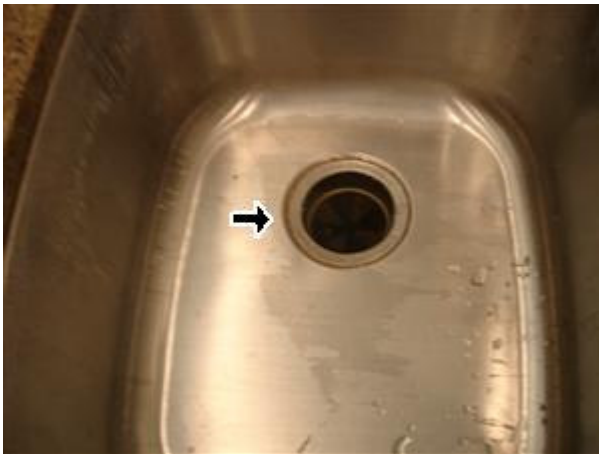
10.4 Picture 1

BUILT-IN KITCHEN APPLIANCES**Styles & Materials****DISHWASHER:**
WHIRLPOOL**RANGE/OVEN:**
WHIRLPOOL**REFRIGERATOR:**
NONE**DISPOSER:**
IN SINK ERATOR**BUILT-IN MICROWAVE:**
WHIRLPOOL**GAS STOVE:**
Whirpool**EXHAUST/RANGE HOOD:**
WHIRLPOOL**TRASH COMPACTORS:**
NONE**Inspection Items****10.0 DISHWASHER****Comments:** Inspected**10.1 RANGES/OVENS/COOKTOPS****Comments:** Inspected**10.2 RANGE HOOD****Comments:** Inspected**10.3 TRASH COMPACTOR****Comments:** Not Present**10.4 FOOD WASTE DISPOSER****Comments:** Repair or Replace
Disposer would not operate. Non functional.

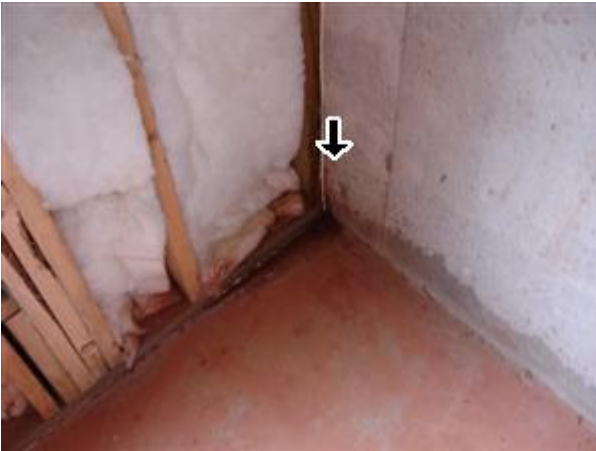
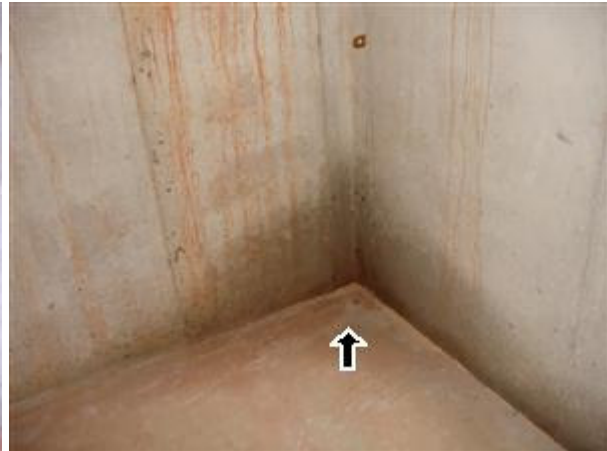
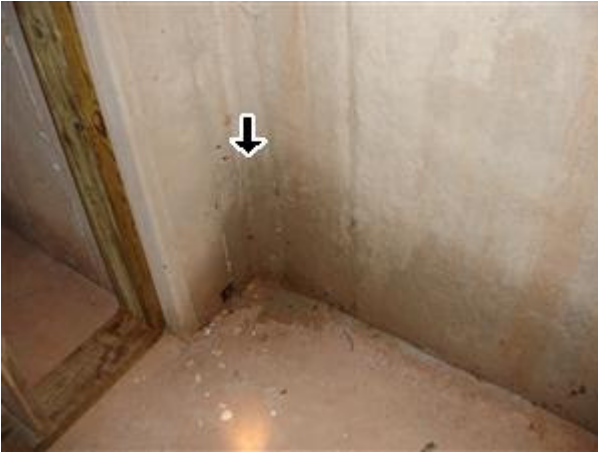
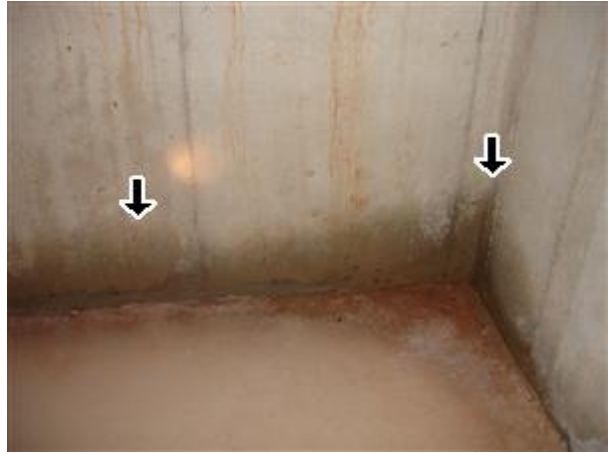
Visible signs of water intrusion in basement (along front of home) , (along rear of home) and in several various other areas also visible are mold, and dampness. Water intrusion can lead to more costly repairs and increase damage if not corrected. Unable to determine the extent of intrusion or how often it occurs. Water intrusion if not corrected can lead to other problems including mold and cause excessive moisture to floor system that can lead to deterioration and increased repair cost. Recommend further investigation or correction by a qualified licensed contractor or water infiltration specialist.

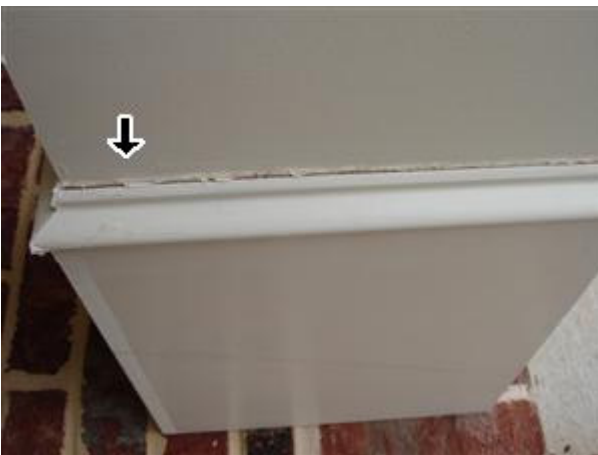
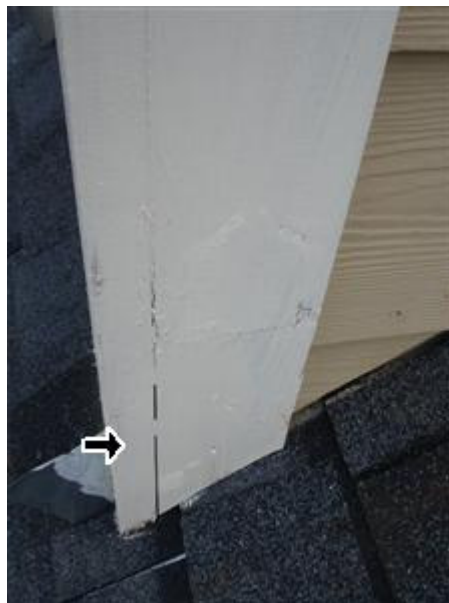
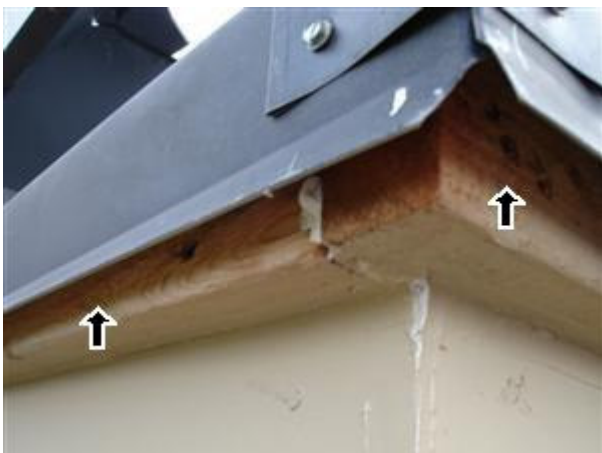
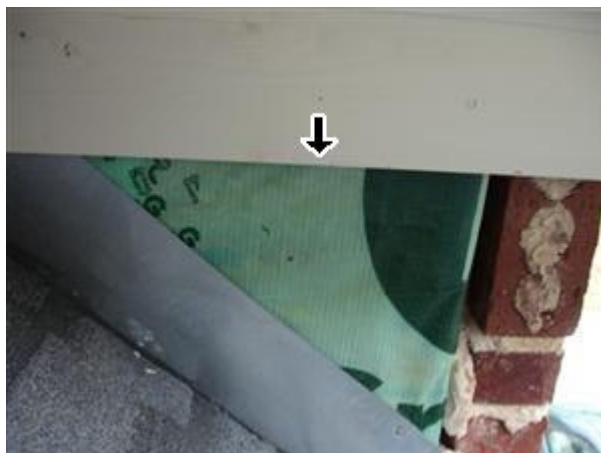
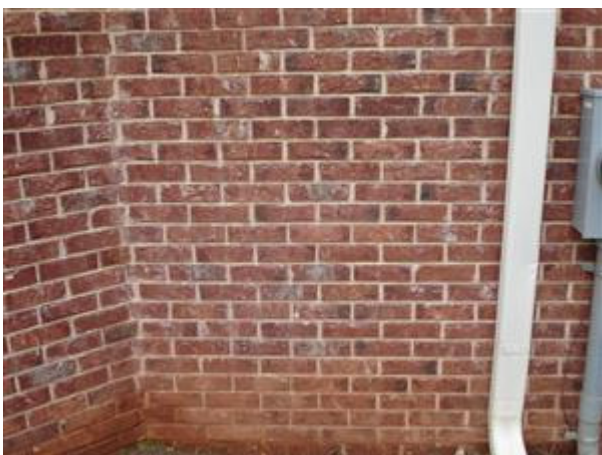
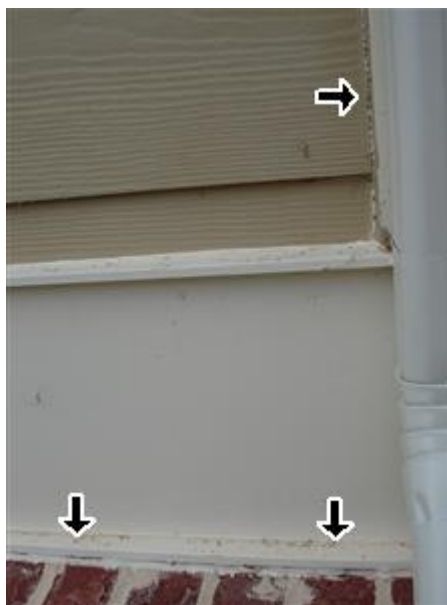
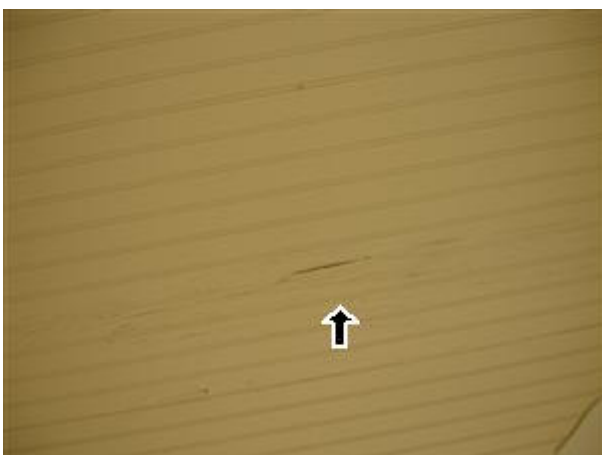
Wood trim and Masonite siding at "All of exterior in areas is missing/improper sealant/caulking. Further deterioration can occur if not corrected. Recommend repair as needed using a qualified person.

Specific areas include chimney bottom right corner, and chimney cap edge(unprimed wood).

Front porch columns at base needs caulking.

Right of main entry on roof missing siding exposed/open framing.

Right side of exterior no noticeable weep hole in brick cladding.

Right side of exterior back bottom corner needs sealant.

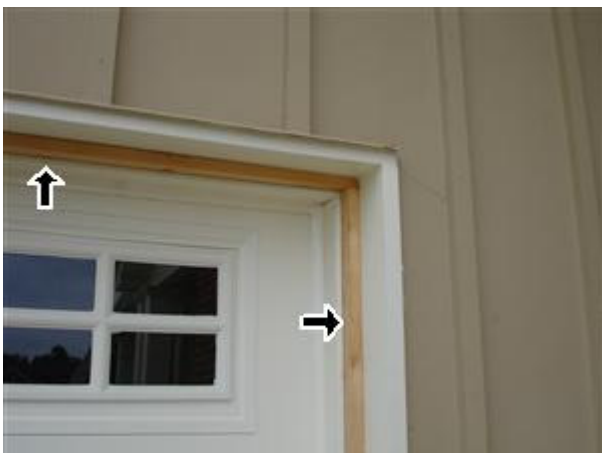
2.1 Picture 1

Garage door trim at front of home needs prep and paint (both doors). Recommend repair as needed using a qualified person.

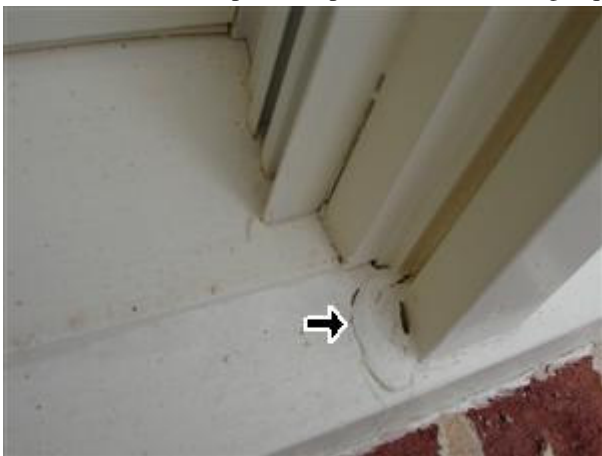
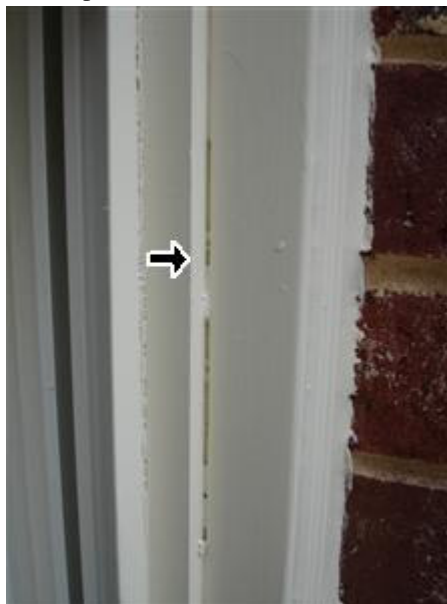
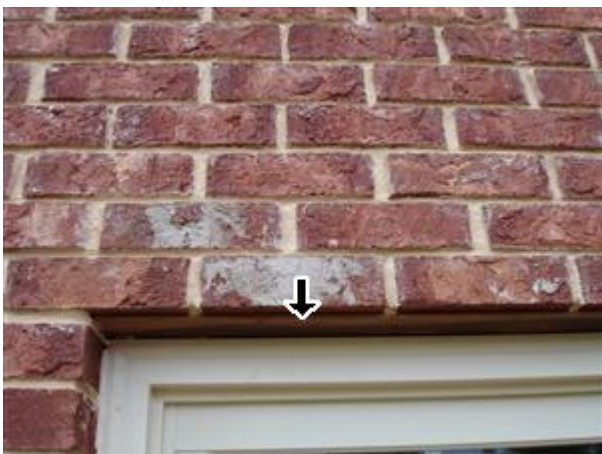
Brick-mold and Window frames/sills missing sealant at most windows. Further deterioration may occur if not repaired. Deterioration can allow water to enter behind siding or wall cavity and more damage could result. Recommend repair or replace as needed using a qualified person.

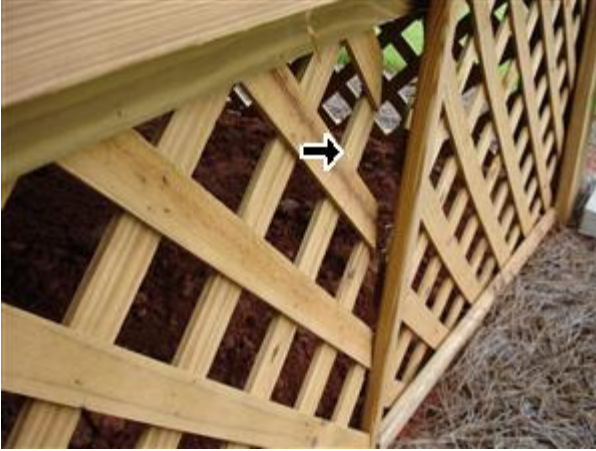
2.4 Picture 1

Lattice on Covered porch at rear of home in several areas is loose and needs tighten or repair. Recommend repair or replace by a qualified contractor.

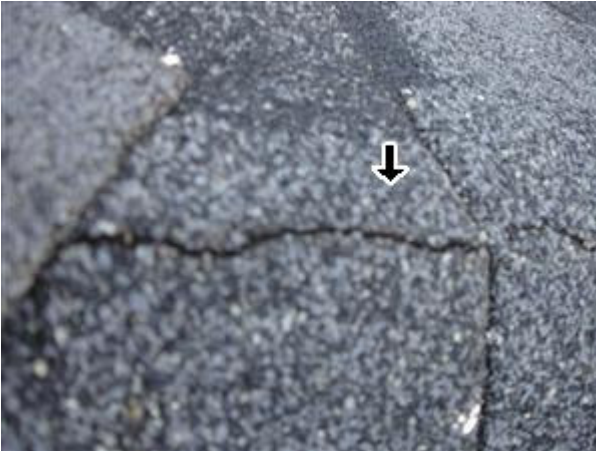
3.0 Picture 1

Roof covering has hairline cracks in various areas mainly along the ridges. This is possibly from a manufacturer defect. Roof could leak. Recommend repair or replace.

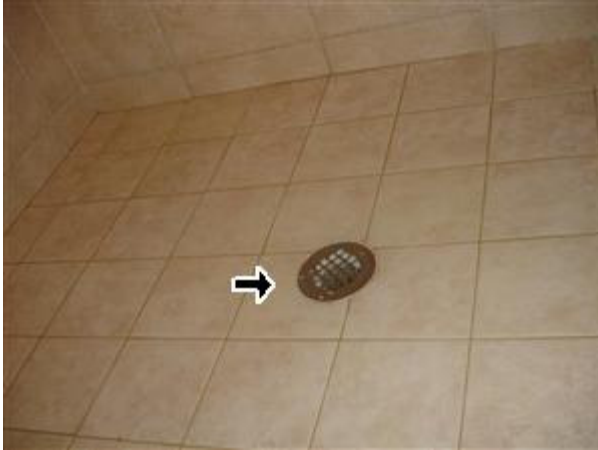
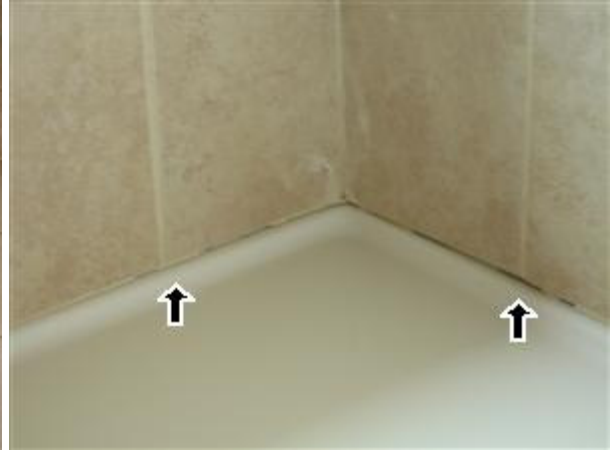
Shower stall does not drain properly at Master Bath. Recommend a qualified licensed plumber repair or correct as needed.

Fiberglass Jacuzzi Tub does not work properly at Master Bath. Recommend a qualified licensed plumber repair or correct as needed. Also missing grout sealant along top edge.

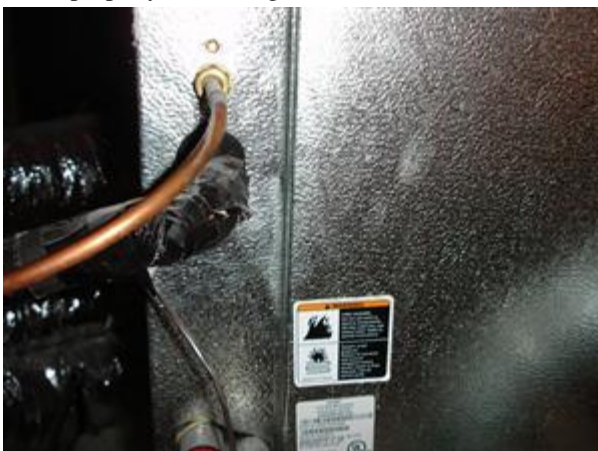
6.0 Picture 1

Service doors on both attic units will not shut properly and is loose. This is a maintenance issue and should be repaired. Recommend service or repair unit using a licensed HVAC contractor. Also recommend making sure unit is sealed properly (air leakage).

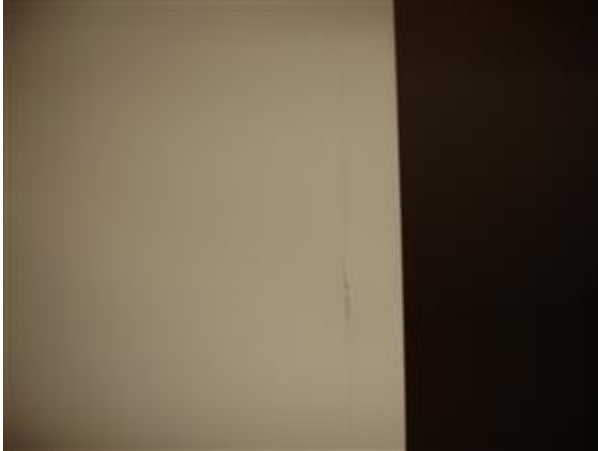
8.1 Picture 1

Sheetrock on wall has several hairline cracks (cosmetic) in bonus room. This damage is considered cosmetic. Recommend repair or replace as needed using a qualified person.

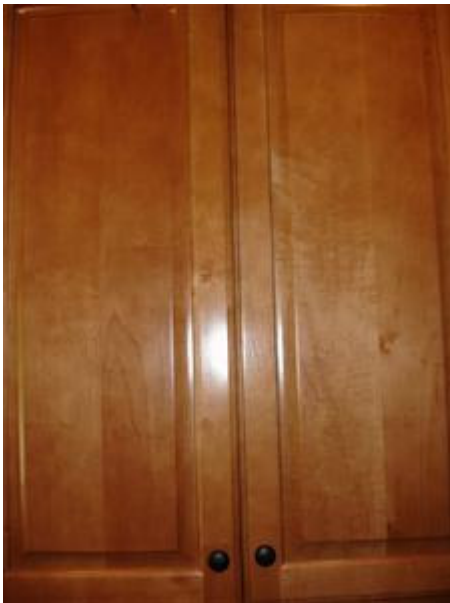
8.4 Picture 1

Cabinet door (s) needs adjustment or repair at some cabinet doors. This is a cosmetic issue for your information. Recommend repair or replace as necessary.

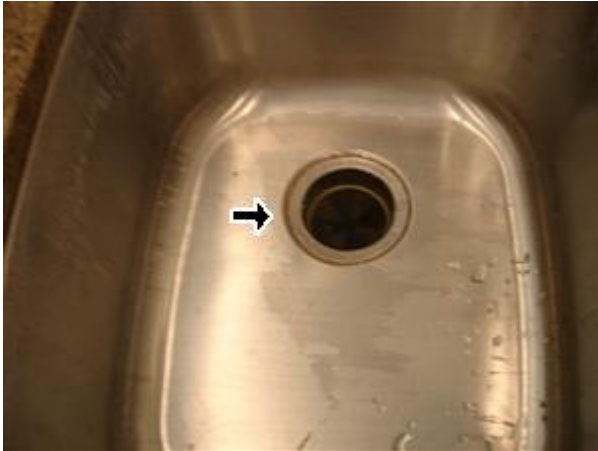
10.4 Picture 1

Disposer would not operate. Non functional.
