Inspection Report

Property Address:
xxx Sandy Plains Road
Building 5
Marietta, GA 30066

Superior Home Inspections

Date: 4/25/2008	Time: 10:40 AM	Report ID: 42508
Property: xxx Sandy Plains Road Building 5 Marietta, GA 30066	Customer: Atlanta Commercial Customer	Real Estate Professional: Kirk Adams Newmark Knight Frank

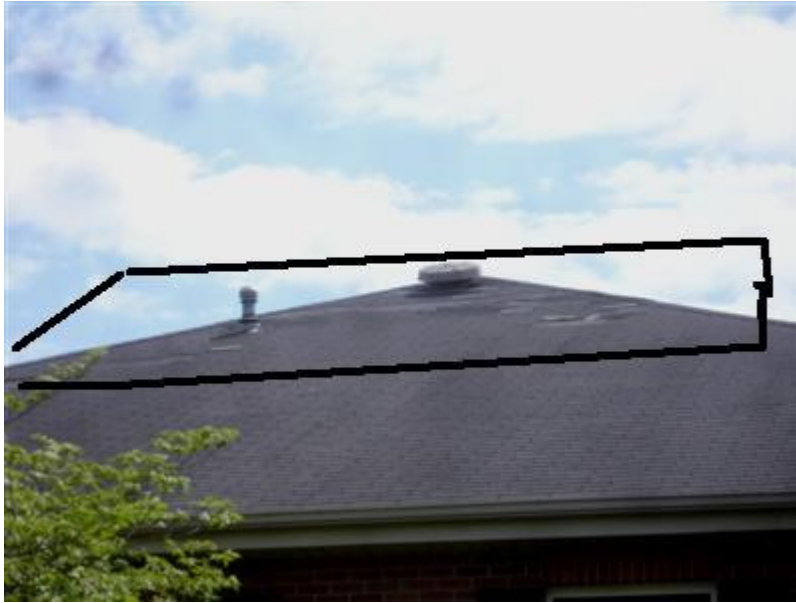
1.0 Picture 1

The roof covering (shingles) is at the end of its expected useful life, and the life of covering has expired. The covering (shingles) does need to be replaced. Recommend replace shingles by licensed qualified roof contractor.

Shingles are damaged, torn, missing, lifted, show signs of loss of granules, brittle, and curled at edges. Further leaking or deterioration may occur if not corrected.

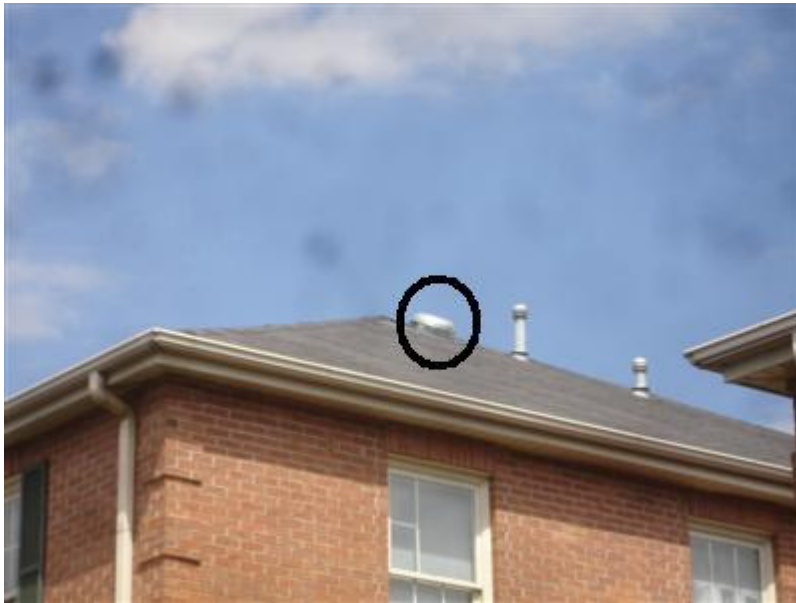
1.3 Picture 1

(1) Power roof vents (2) appear to have been installed recently. These were likely installed due to improper or lack of ventilation at top of roof. Power vents did not function at time of inspection. Recommend repair by licensed roof or electrical contractor.

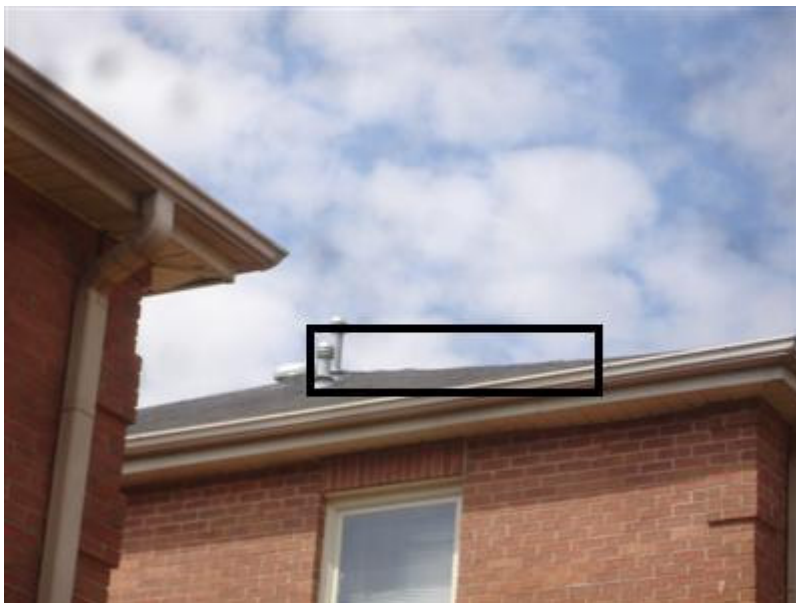
1.5 Picture 1

(1) There are some large dips or sags noted at roof left side upper section. This may be caused from excessive moisture in attic, improper fastening of roof sheathing, or poorly constructed (rafters are not plane).. Recommend repair by licensed qualified contractor..

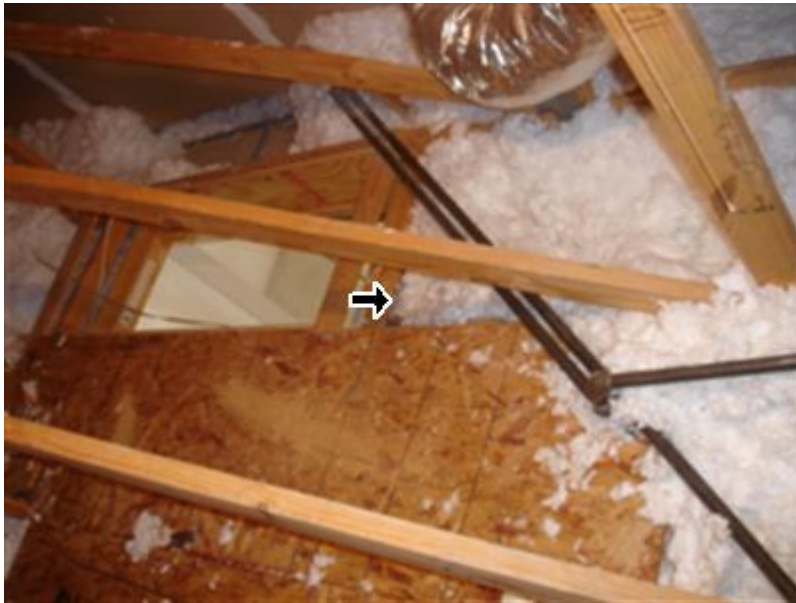
1.5 Picture 2

(2) Recommend installing platform in attic at top of attic access stairs (both attic accesses). Injury may occur. Recommend repair by qualified contractor.

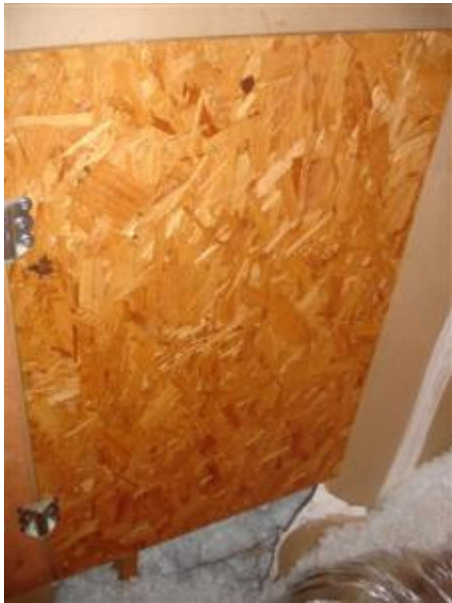
1.5 Picture 4

(3) I was unable to visually inspection a small section of attic due to limited accessibility.

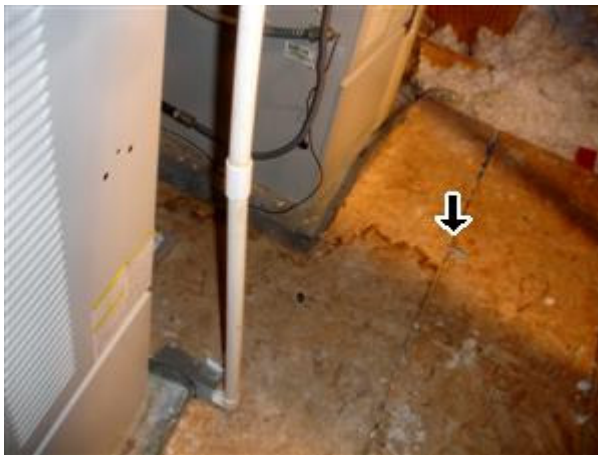
1.5 Picture 5

(4) Water stains noted in attic around HVAC units. These stains appear to be old leaks from old HVAC units. Recommend further evaluation and repair if needed by qualified contractor.

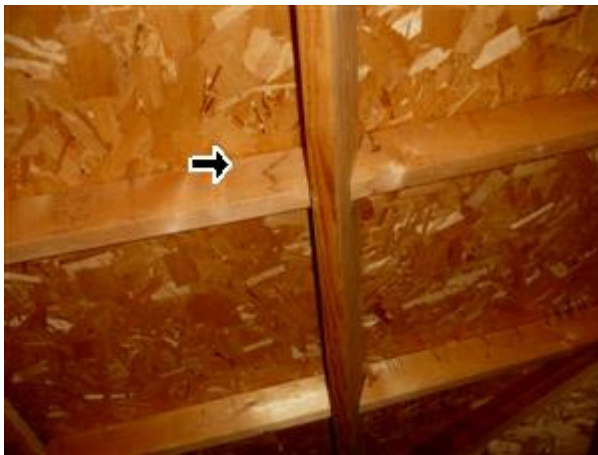
1.5 Picture 6

(5) Water stains noted in attic at plywood and rafters in several areas. This is likely due to damaged shingles. Further leaking or damage may occur. Recommend repair by qualified contractor.

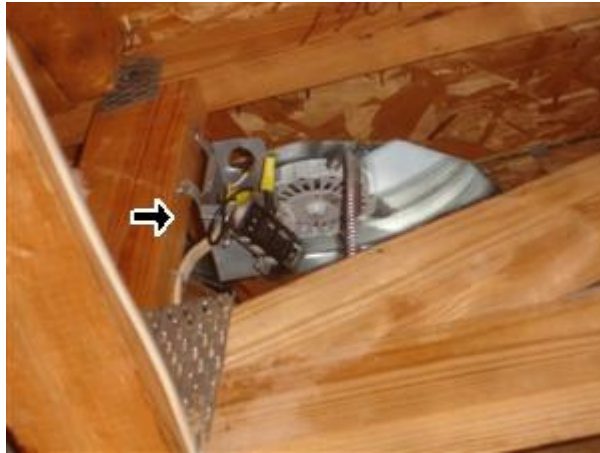
1.8 Picture 1

Power vent fan in attic has exposed electrical wiring/splice. This is a safety issue. Recommend repair by licensed electrician.

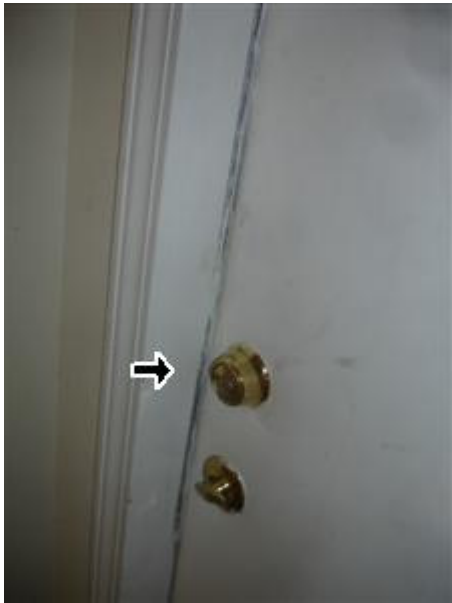
2.1 Picture 1

Exterior entry doors have double sided key dead bolt locks. This is a safety issue (fire escape hazard). Recommend replace locks with turn handle type for insides.

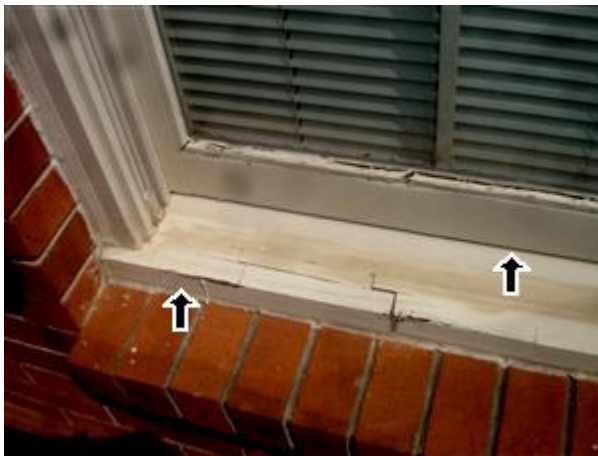
2.2 Picture 1

The wood trim and window frames are deteriorated or damaged at most windows. Further deterioration may occur if not repaired. Due to amount of damage replacement of windows is likely. Recommend repair by qualified licensed contractor.

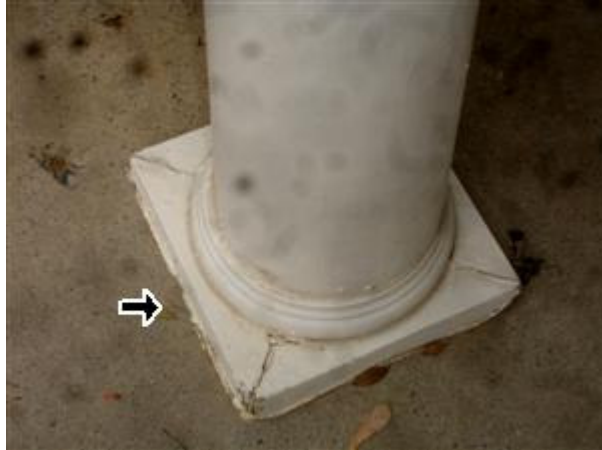
2.4 Picture 1

Front porch main entry support columns are deteriorated at bottoms. Further deterioration may occur. Recommend repair by qualified licensed contractor.

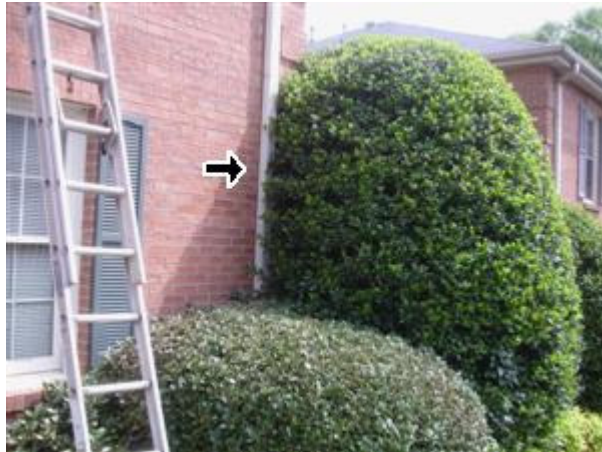
2.5 Picture 1

(1) The tree limbs that are in contact with roof or hanging near roof should be trimmed. Plants, shrubs, and all vegetation should be trimmed 6 inches away from exterior cladding. Pest intrusion or deterioration may occur if not corrected. Recommend repair by qualified person.

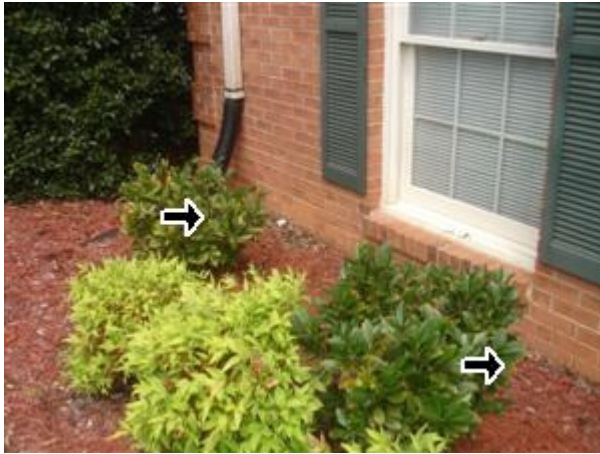
2.5 Picture 4

- 🏠 (2) There is a negative slope towards the front of building left side of main entry. Water intrusion may occur. This area does not appear to drain water away from building and needs landscaping and drainage corrected by licensed contractor.

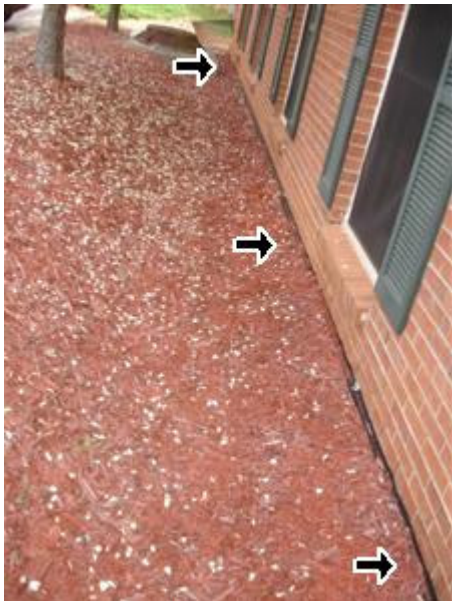
2.5 Picture 5

- 🏠 (3) It appears recent repairs were made at grade left side of building due to water or moisture intrusion into building. Repairs do not appear to be sufficient as water or moisture intrusion is still occurring into building. Additional repairs to grade and drainage are needed. Further damage may occur if not corrected. Recommend repair by water infiltration specialist or licensed contractor.

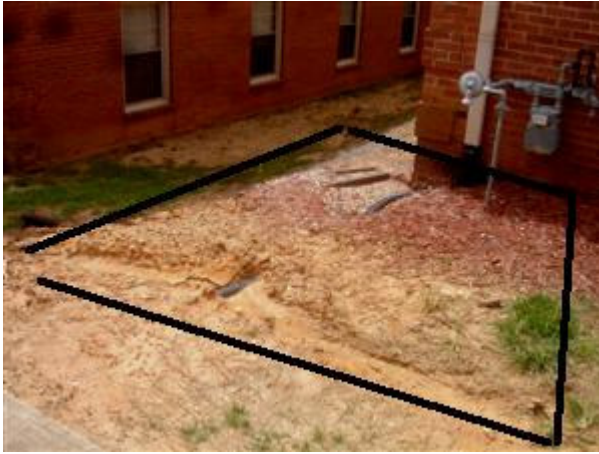
2.5 Picture 6

(4) Erosion is occurring rear left corner of building. Further erosion may occur if not corrected. Recommend repair by qualified contractor.

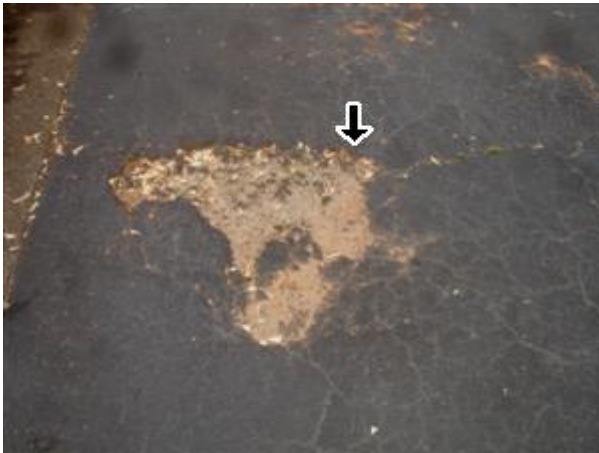
2.5 Picture 7

(5) The asphalt parking lot at the front and side of building is pitted and/or cracked in areas. Water can cause further deterioration if not repaired and sealed properly. Recommend repair by qualified contractor..

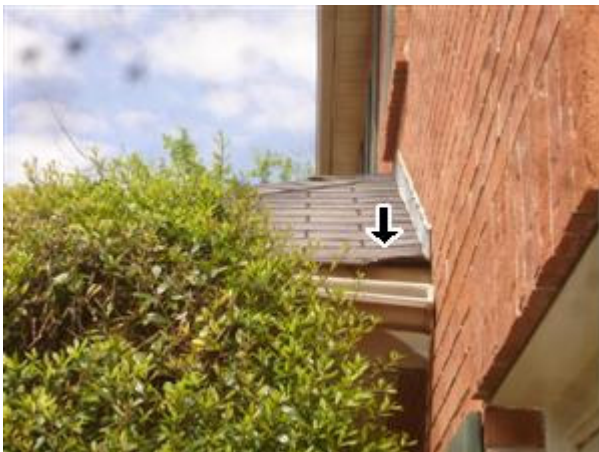
2.6 Picture 1

Fascia and soffit front porch main entry are damaged or pulling loose. Further damage may occur. Recommend repair by licensed qualified contractor.

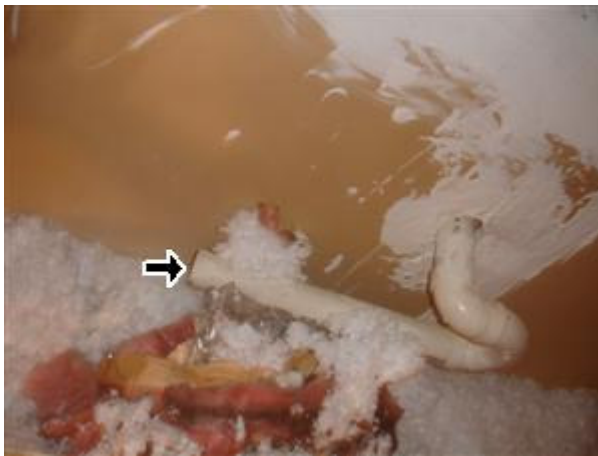
4.0 Picture 1

Open plumbing vent piping noted in attic. Vents did not extend through roof. Recommend extending vent piping thorough roof by licensed plumber.

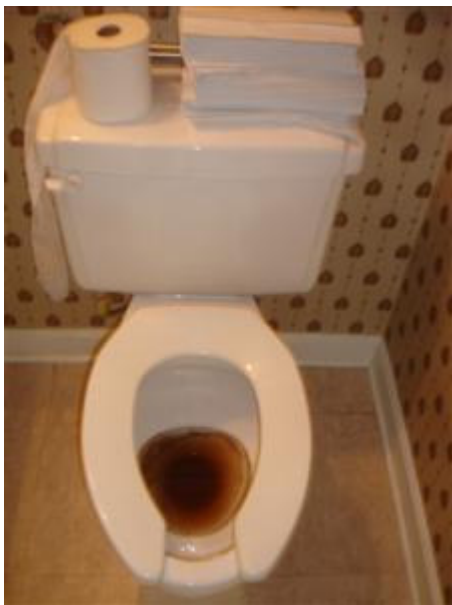
4.1 Picture 1

Water was not turned onto building at time of inspection. Recommend further evaluation by licensed plumber.

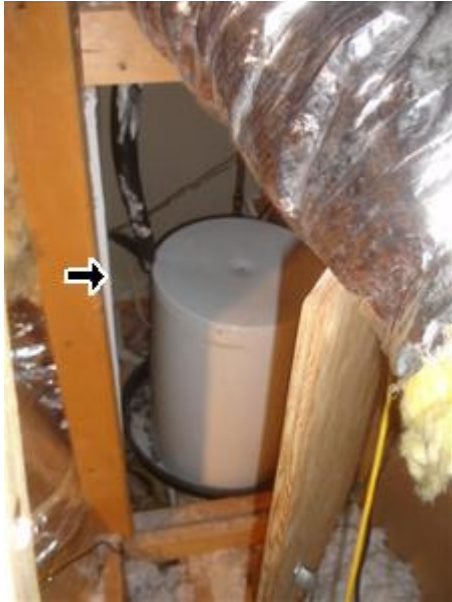
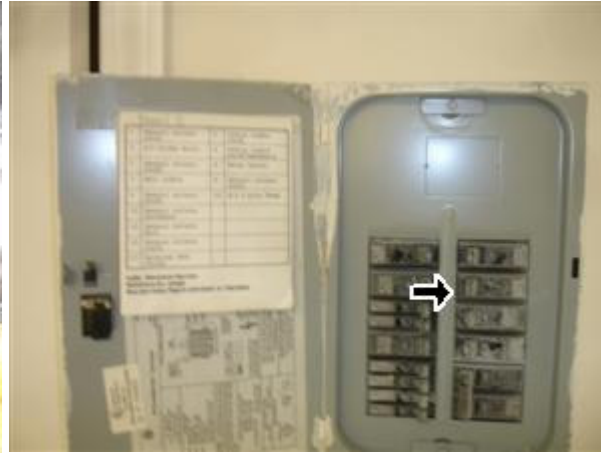
- 🏠 (1) Electrical disconnect breaker not present for electric water heater in attic. Recommend install by licensed plumber. Electric breaker was on at time of inspection and water was not. This may have caused damage to water heater.

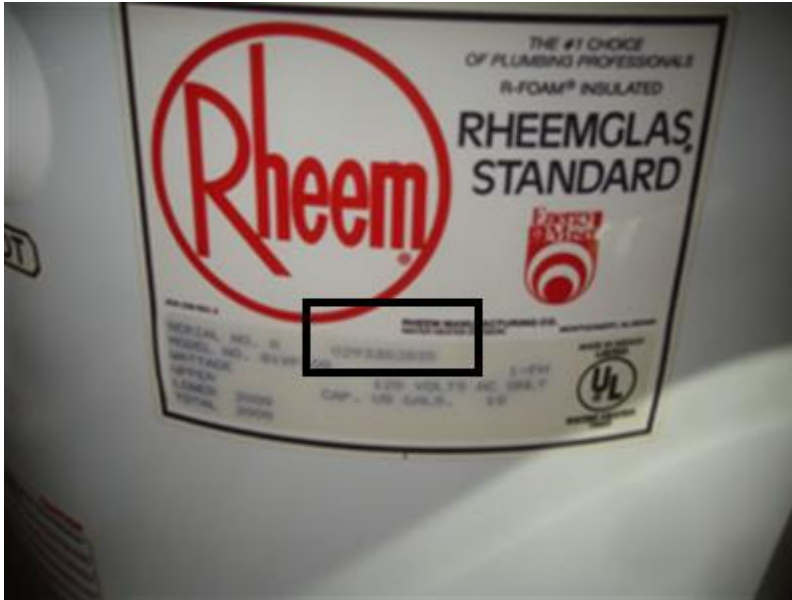
4.2 Picture 3

- (2) Electric water heater is 15 years old and past its expected useful life. I was not able to test for proper operation due to water not being turned on at time of inspection. Recommend budget on replacement.

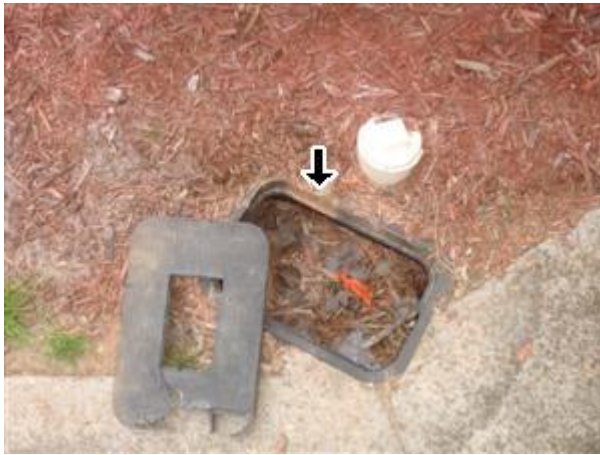
4.3 Picture 1

- 🏠 (1) Main waste meter box rear of building is damaged and full of debris/dirt. Recommend repair by licensed plumber or water service company.

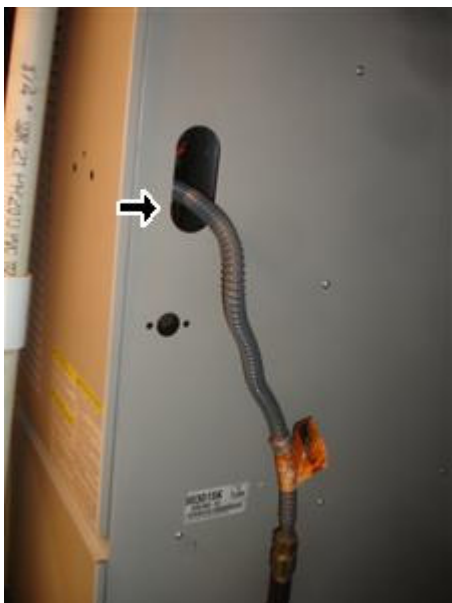
4.4 Picture 1

- 🏠 Gas line for HVAC unit in attic is flex type and should be solid piping. This is a safety issue. Recommend repair by licensed HVAC contractor.

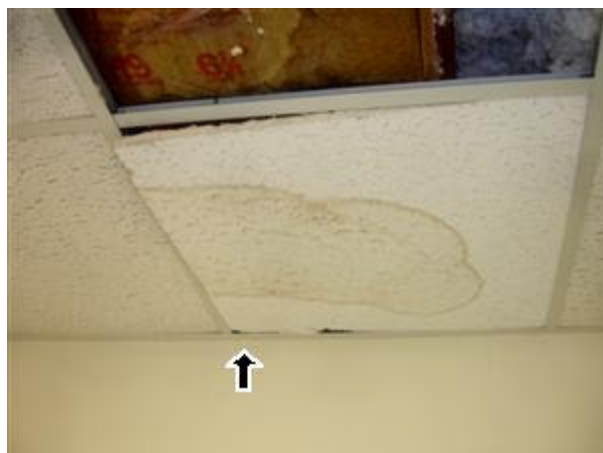
5.0 Picture 1

Water stains/damage noted at ceiling tiles in several rooms. This is likely due to improper insulating of duct piping. Unable to determine exact issues for all leaks. Further damage may occur. Recommend repair by qualified contractor.

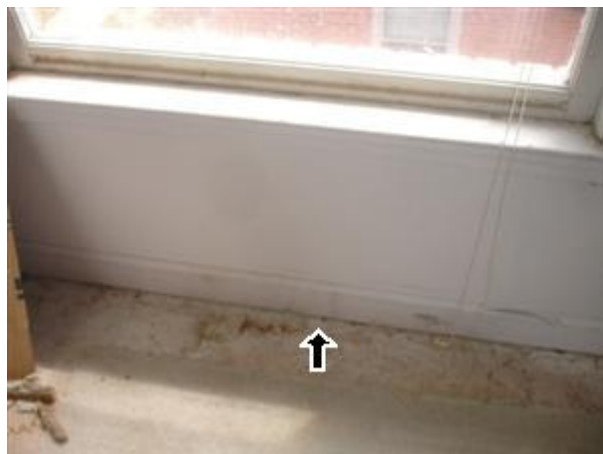
5.1 Picture 1

(1) Water stains/damage noted in upstairs office room rear left side of building below window. This is likely due to failing trim/sealant at exterior. Further damage may occur. Recommend repair by qualified contractor.

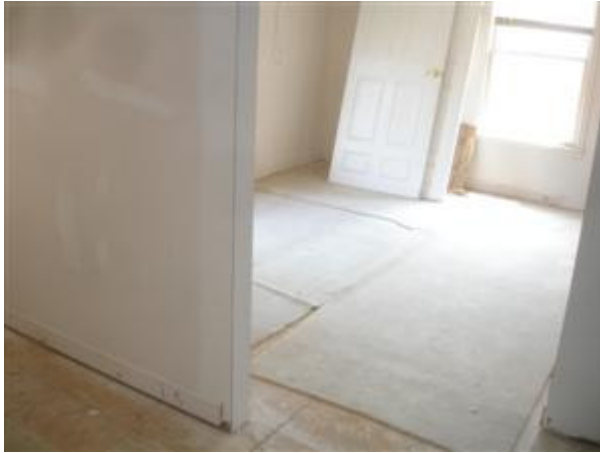
5.1 Picture 2

- (2) Several rooms were incomplete. Recommend completing rooms such as trim, doors, flooring, paint as desired by qualified licensed contractor.

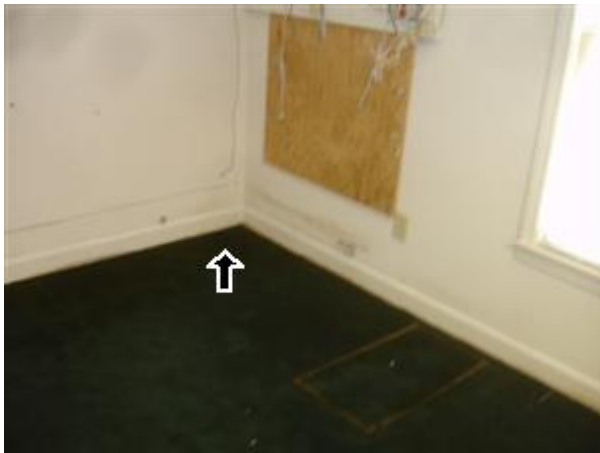
5.1 Picture 3

(3) Water intrusion/damage noted at bottom of walls left side of building (due to grade/drainage exterior). Further damage may occur. Recommend repair by qualified contractor.

Signs of fungi growth is present on the walls/floors main floor left side of building in several areas. We did not inspect, test or determine if this growth is or is not a health hazard. The underlying cause is moisture. I recommend you contact a mold inspector or expert for investigation or correction if needed.

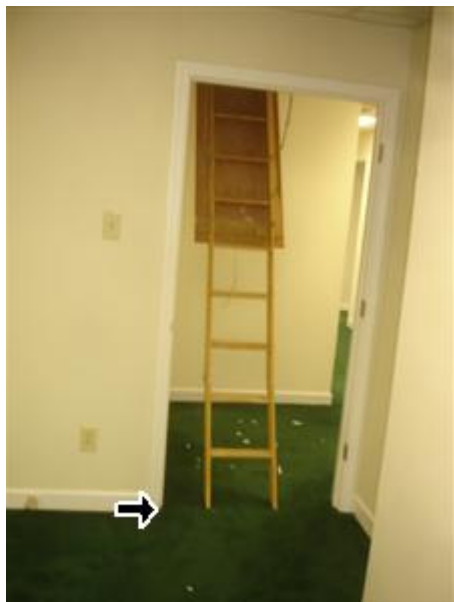
5.2 Picture 1

Signs of settlement noted upstairs in a few areas. Further settlement may occur if not corrected. Doors may not open/close properly because of settlement. Recommend repair by qualified contractor.

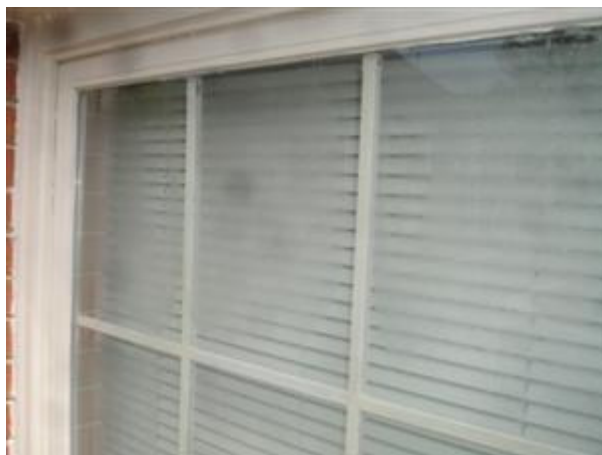
5.4 Picture 1

Most Windows are cloudy (lost seal) in Most Rooms. This can cause some heat loss in winter and loss of cool air in summer if not corrected (HVAC lower units ran continuously at time of inspection). In order to correct the cloudy appearance of glass, a replacement of glass pane or the unit will be necessary. Recommend replace by licensed contractor..

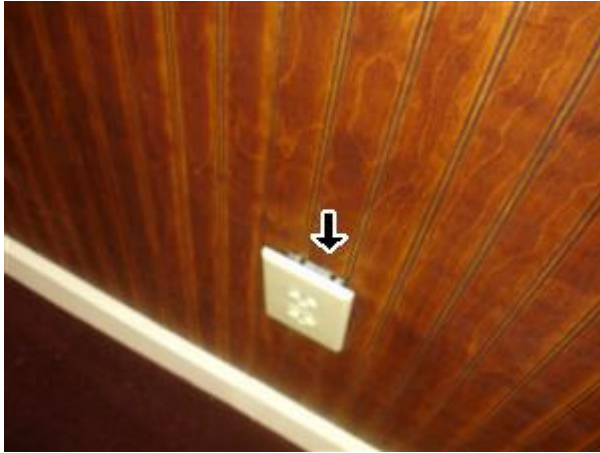
5.6 Picture 1

Receptacles were loose in a few rooms. This is a safety issue. Recommend repair by licensed electrician.

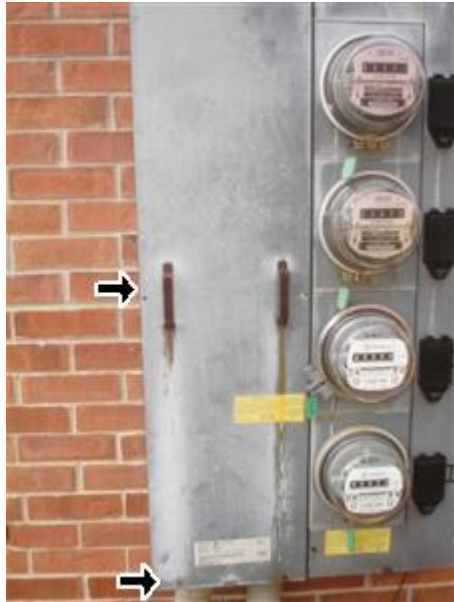
8.1 Picture 1

Main electrical disconnect box was rusted and I could not access the left side. Box is also loose and not properly secured or sealed to brick cladding. Recommend repair by licensed electrician.

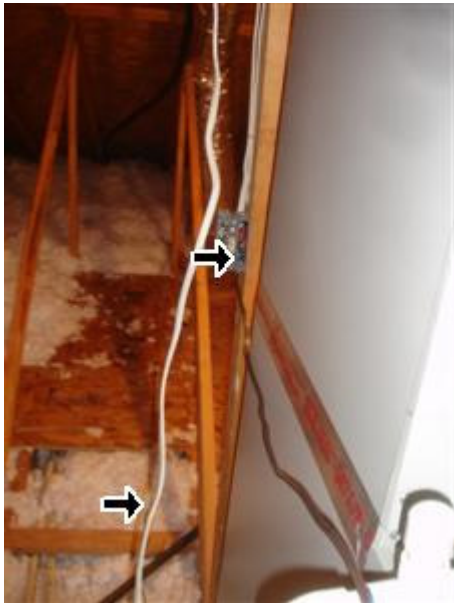
8.3 Picture 1

Electrical wiring in attic is not properly covered or fastened near attic access and HVAC units. Switch plate covers were also missing/damaged. These are safety issues. Recommend repair by licensed electrician.

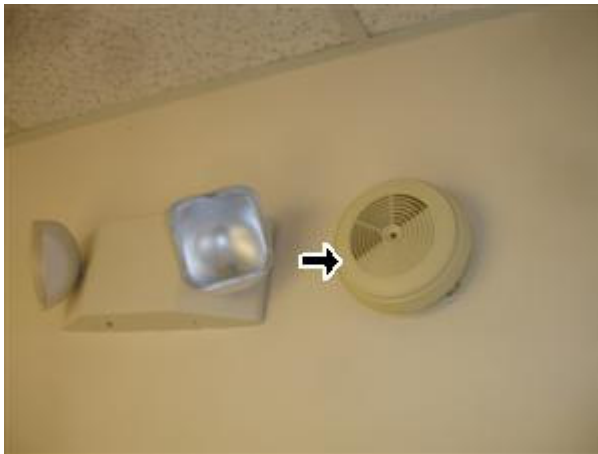
8.7 Picture 1

Several smoke detectors did not work when tested at time of inspection. Recommend repair by qualified contractor.

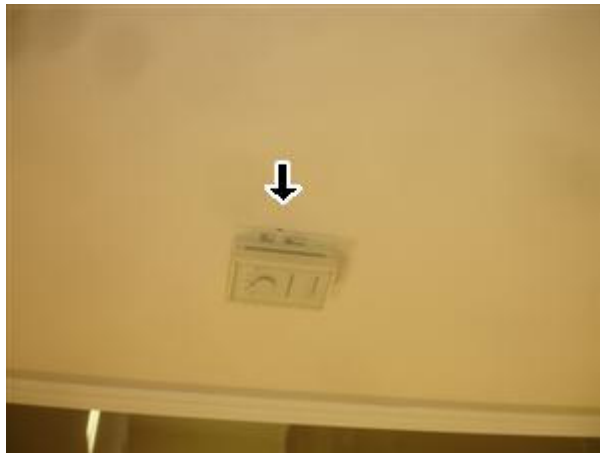
9.0 Picture 1

(1) Main floor HVAC units ran continuously at time of inspection (ran AC only). This was likely due to the amount of damage at windows and building not being properly sealed. This may cause damage to HVAC units if not corrected.

Recommend repair by licensed HVAC contractor.

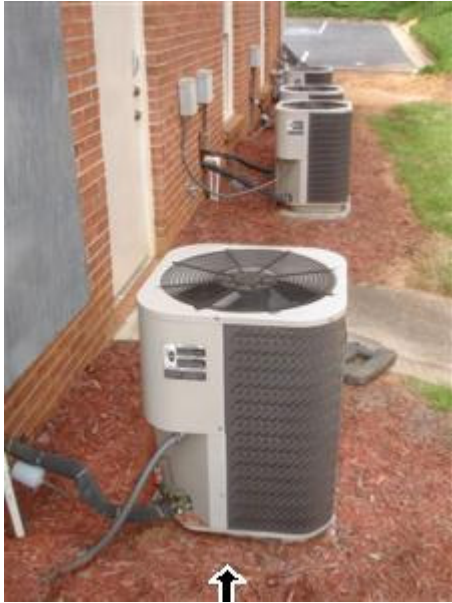
9.2 Picture 1

Platform for AC units rear of building are below grade and/or not level. Damage to units may occur. Recommend repair by licensed contractor.

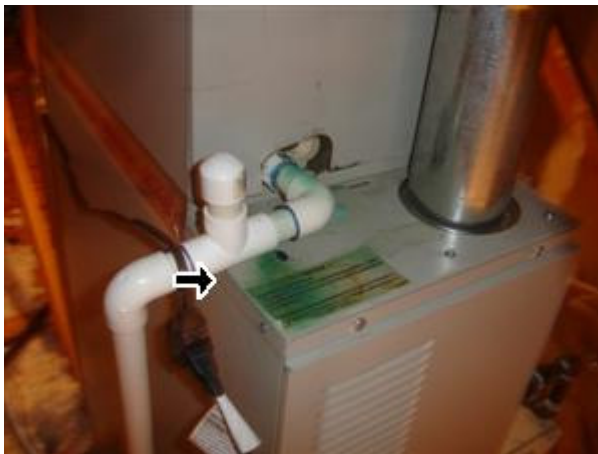
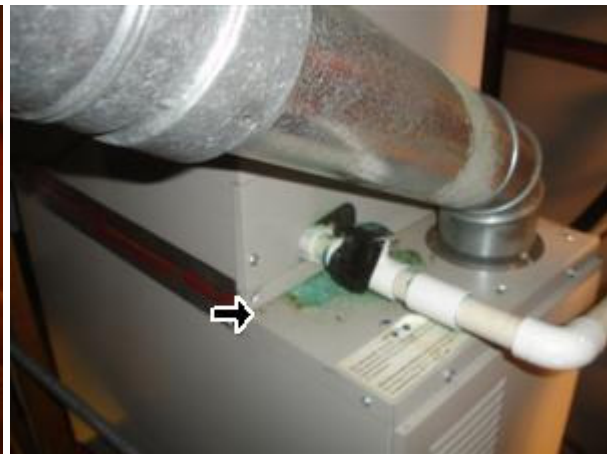
- 🏠 (1) Condensation piping for AC units in attic are leaking where piping enters into unit. Further leaking or damage to HVAC units may occur. Recommend repair by licensed HVAC contractor.

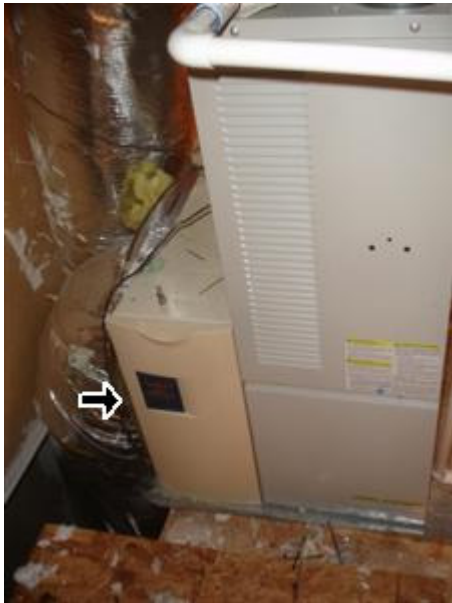
9.6 Picture 3

- 🏠 (2) HVAC filters are located at units in attic and ceilings at main and upper floors. Filters are clogged/dirty. Recommend change filters.

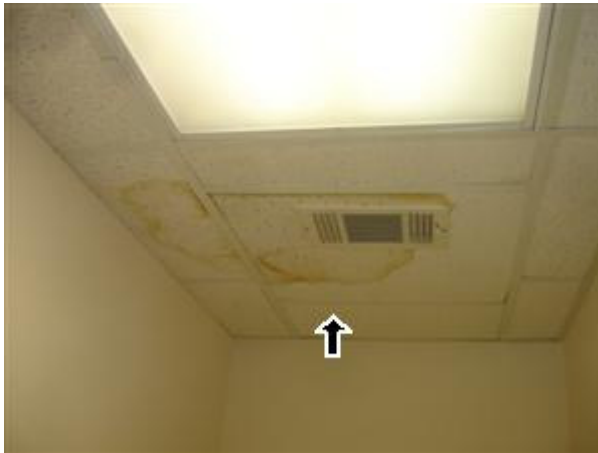
9.6 Picture 5

(3) Water stains/damage noted around HVAC registers. This is likely due to improper insulating of duct piping. Further damage may occur. Recommend repair by licensed HVAC contractor.

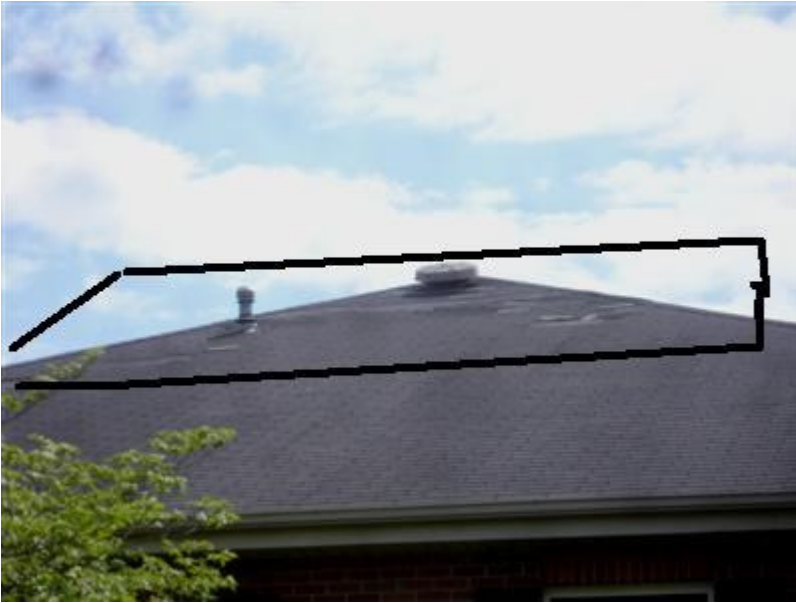
1.0 Picture 1

The roof covering (shingles) is at the end of its expected useful life, and the life of covering has expired. The covering (shingles) does need to be replaced. Recommend replace shingles by licensed qualified roof contractor.

Shingles are damaged, torn, missing, lifted, show signs of loss of granules, brittle, and curled at edges. Further leaking or deterioration may occur if not corrected.

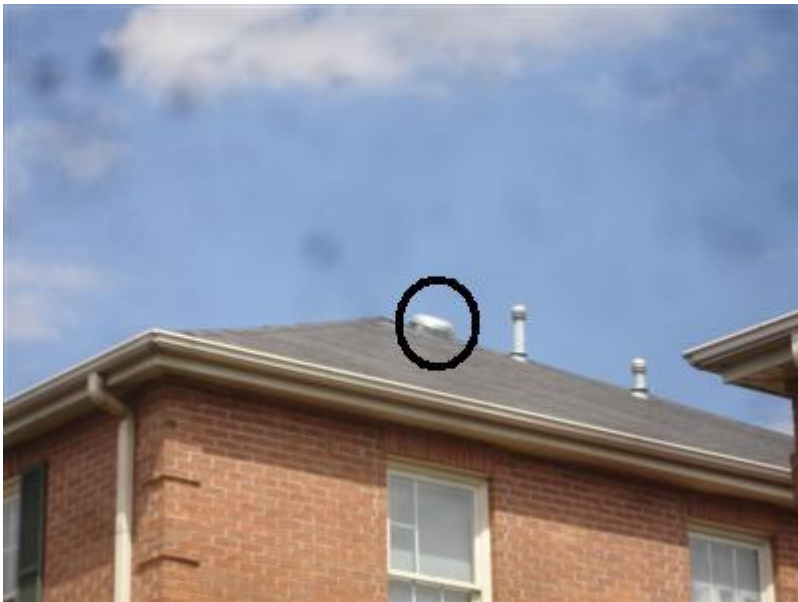
1.3 Picture 1

(1) Power roof vents (2) appear to have been installed recently. These were likely installed due to improper or lack of ventilation at top of roof. Power vents did not function at time of inspection. Recommend repair by licensed roof or electrical contractor.

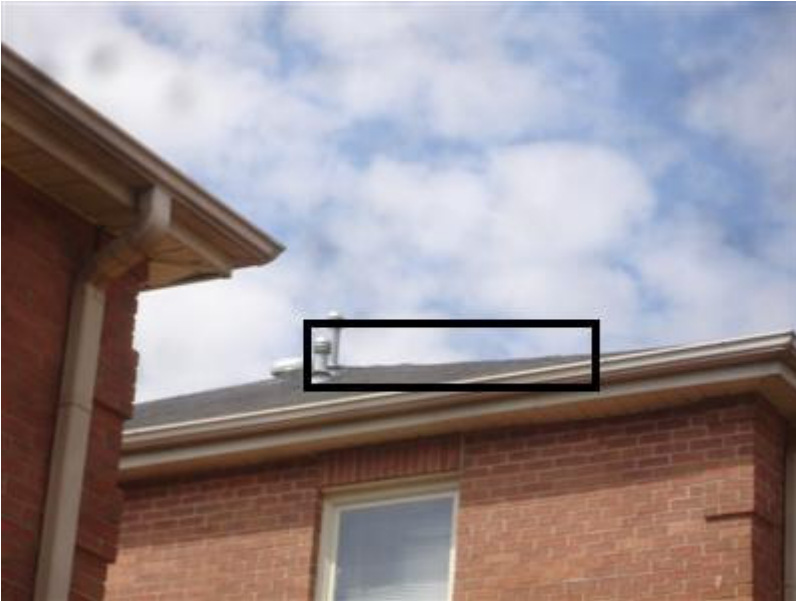
1.5 Picture 1

(1) There are some large dips or sags noted at roof left side upper section. This may be caused from excessive moisture in attic, improper fastening of roof sheathing, or poorly constructed (rafters are not plane).. Recommend repair by licensed qualified contractor..

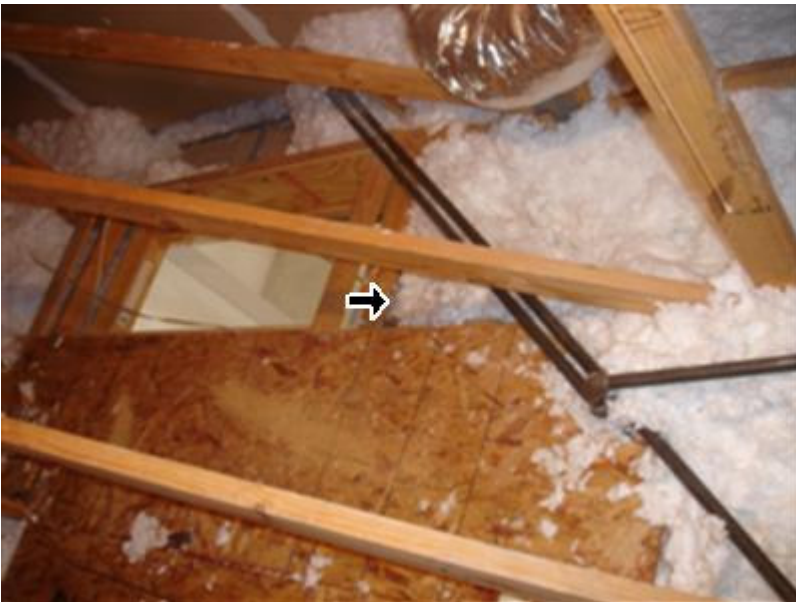
1.5 Picture 2

(2) Recommend installing platform in attic at top of attic access stairs (both attic accesses). Injury may occur. Recommend repair by qualified contractor.

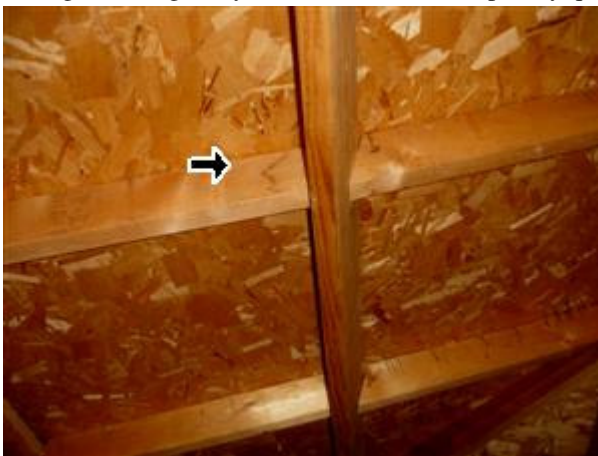
1.5 Picture 6

(5) Water stains noted in attic at plywood and rafters in several areas. This is likely due to damaged shingles. Further leaking or damage may occur. Recommend repair by qualified contractor.

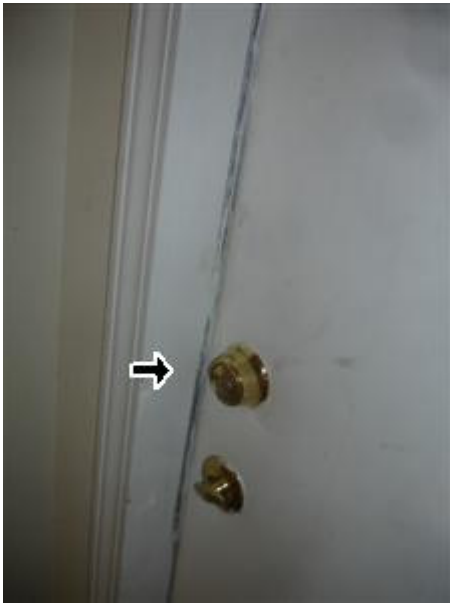
2.1 Picture 1

Exterior entry doors have double sided key dead bolt locks. This is a safety issue (fire escape hazard). Recommend replace locks with turn handle type for insides.

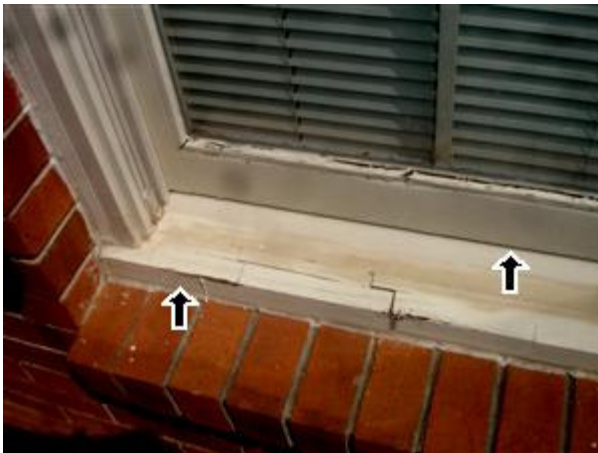
2.2 Picture 1

The wood trim and window frames are deteriorated or damaged at most windows. Further deterioration may occur if not repaired. Due to amount of damage replacement of windows is likely. Recommend repair by qualified licensed contractor.

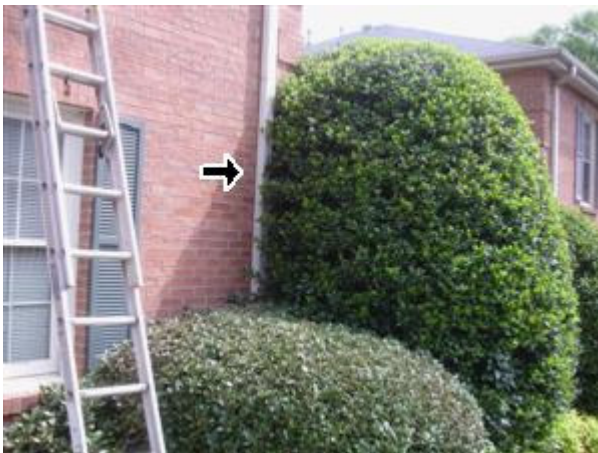
2.5 Picture 1

(1) The tree limbs that are in contact with roof or hanging near roof should be trimmed. Plants, shrubs, and all vegetation should be trimmed 6 inches away from exterior cladding. Pest intrusion or deterioration may occur if not corrected. Recommend repair by qualified person.

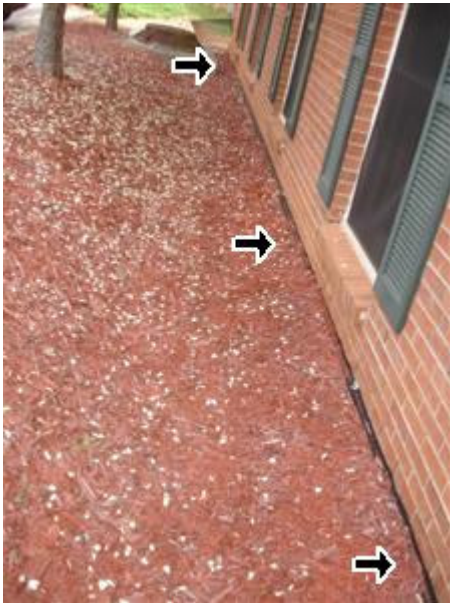
2.5 Picture 5

(3) It appears recent repairs were made at grade left side of building due to water or moisture intrusion into building. Repairs do not appear to be sufficient as water or moisture intrusion is still occurring into building. Additional repairs to grade and drainage are needed. Further damage may occur if not corrected. Recommend repair by water infiltration specialist or licensed contractor.

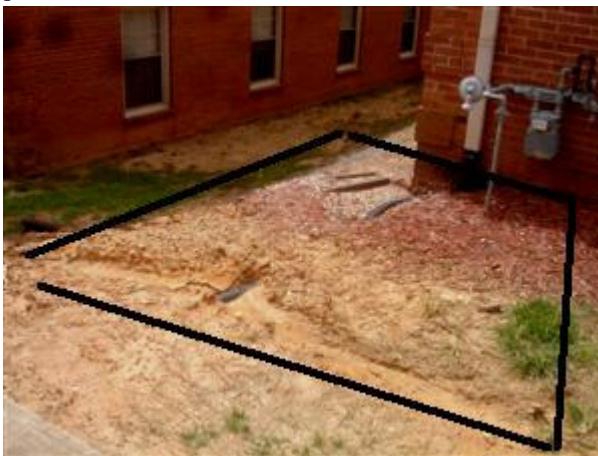
2.5 Picture 6

(4) Erosion is occurring rear left corner of building. Further erosion may occur if not corrected. Recommend repair by qualified contractor.

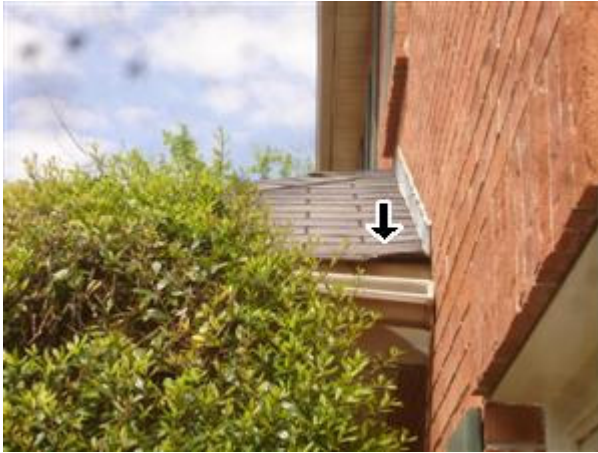
2.6 Picture 1

Fascia and soffit front porch main entry are damaged or pulling loose. Further damage may occur. Recommend repair by licensed qualified contractor.

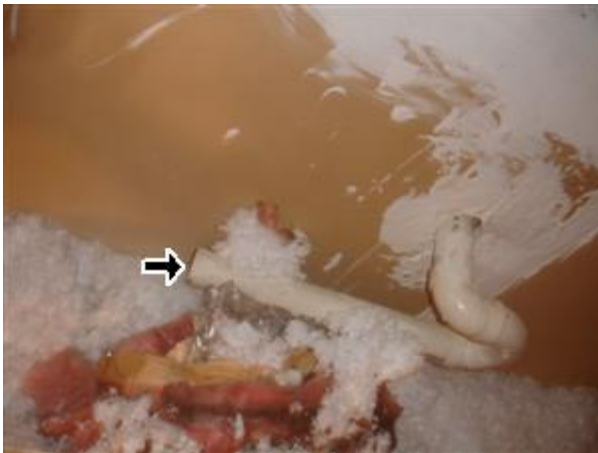
4.0 Picture 1

Open plumbing vent piping noted in attic. Vents did not extend through roof. Recommend extending vent piping through roof by licensed plumber.

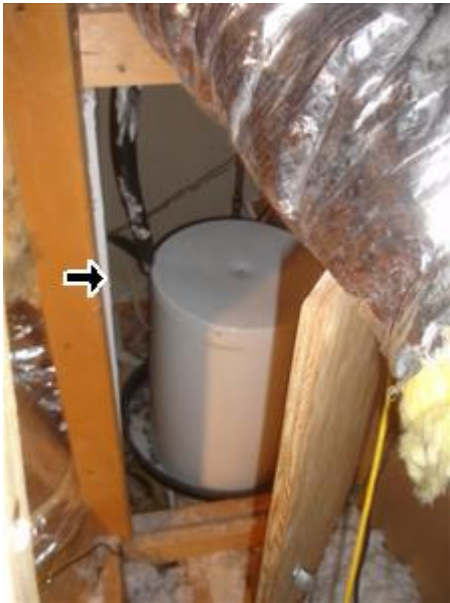
4.2 Picture 1

(1) Electrical disconnect breaker not present for electric water heater in attic. Recommend install by licensed plumber. Electric breaker was on at time of inspection and water was not. This may have caused damage to water heater.

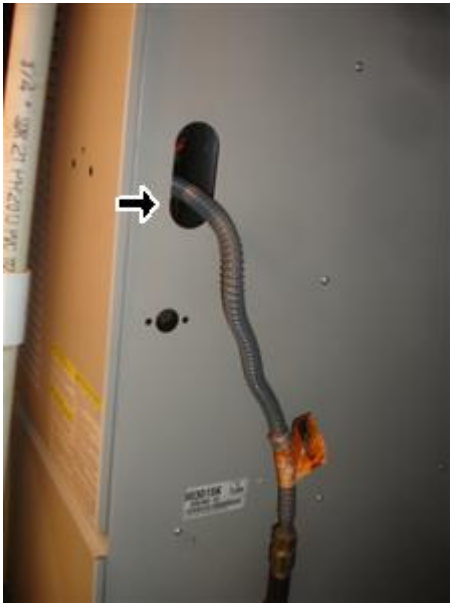
4.4 Picture 1

Gas line for HVAC unit in attic is flex type and should be solid piping. This is a safety issue. Recommend repair by licensed HVAC contractor.

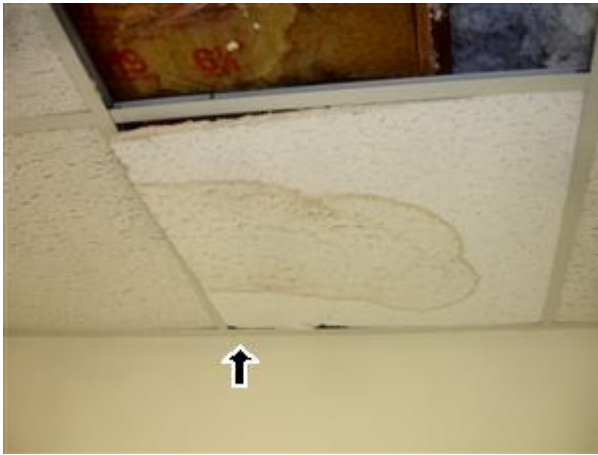
5.0 Picture 1

Water stains/damage noted at ceiling tiles in several rooms. This is likely due to improper insulating of duct piping. Unable to determine exact issues for all leaks. Further damage may occur. Recommend repair by qualified contractor.

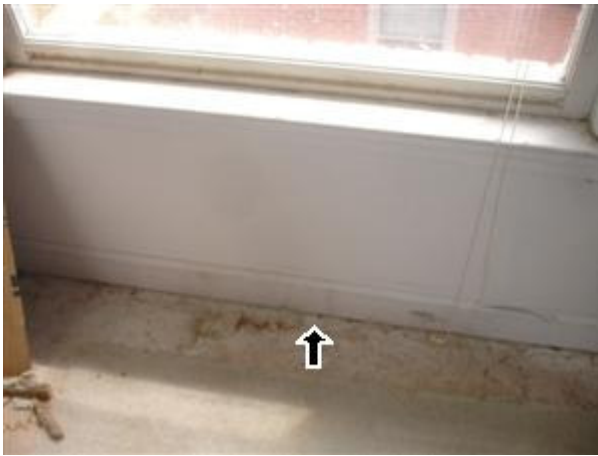
5.1 Picture 1

(1) Water stains/damage noted in upstairs office room rear left side of building below window. This is likely due to failing trim/sealant at exterior. Further damage may occur. Recommend repair by qualified contractor.

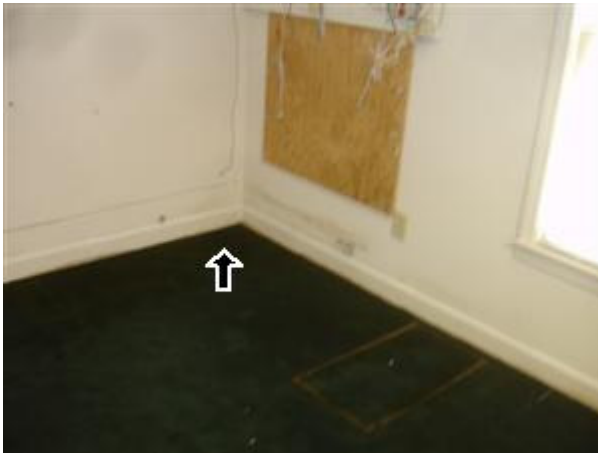
5.1 Picture 3

(3) Water intrusion/damage noted at bottom of walls left side of building (due to grade/drainage exterior). Further damage may occur. Recommend repair by qualified contractor.

Signs of fungi growth is present on the walls/floors main floor left side of building in several areas. We did not inspect, test or determine if this growth is or is not a health hazard. The underlying cause is moisture. I recommend you contact a mold inspector or expert for investigation or correction if needed.

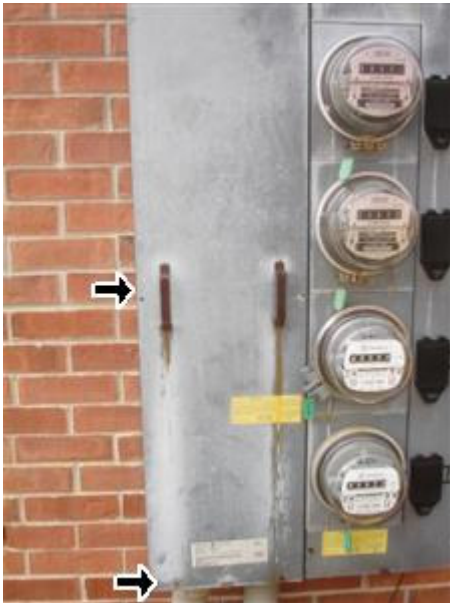
8.1 Picture 1

Main electrical disconnect box was rusted and I could not access the left side. Box is also loose and not properly secured or sealed to brick cladding. Recommend repair by licensed electrician.

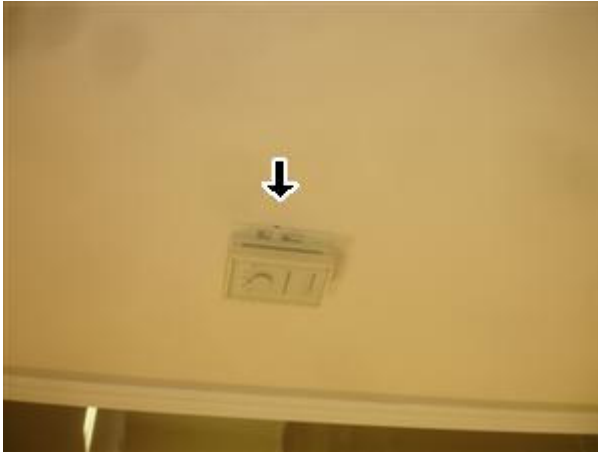
9.0 Picture 1

(2) Main floor data room (near rear bathroom) thermostat does not work. Room also did not produce controlled air. Recommend repair by licensed HVAC contractor.
