Inspection Report

Atlanta Home Inspection

Property Address:
Springdale Road NE
Atlanta GA 30306

Date: 6/26/2012	Time: 12:25 PM	Report ID: 062612-2
Property: Springdale Road NE Atlanta GA 30306	Customer: Atlanta Home Inspection	Real Estate Professional:

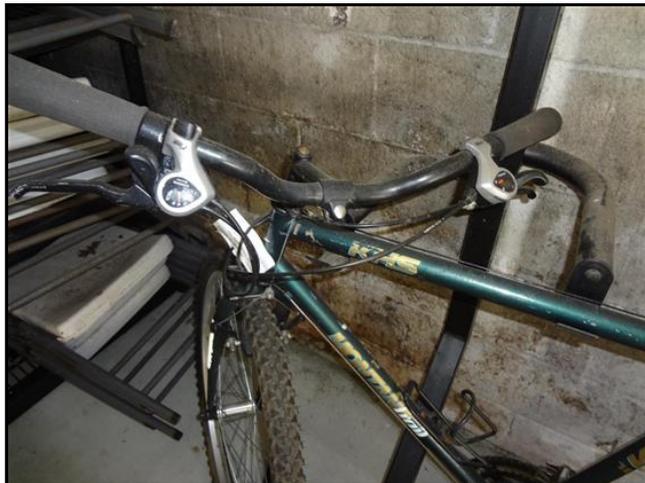
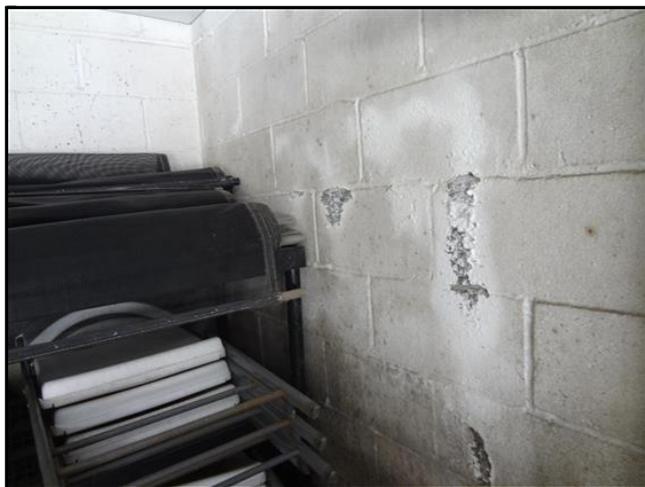
(1) Evidence of elevated moisture was noted in garage at rear foundation block wall. Recommend evaluate by qualified foundation contractor and correct issues as needed.

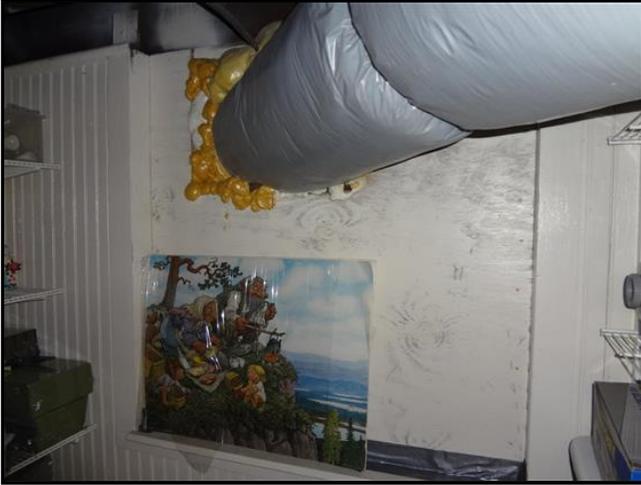
1.0 Item 4(Picture)

(2) There was a section at rear storage room adjacent to the garage that had a plywood cover where duct piping was entering through. I did not see any crawlspace foundations, however I would ask the seller if there was access through this fixed section. If so, evaluate by qualified contractor.

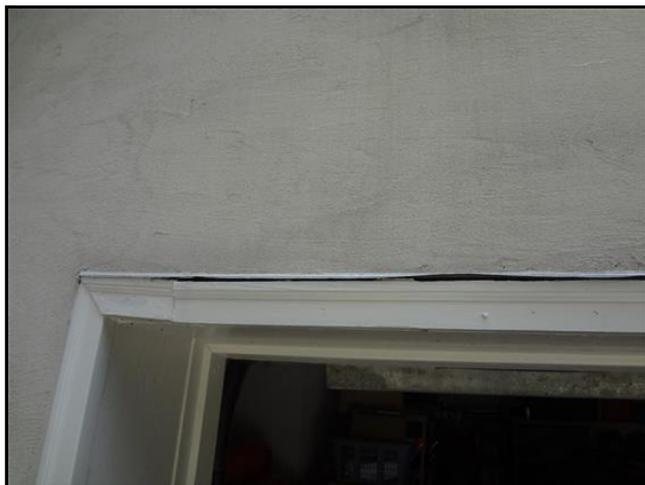
1.1 Item 1(Picture)

Garage header had evidence of sagging or deflection at header. Trim had gaps where it meets flashing. Further damage may occur if not corrected. Recommend further evaluation by qualified structural contractor and repair issues as needed.

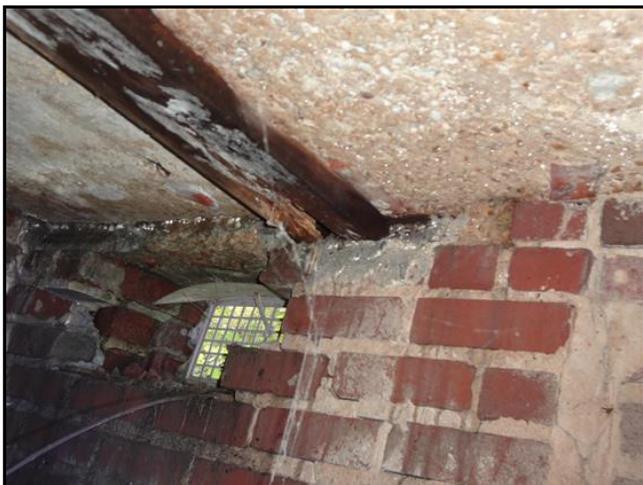
1.3 Item 1(Picture)

Front porch stoop had access through the basement crawlspace door. Evidence of wood structure deterioration and evidence of rusting at the steel floor beams (common due to age). Recommend evaluate by qualified foundation contractor and repair or reinforce as needed.

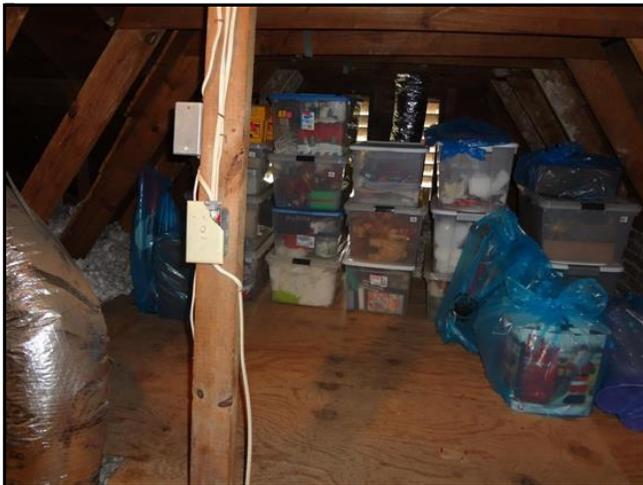
1.5 Item 1(Picture)

(2) I was not able to visually inspect several sections of the attic due to stored items.

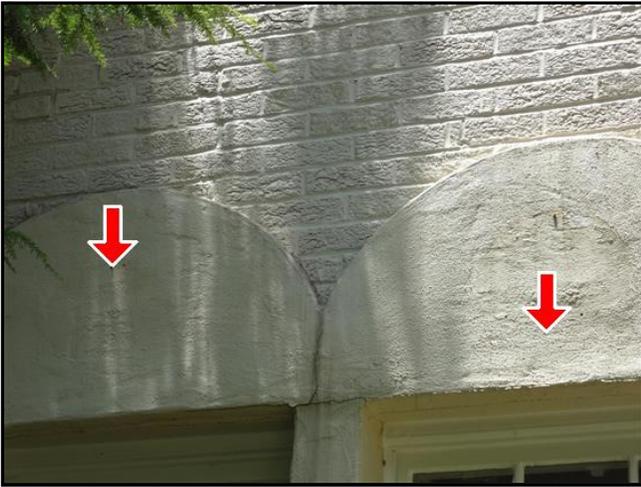
2.0 Item 1(Picture)

Several sections of cladding was hard coat stucco. At these areas, several cracks were noted. Further moisture issues may occur. Recommend repair by qualified stucco contractor.

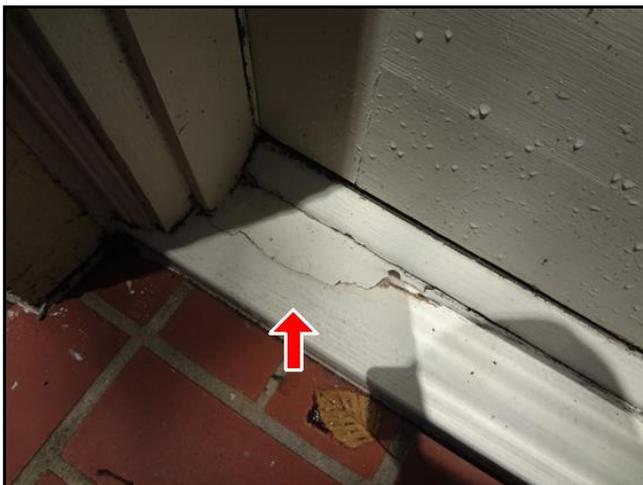
2.1 Item 1(Picture)

(1) Wood entry doors, trim, frames and thresholds had evidence of peeling paint, failing sealant, improper repairs, and small deterioration, several areas, most doors. Recommend repair issues as needed.

Recommend installing cap flashing over top of rear window/doors.

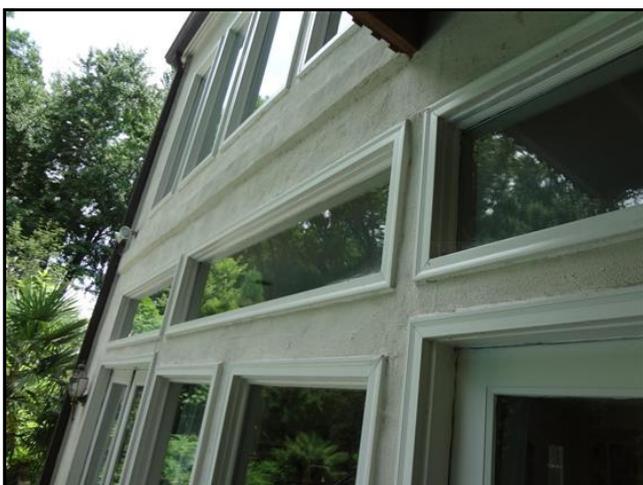
2.1 Item 5(Picture) Recommend installing drip cap flashing

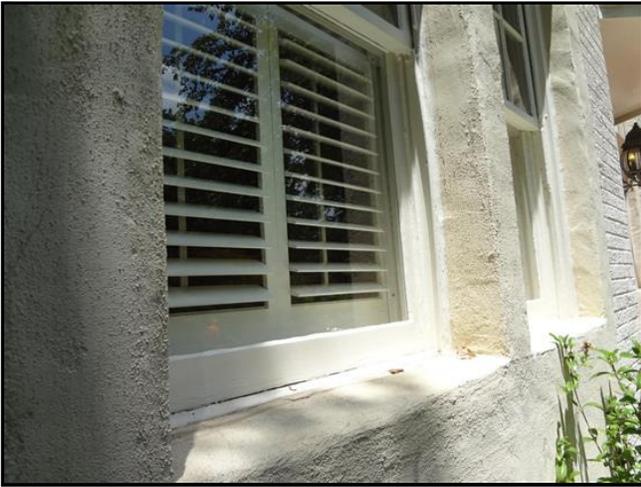
2.2 Item 1(Picture)

Multiple windows were painted shut. Peeling paint, failing sealant and minor deterioration noted at wood sashes, trim and frames. Recommend repair by qualified contractor.

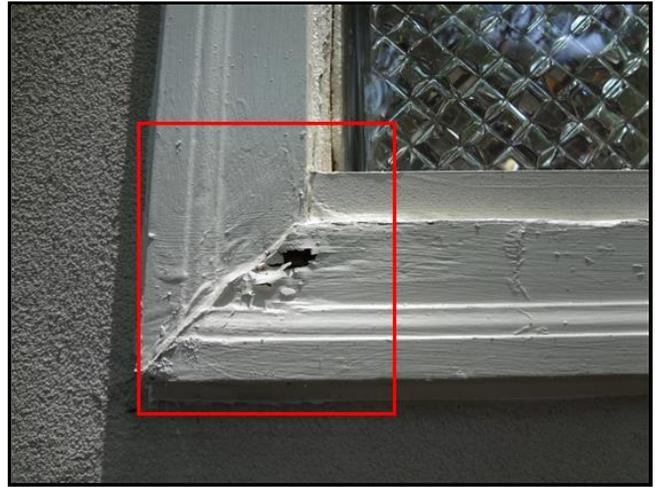
2.2 Item 2(Picture) Deteriorated window trim

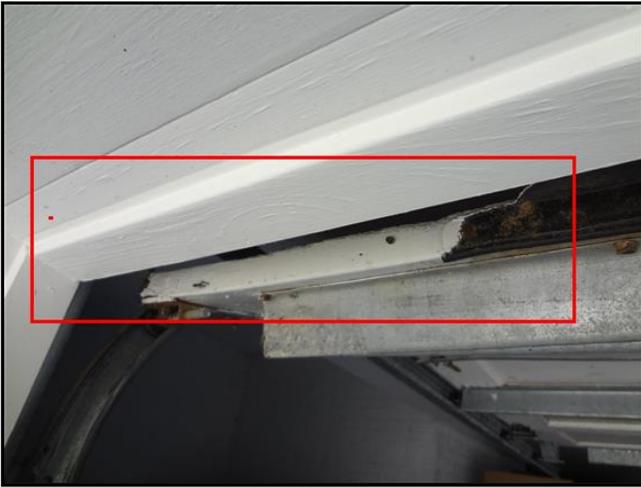
2.3 Item 1(Picture)

Garage door operator did not function properly when tested. Also bottom sweep was deteriorated. Recommend repair issues by qualified contractor.

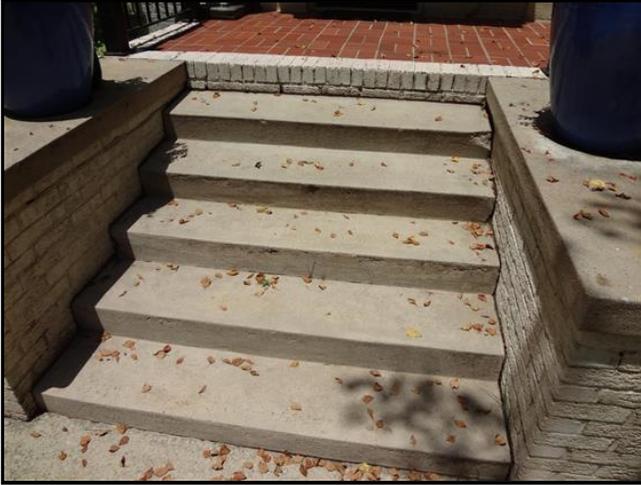
2.4 Item 1(Picture)

(1) Front porch steps were not level and evidence of settlement. Porch brick had multiple cracks. Metal guard railing was loose. Injury or further damage may occur. Recommend repair by qualified contractor.

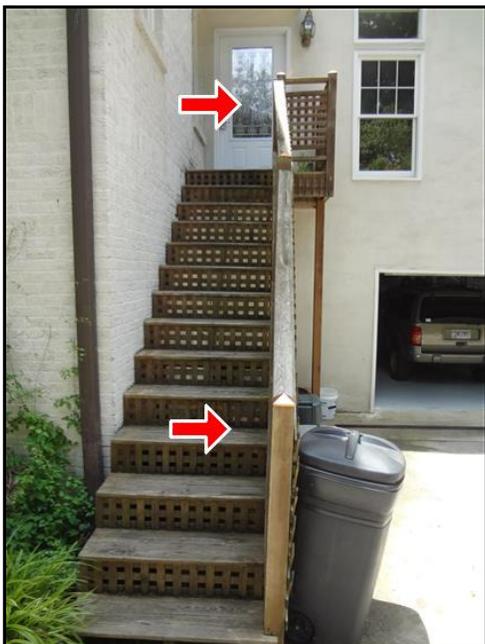
2.4 Item 5(Picture)

(2) Rear set of steps and landing to kitchen entry had issues noted such as: 1. Loose guard railing. 2. Improper support post. 3. Joists not properly secured. 4. Ledger board not properly secured to home. 5. Deterioration at bottom of support post. Injury or further damage may occur. Recommend repair by qualified contractor.

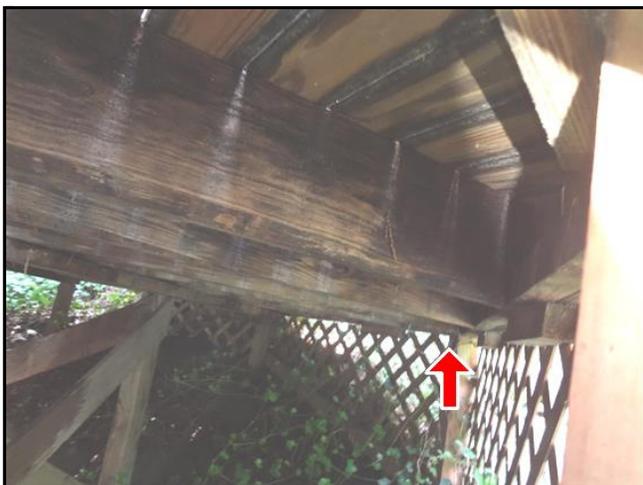
(4) Issues noted at rear decks, balcony and steps such as: 1. Several joists did not have proper support. 2. Wood in contact with ground (causes deterioration and termite coverage is excluded in these areas). 3. Carpenter bee damage. 4. Decking and railing material was aged (at the end of its expected useful life) and no sealant coat noted. Several pieces were deteriorating. 5. Metal railing was rusted. 6. Rusting at upper balcony flashing where it attaches to the home. 7. Stair treads had improper fasteners and improper support.

2.4 Item 13(Picture) Improper support

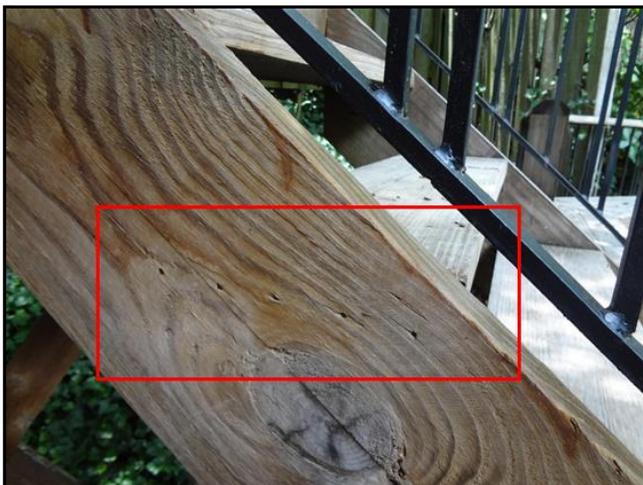
2.4 Item 23(Picture) Improper fasteners for stair tread

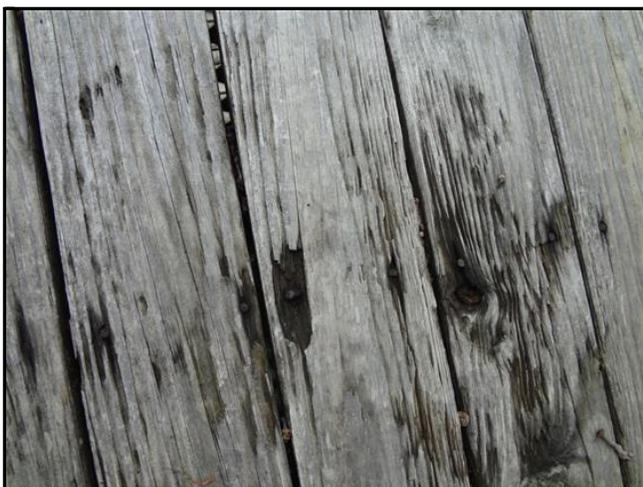
2.4 Item 25(Picture) Example of aged/deteriorated decking

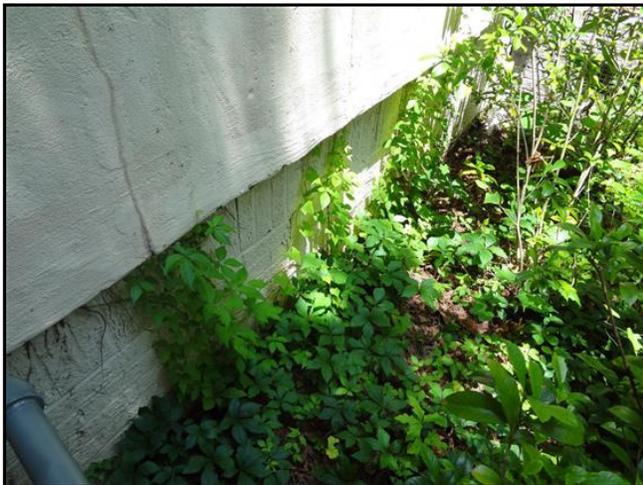
2.5 Item 1(Picture)

(1) Shrubs, Plants, and Vines should be trimmed back at least 6 inches from exterior cladding. Pests, insects, and damage to home may occur if not corrected.

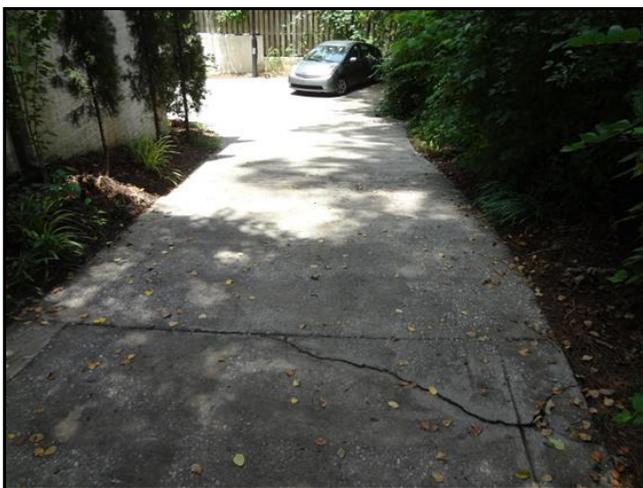
2.5 Item 2(Picture)

(2) Driveway had common settlement cracks. Repair as desired.

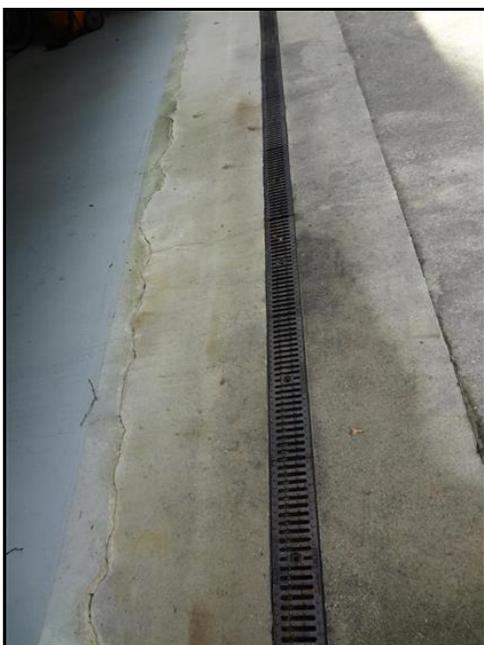
2.5 Item 4(Picture)

(3) French drain installed in front of garage. It will need periodical cleaning.

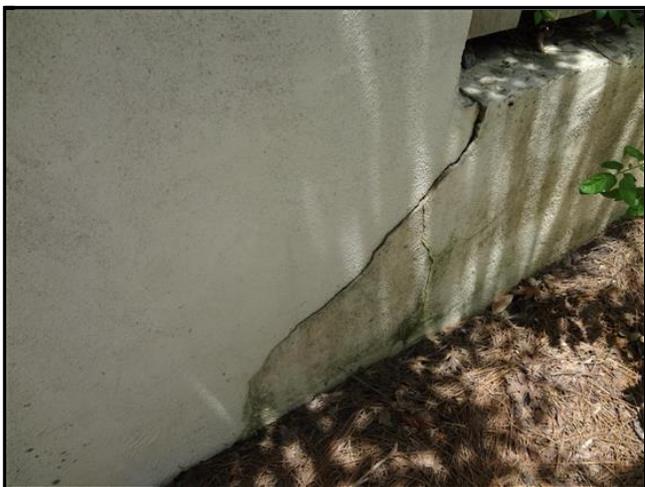
2.5 Item 5(Picture)

(4) Bottom driveway stucco retaining wall had several cracks and veneer was peeling. Recommend repair as needed.

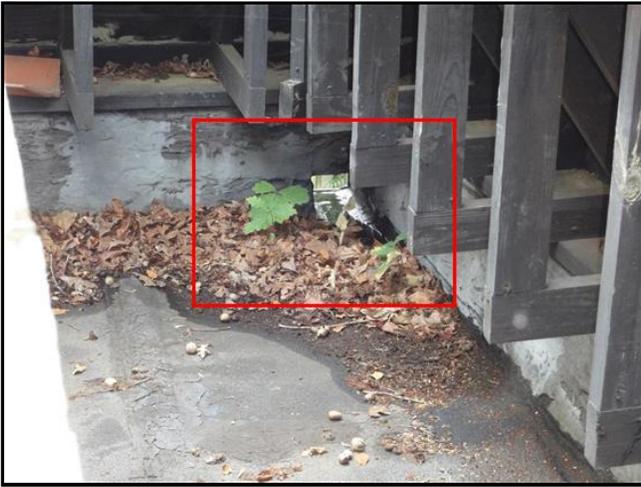
(1) One section of roof was flat at lower right side addition (office room) and several issues noted such as aged rolled roofing material, debris, and roof sealant repairs. Due to type of roof (flat) and the design along with issues noted, I recommend replacing roof material along with a better design (pitched roof) to prevent moisture damage. Roof structure material was aged and showing signs of deterioration. Clay tile were also not constructed or installed properly at this section. Exposed roof decking also present.

3.0 Item 1(Picture) Poor drainage design and debris clogging it

Evaluate by qualified roof contractor and correct issues accordingly.

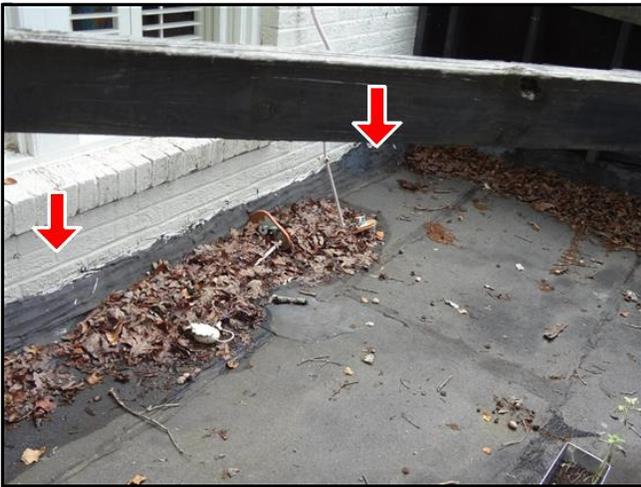
3.0 Item 3(Picture) Layers or roof repairs

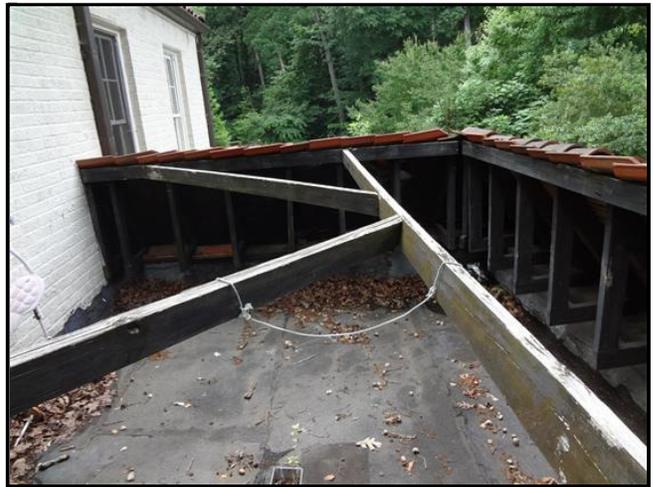
3.0 Item 4(Picture) Structure was a poor design and was aged/deteriorating

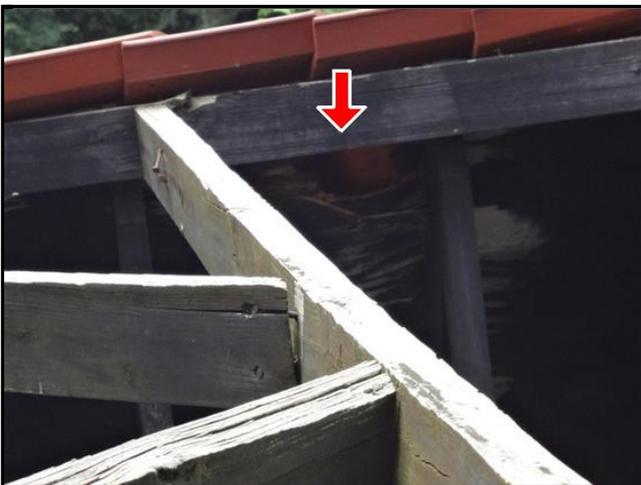
3.0 Item 5(Picture) Deterioration.

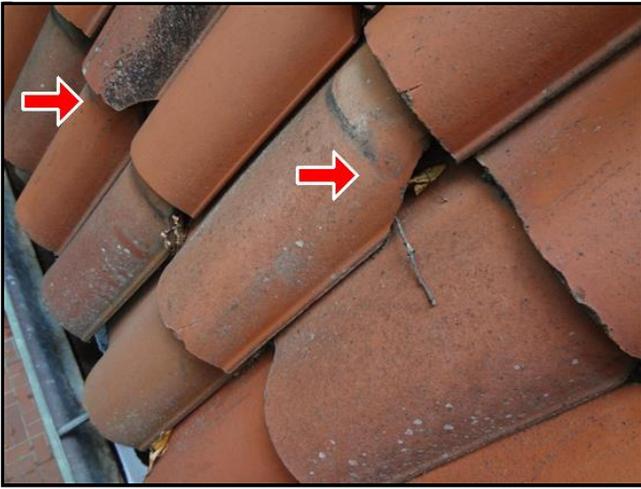
3.0 Item 7(Picture)

(2) Roof covering clay tiles were aged and nearing the end of their expected useful life. Determining life span can be difficult, usually it consists of 30-50 years. As the roof ages, issues arise such as damaged, cracked, loose or missing tiles. Approximately 20 tiles were cracked/damaged/loose. I recommend further evaluation by qualified roof contractor and repair tiles as needed.

I also recommend budget replacement of clay tile roof covering accordingly.

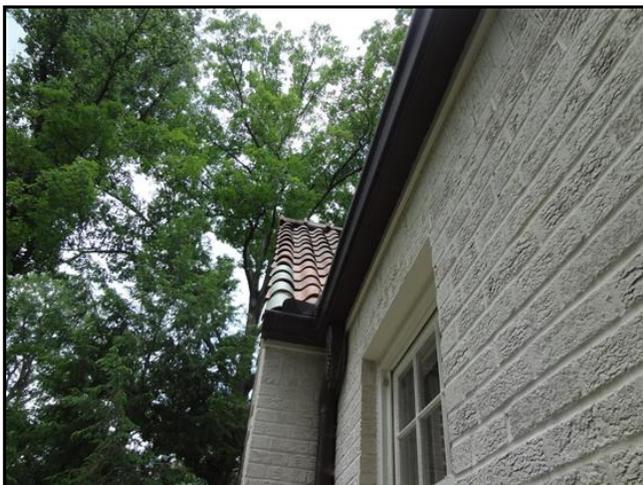
3.0 Item 12(Picture)

(3) Tree limbs that are in contact with home and over roofline should be removed/trimmed to prevent damage or pests.

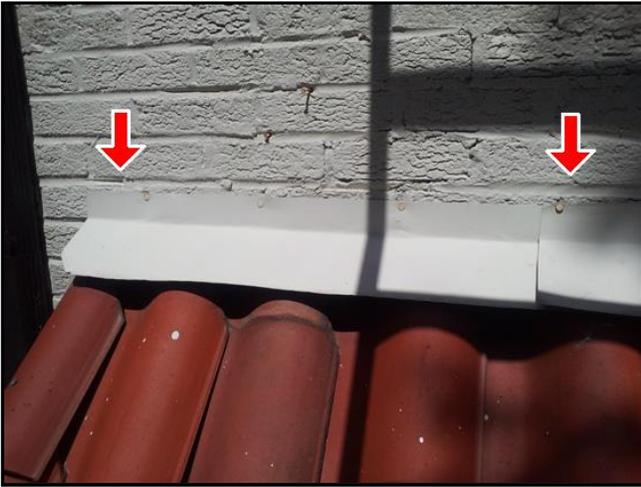
3.1 Item 1(Picture)

(1) Metal flashing sealant was not present, exposed fasteners as well. Recommend repair by qualified roof contractor.

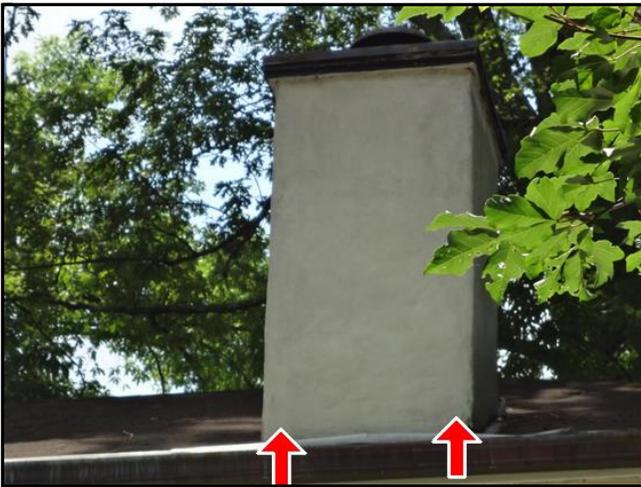
3.1 Item 3(Picture) Proper flashing needed

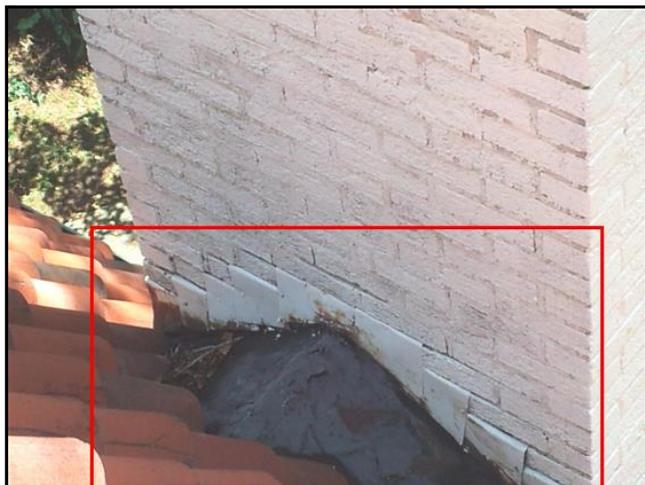
3.1 Item 4(Picture)

(2) Chimney chase flashings were aged, cracked, failing and showed signs of deterioration. Recommend replace all flashing at both chimney chases. Stucco chimney chase needs a saddle installed for proper drainage. Recommend repair by qualified roof contractor.

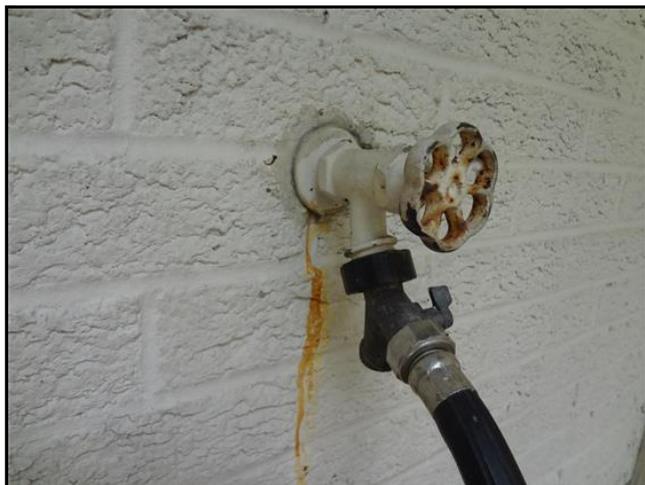
4.1 Item 1(Picture)

(1) Rear hose bib next to basement entry door had evidence of leaking/rust. Recommend repair.

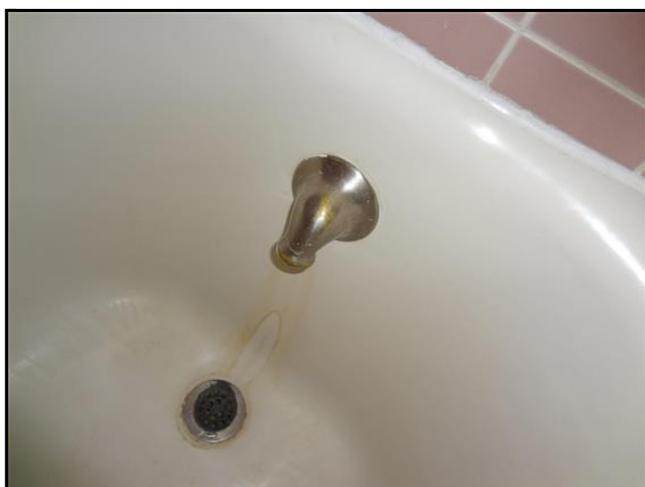
4.1 Item 2(Picture)

(2) Several plumbing fixtures were aged. Evidence of drips were noted when faucets are at off position. Recommend repair issues by qualified plumber and expect more with aged fixtures.

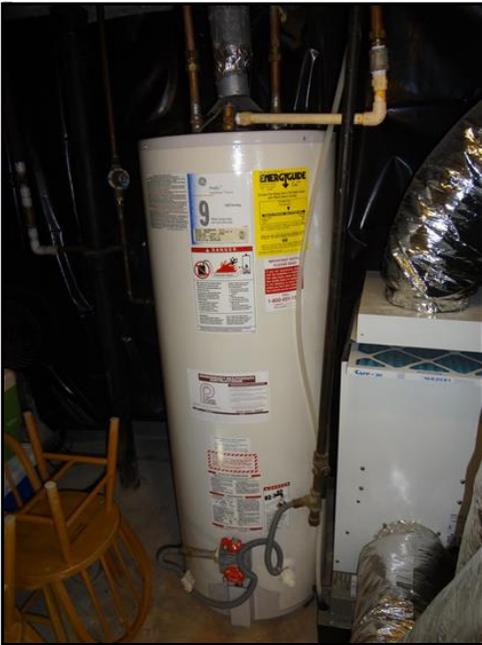
4.2 Item 1(Picture)

Gas water heater was functional at time of inspection. Unit was 14 years old and at the end of its expected useful life. Unable to determine life remaining. Recommend budget replacement accordingly.

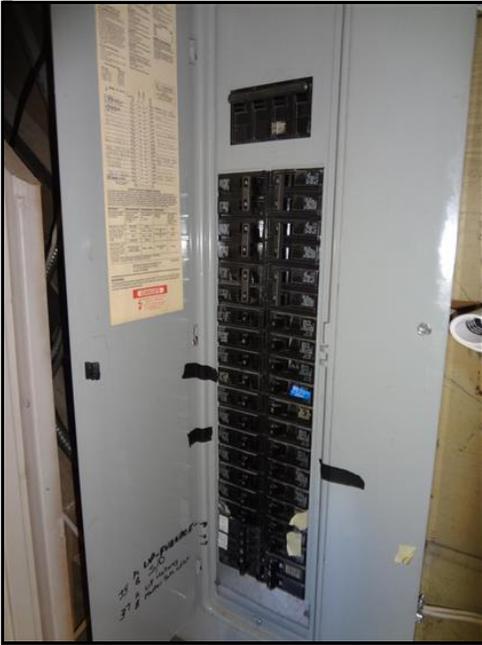
5.1 Item 1(Picture)

Main electrical service panel had several breakers that were not labeled. Recommend correct.

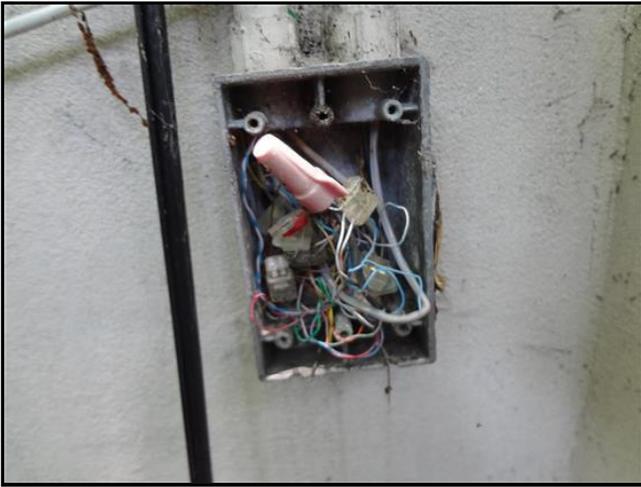
5.3 Item 1(Picture)

(1) Exposed electrical wiring left rear of home. Recommend repair by qualified electrician.

I do not inspect pools or their components, however I noted a safety issue. The motor bond/ground wire was not present. Recommend repair by qualified electrician.

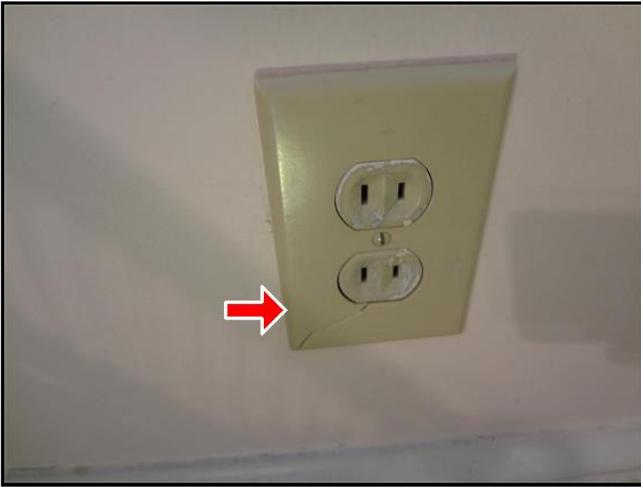
5.3 Item 4(Picture)

(2) Several plate covers were damaged or cracked. Recommend repair as needed.

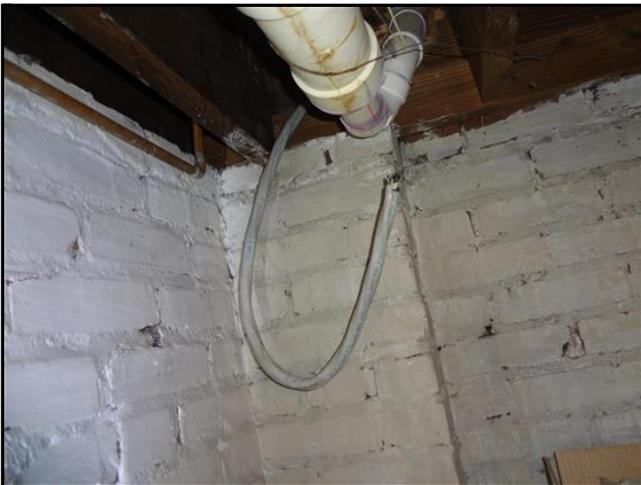
5.3 Item 7(Picture)

(3) Exposed non-terminated electric wiring at rear storage room. Open J-box noted. Recommend capping.

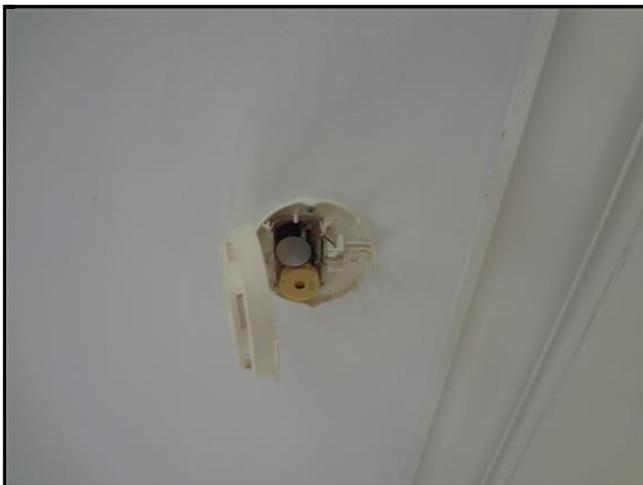
5.7 Item 1(Picture)

Recommend installing proper working smoke detectors at all levels of home, including basement.

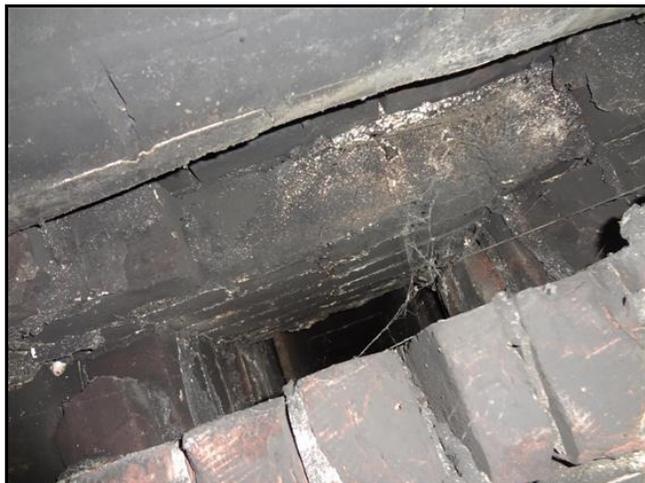
6.4 Item 1(Picture)

(1) Front fireplace was aged. It did not have a proper damper or throat, which is recommended for direct wood burning. Rear great room fireplace firebox liner was cracked and creosote build-up was noted. Fireplaces are not safe to use in current condition. Recommend evaluate by licensed chimney sweep and correct issues as needed.

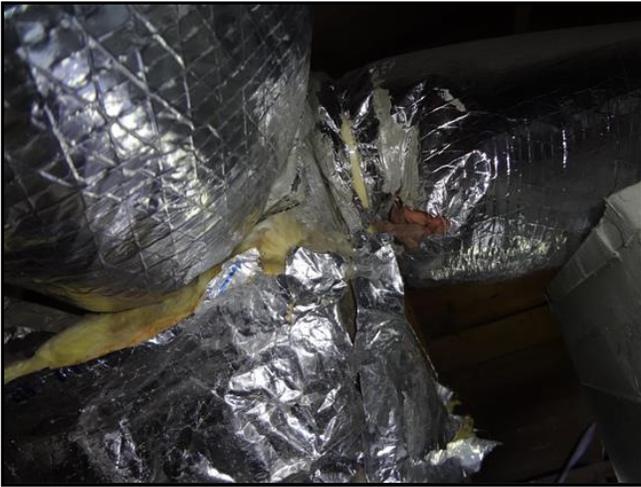
6.5 Item 1(Picture)

(1) HVAC duct piping in attic and basement had several sections that were aged/punctured/loose. Recommend sealing for better energy efficiency.

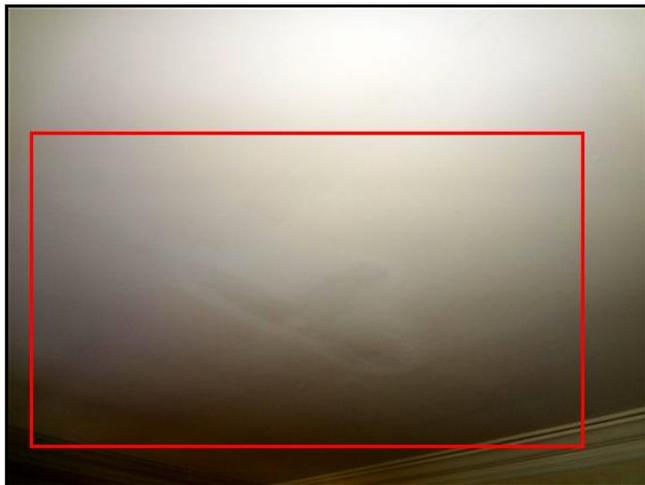
8.0 Item 1(Picture)

Evidence of water stains were noted in front living room at ceiling. No active moisture was noted at time of inspection. Recommend evaluate by qualified contractor and repair as needed.

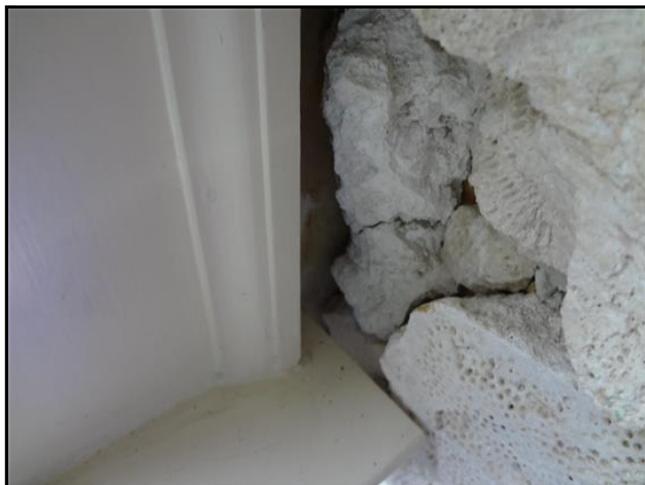
8.1 Item 10(Picture)

(3) Evidence of water stains was noted behind the fireplace left hand side at wall between covering and window. Recommend evaluate by qualified contractor and repair as needed (likely caused from failing flashing or roof).

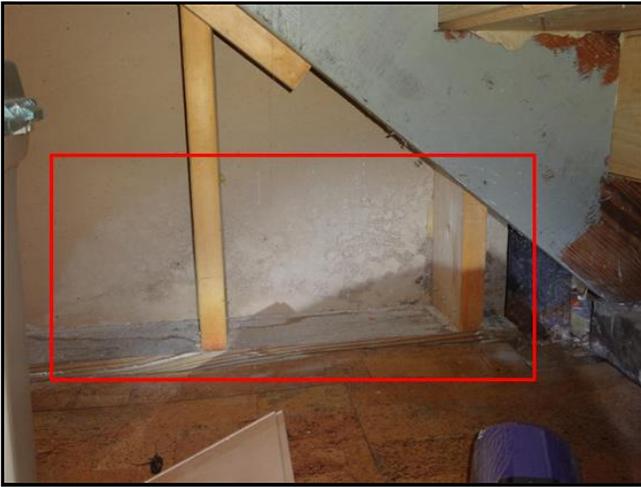
8.1 Item 13(Picture)

(4) Evidence of possible mold growth was noted in basement under stairwell at bottom walls. Recommend evaluate by mold remediation contractor and correct/sanitize as needed.

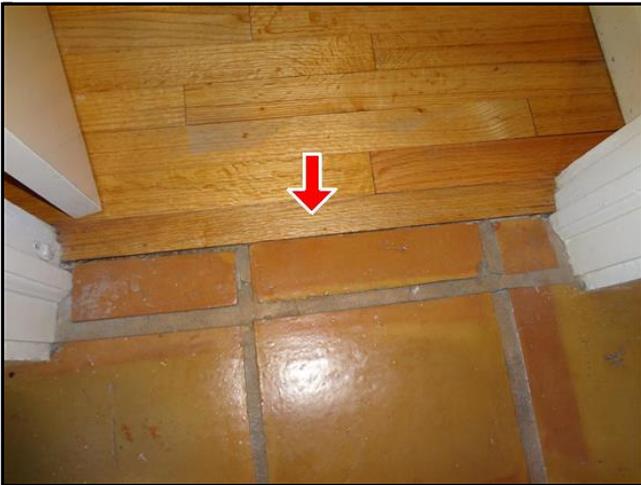
8.2 Item 1(Picture)

Tile flooring at kitchen and great room had cracked/loose mortar and loose/cracked tile in a few areas. Recommend repair as needed by qualified contractor.

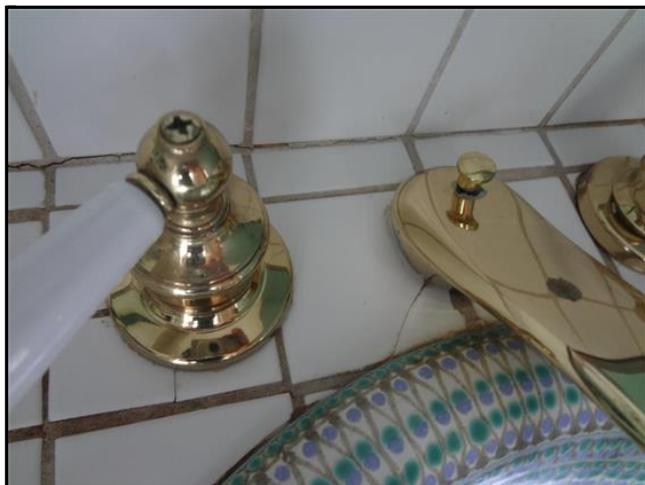
8.4 Item 1(Picture)

Mail floor guest bathroom vanity counter top had cracked tiles. Recommend repair as needed.

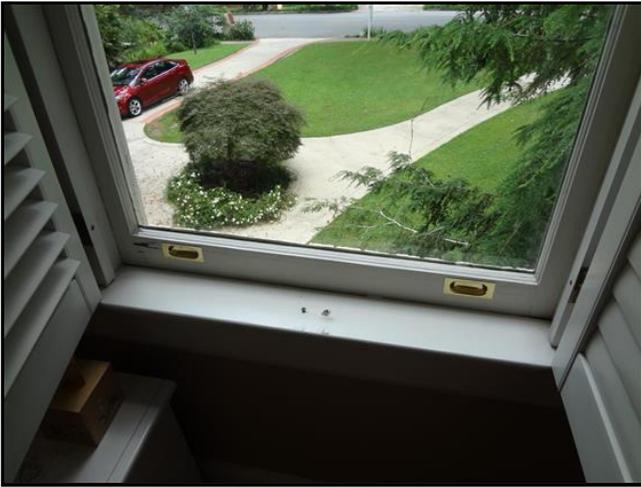
8.6 Item 1(Picture)

(1) Several windows were stuck painted shut or not functional due to age. All bedrooms should have a least one operable window for safety reasons. Recommend repair as needed.

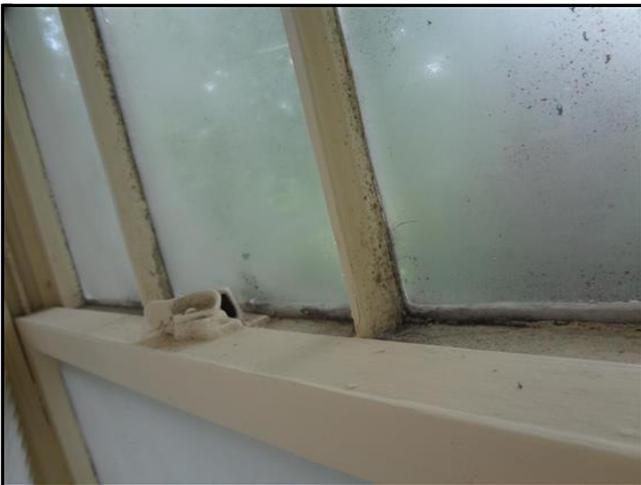
8.6 Item 4(Picture)

(2) Mildew was noted inside of a few windows. Recommend clean/sanitize.

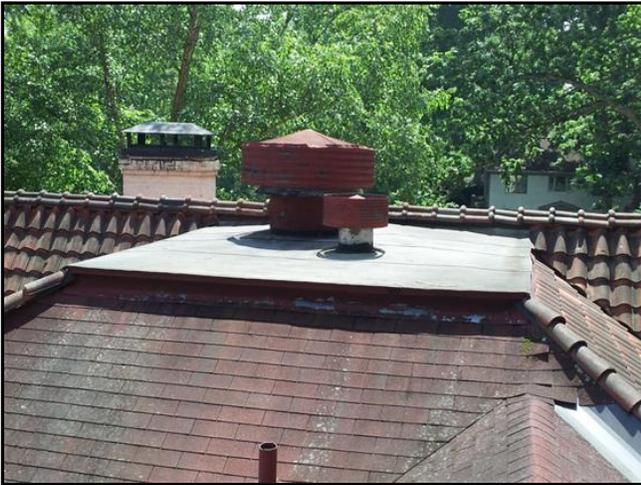
9.1 Item 1(Picture)

Roof venting was insufficient, rusting and dated. Recommend installing properly roof ventilation by qualified roof contractor.

Also soffit venting was painted over, which is reducing the air intake needed for the roof/attic. Recommend correct this is as well.

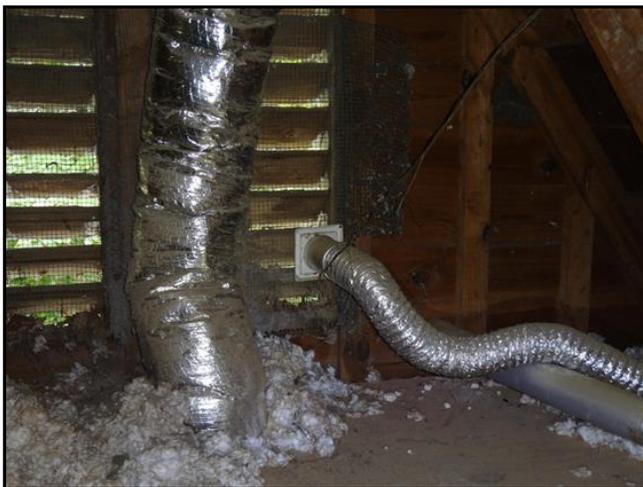
9.2 Item 1(Picture)

Dryer exhaust vents into attic gable. Recommend correct issue.
