Inspection Report

Property Address:
xxx Sandy Plains Road
Building 5
Marietta, GA 30066

Superior Home Inspections

Date: 4/25/2008	Time: 10:40 AM	Report ID: 42508
Property: xxx Sandy Plains Road Building 5 Marietta, GA 30066	Customer: Atlanta Commercial Customer	Real Estate Professional: Kirk Adams Newmark Knight Frank

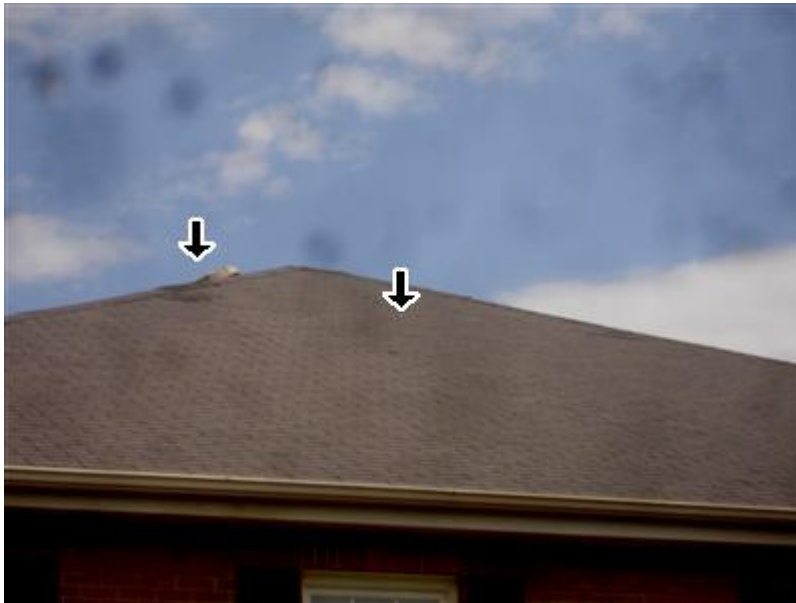
1.0 Picture 2

The roof covering (shingles) is at the end of its expected useful life, and the life of covering has expired. The covering (shingles) does need to be replaced. Recommend replace shingles by licensed qualified roof contractor.

Shingles are damaged, torn, missing, lifted, show signs of loss of granules, brittle, and curled at edges. Further leaking or deterioration may occur if not corrected.

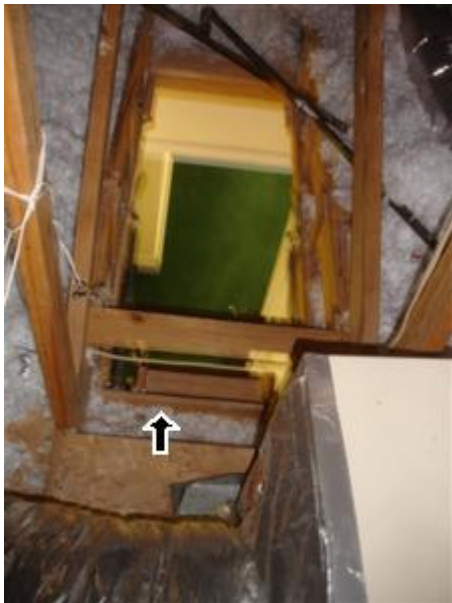
1.5 Picture 3

(2) Recommend installing platform in attic at top of attic access stairs (both attic accesses). Injury may occur. Recommend repair by qualified contractor.

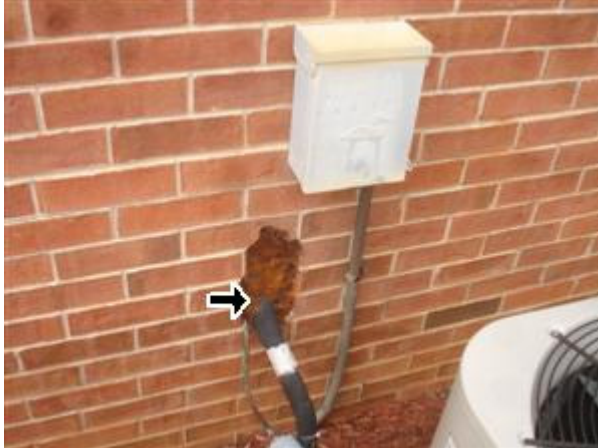
2.0 Picture 1

(1) Recommend sealing all penetrations or gaps at exterior cladding by qualified person.

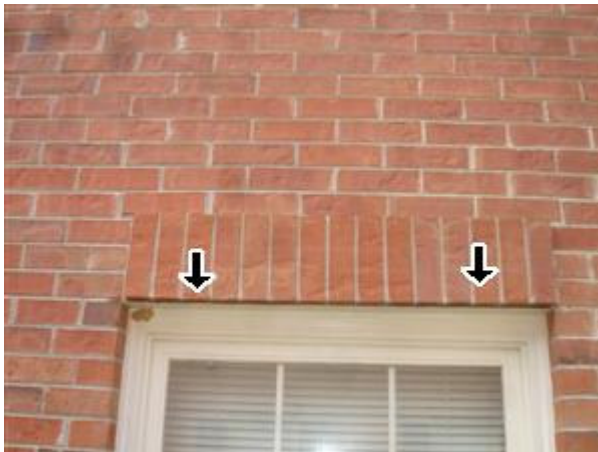
2.0 Picture 3

(2) Weep holes were not visible at brick cladding. Moisture damage may occur if not corrected. Recommend repair by qualified licensed contractor.

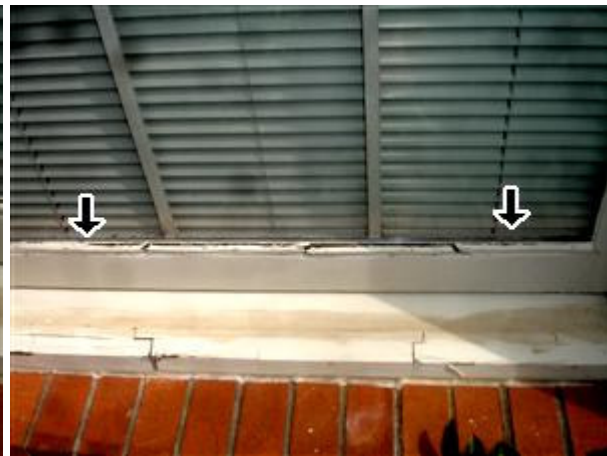
2.2 Picture 2

The wood trim and window frames are deteriorated or damaged at most windows. Further deterioration may occur if not repaired. Due to amount of damage replacement of windows is likely. Recommend repair by qualified licensed contractor.

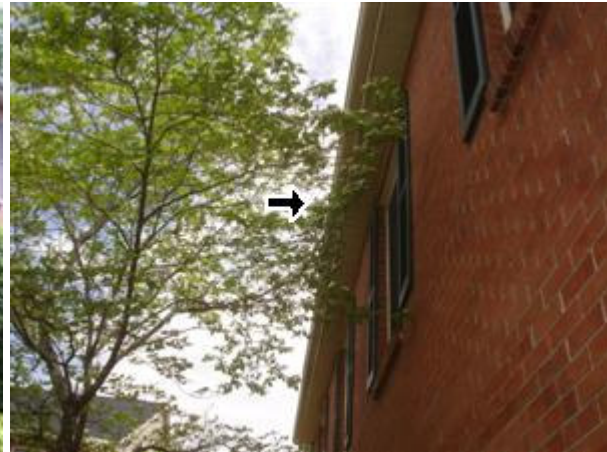
2.5 Picture 2

(1) The tree limbs that are in contact with roof or hanging near roof should be trimmed. Plants, shrubs, and all vegetation should be trimmed 6 inches away from exterior cladding. Pest intrusion or deterioration may occur if not corrected. Recommend repair by qualified person.

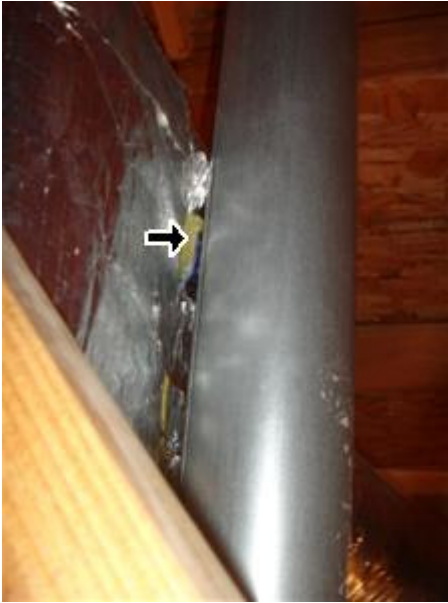
9.7 Picture 1

The vent pipe for gas furnace needs at least a 1 inch clearance from combustibles. Flue piping is not properly fastened (screws missing). This is a safety issue and should be repaired. I recommend a qualified licensed HVAC repair.

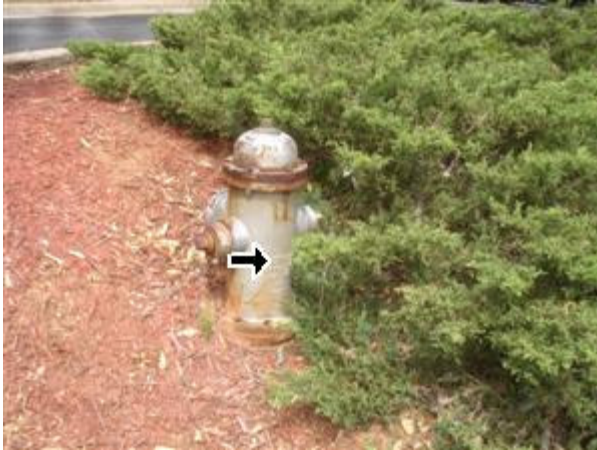
10.0 Picture 1

Shrub/vegetation block fire hydrant at parking lot. Recommend repair by qualified contractor.

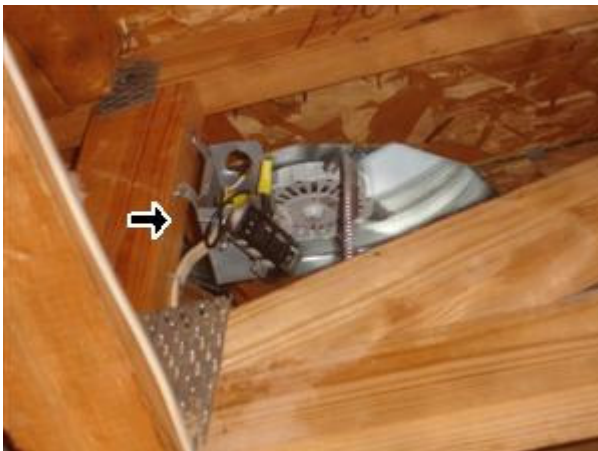
1.8 Picture 1

Power vent fan in attic has exposed electrical wiring/splice. This is a safety issue. Recommend repair by licensed electrician.

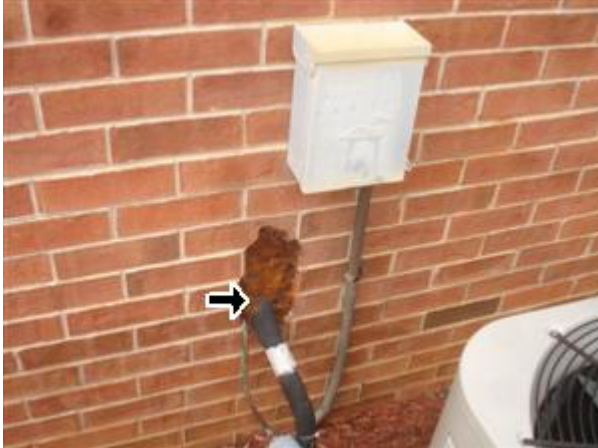
2.0 Picture 1

(1) Recommend sealing all penetrations or gaps at exterior cladding by qualified person.

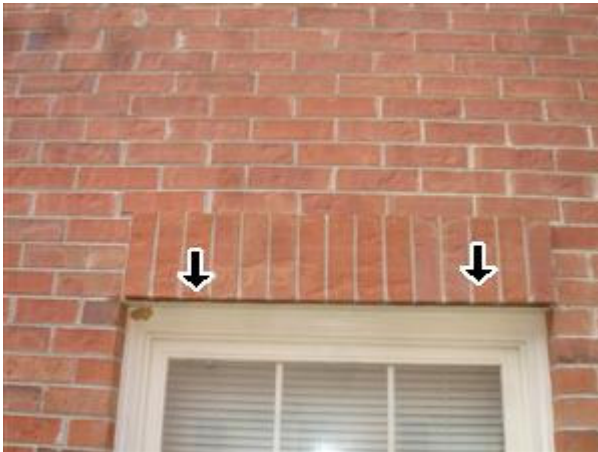
2.0 Picture 3

(2) Weep holes were not visible at brick cladding. Moisture damage may occur if not corrected. Recommend repair by qualified licensed contractor.

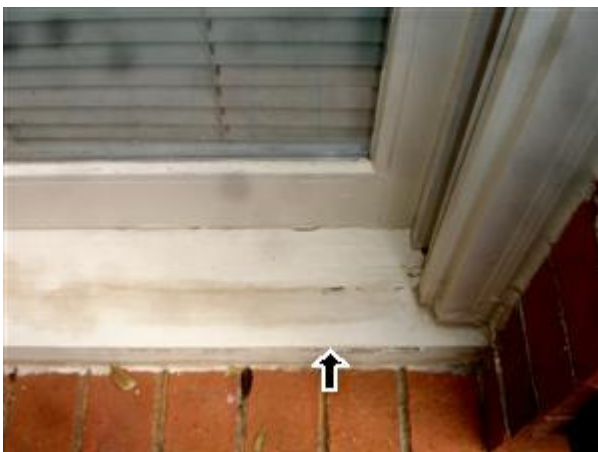
2.2 Picture 2

The wood trim and window frames are deteriorated or damaged at most windows. Further deterioration may occur if not repaired. Due to amount of damage replacement of windows is likely. Recommend repair by qualified licensed contractor.

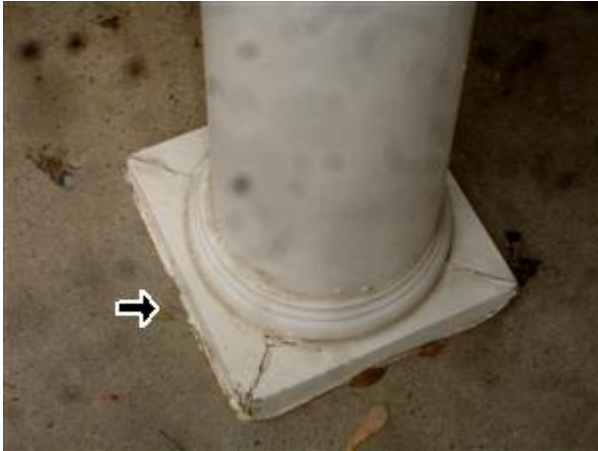
2.4 Picture 1

Front porch main entry support columns are deteriorated at bottoms. Further deterioration may occur. Recommend repair by qualified licensed contractor.

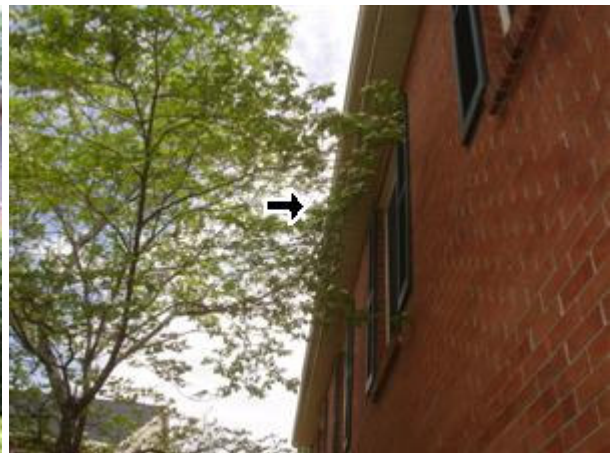
2.5 Picture 2

(1) The tree limbs that are in contact with roof or hanging near roof should be trimmed. Plants, shrubs, and all vegetation should be trimmed 6 inches away from exterior cladding. Pest intrusion or deterioration may occur if not corrected. Recommend repair by qualified person.

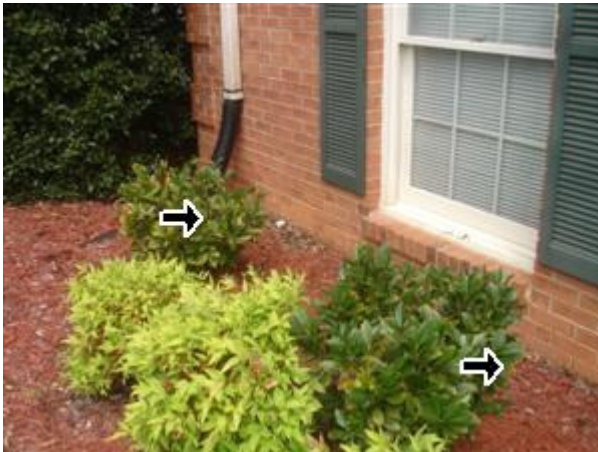
2.5 Picture 4

(2) There is a negative slope towards the front of building left side of main entry. Water intrusion may occur. This area does not appear to drain water away from building and needs landscaping and drainage corrected by licensed contractor.

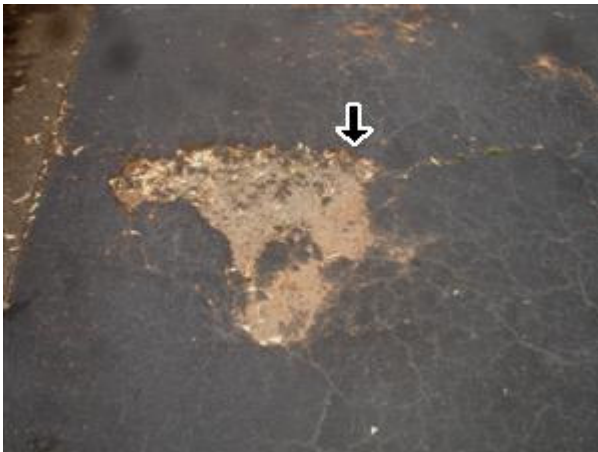
2.5 Picture 7

(5) The asphalt parking lot at the front and side of building is pitted and/or cracked in areas. Water can cause further deterioration if not repaired and sealed properly. Recommend repair by qualified contractor..

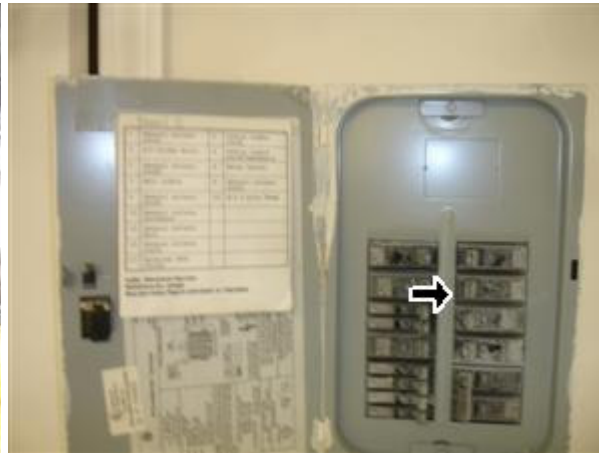
4.2 Picture 2

(1) Electrical disconnect breaker not present for electric water heater in attic. Recommend install by licensed plumber. Electric breaker was on at time of inspection and water was not. This may have caused damage to water heater.

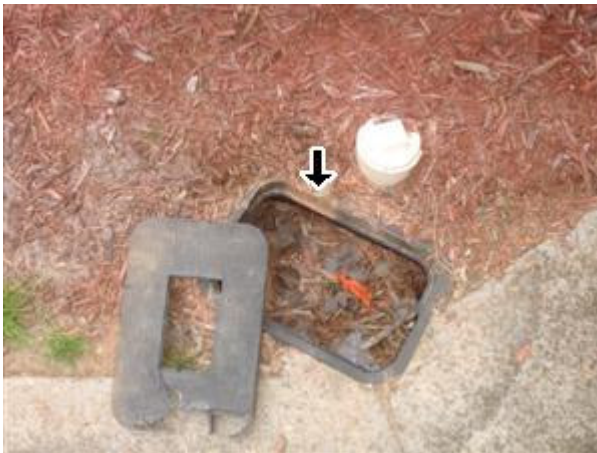
4.3 Picture 1

(1) Main waste meter box rear of building is damaged and full of debris/dirt. Recommend repair by licensed plumber or water service company.

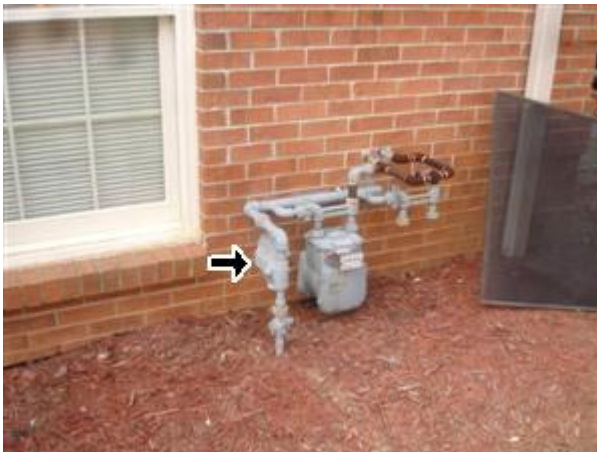
4.5 Picture 1

Rear of building, two gas meters with two main fuel shut offs.

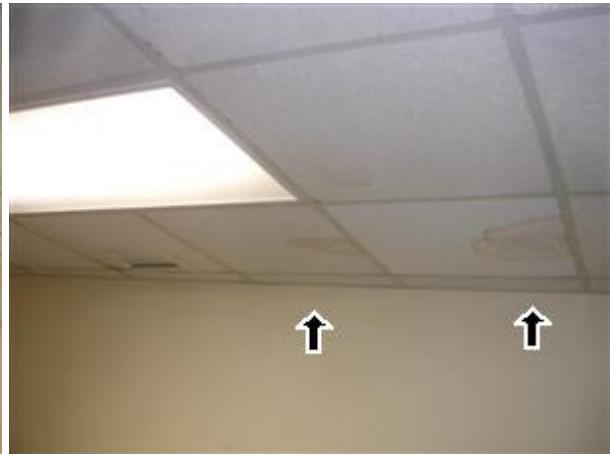
5.0 Picture 2

Water stains/damage noted at ceiling tiles in several rooms. This is likely due to improper insulating of duct piping. Unable to determine exact issues for all leaks. Further damage may occur. Recommend repair by qualified contractor.

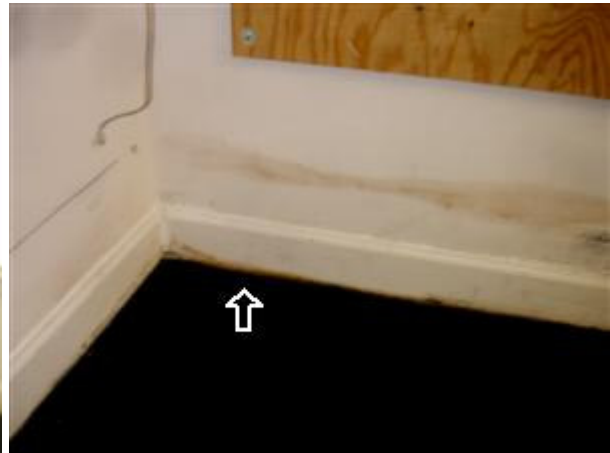
5.1 Picture 4

(3) Water intrusion/damage noted at bottom of walls left side of building (due to grade/drainage exterior). Further damage may occur. Recommend repair by qualified contractor.

Signs of fungi growth is present on the walls/floors main floor left side of building in several areas. We did not inspect, test or determine if this growth is or is not a health hazard. The underlying cause is moisture. I recommend you contact a mold inspector or expert for investigation or correction if needed.

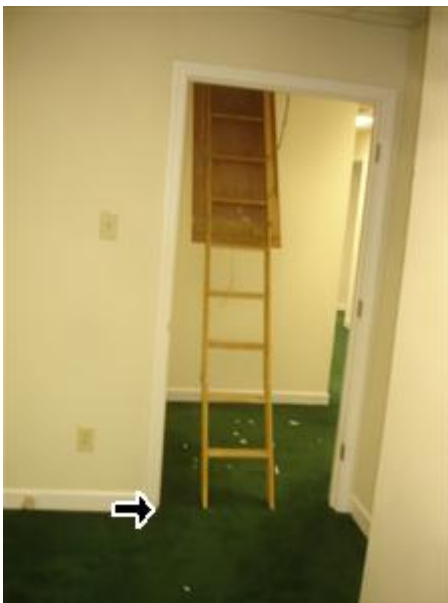
5.2 Picture 1

Signs of settlement noted upstairs in a few areas. Further settlement may occur if not corrected. Doors may not open/close properly because of settlement. Recommend repair by qualified contractor.

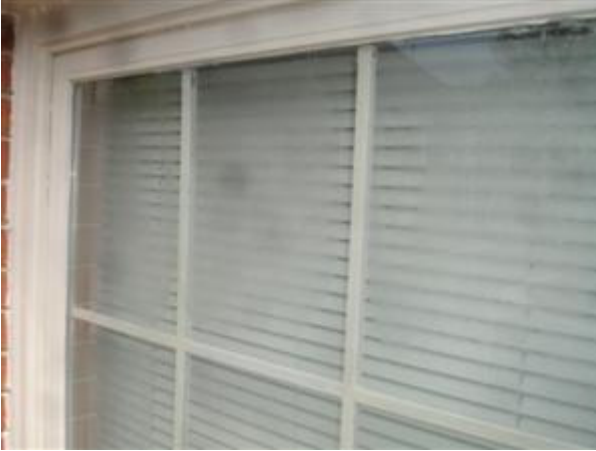
5.4 Picture 1

Most Windows are cloudy (lost seal) in Most Rooms. This can cause some heat loss in winter and loss of cool air in summer if not corrected (HVAC lower units ran continuously at time of inspection). In order to correct the cloudy appearance of glass, a replacement of glass pane or the unit will be necessary. Recommend replace by licensed contractor..

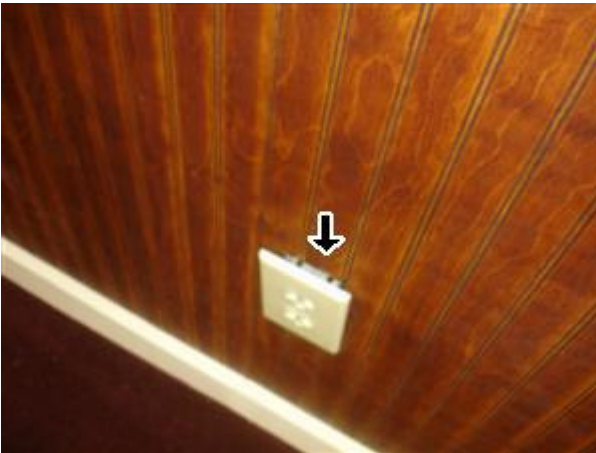
5.6 Picture 1

Receptacles were loose in a few rooms. This is a safety issue. Recommend repair by licensed electrician.

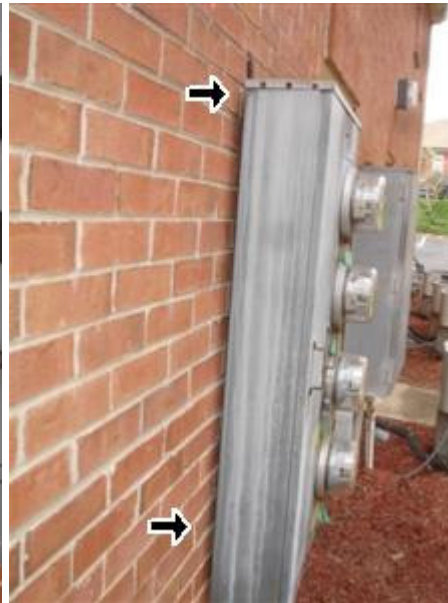
8.1 Picture 2

Main electrical disconnect box was rusted and I could not access the left side. Box is also loose and not properly secured or sealed to brick cladding. Recommend repair by licensed electrician.

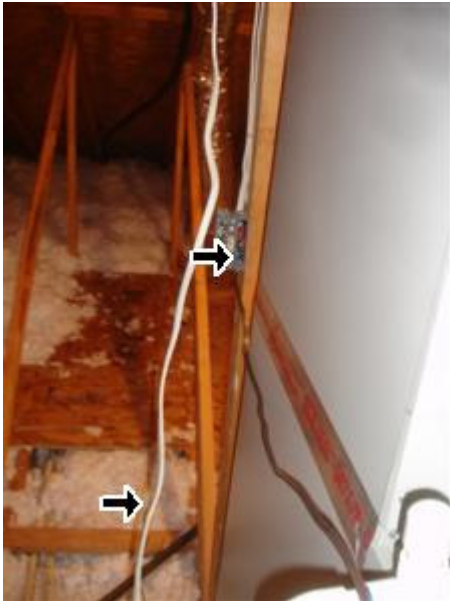
8.3 Picture 1

Electrical wiring in attic is not properly covered or fastened near attic access and HVAC units. Switch plate covers were also missing/damaged. These are safety issues. Recommend repair by licensed electrician.

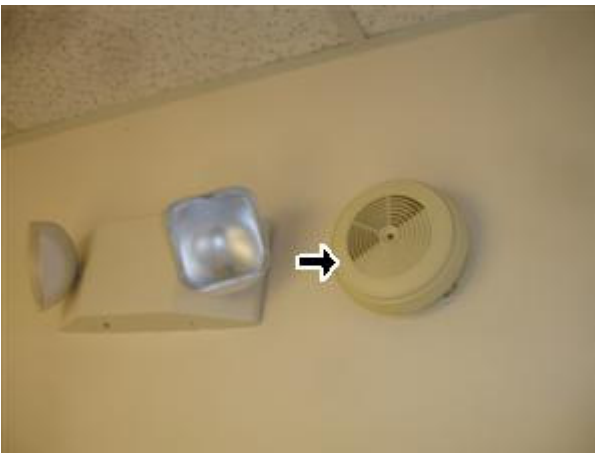
8.7 Picture 1

Several smoke detectors did not work when tested at time of inspection. Recommend repair by qualified contractor.

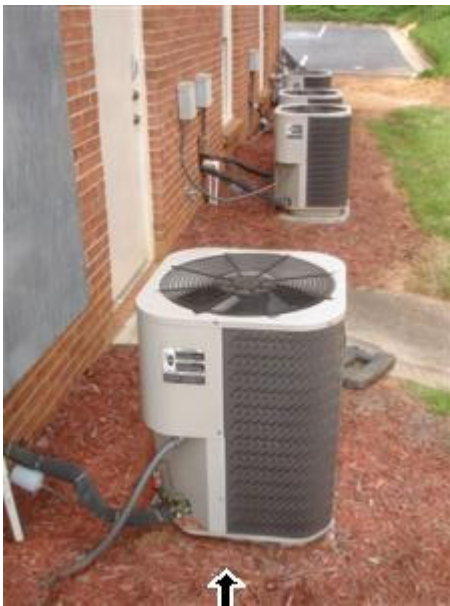
9.2 Picture 1

Platform for AC units rear of building are below grade and/or not level. Damage to units may occur. Recommend repair by licensed contractor.

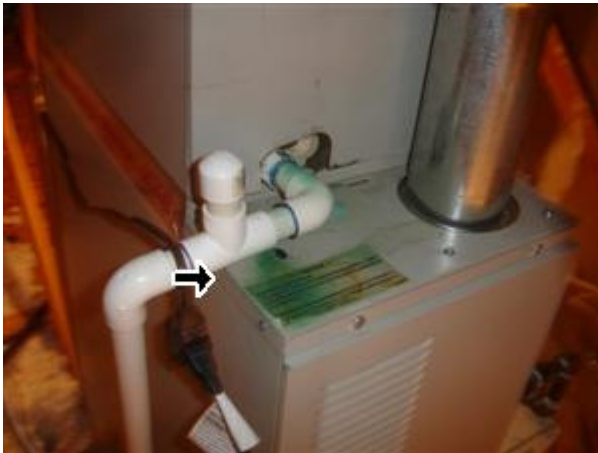
9.6 Picture 1

(1) Condensation piping for AC units in attic are leaking where piping enters into unit. Further leaking or damage to HVAC units may occur. Recommend repair by licensed HVAC contractor.

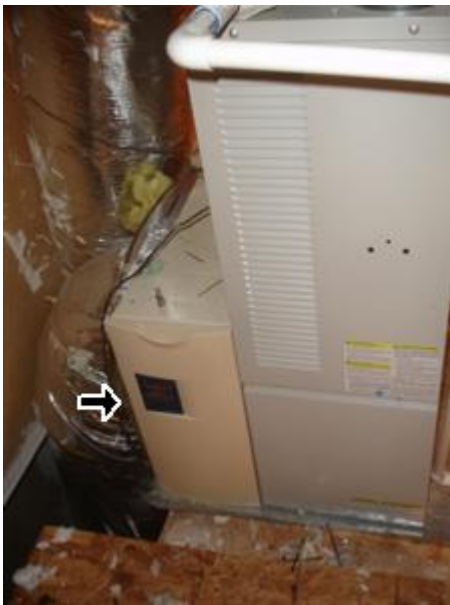
9.6 Picture 3

(2) HVAC filters are located at units in attic and ceilings at main and upper floors. Filters are clogged/dirty. Recommend change filters.

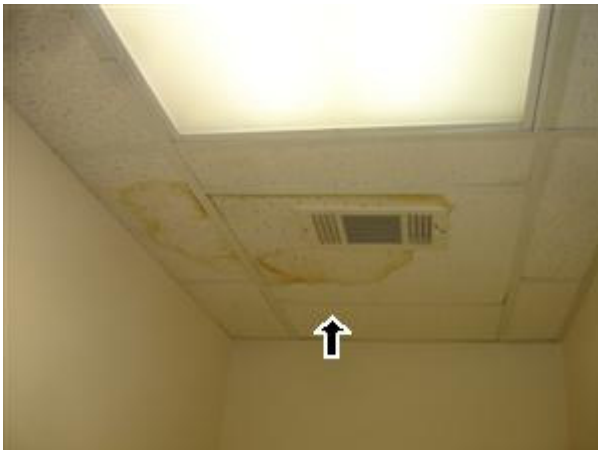
9.6 Picture 5

(3) Water stains/damage noted around HVAC registers. This is likely due to improper insulating of duct piping. Further damage may occur. Recommend repair by licensed HVAC contractor.

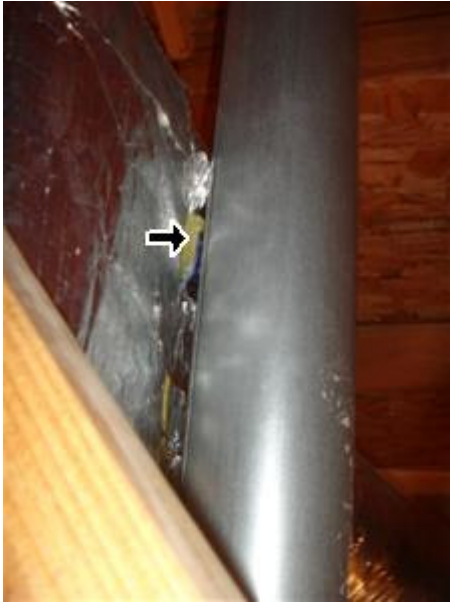
9.7 Picture 1

The vent pipe for gas furnace needs at least a 1 inch clearance from combustibles. Flue piping is not properly fastened (screws missing). This is a safety issue and should be repaired. I recommend a qualified licensed HVAC repair.

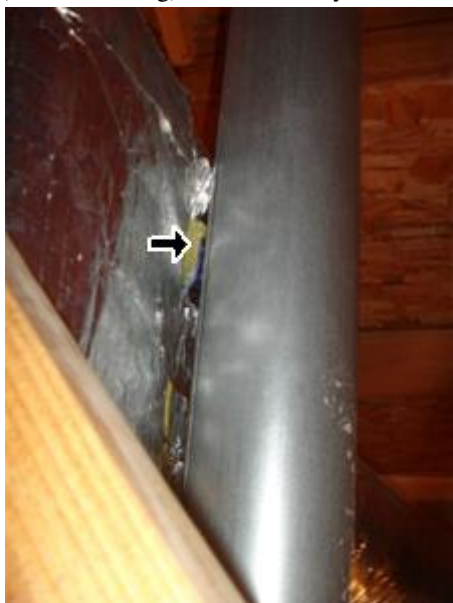
9.7 Picture 1

The vent pipe for gas furnace needs at least a 1 inch clearance from combustibles. Flue piping is not properly fastened (screws missing). This is a safety issue and should be repaired. I recommend a qualified licensed HVAC repair.
