Inspection Report

Atlanta Home Inspection

Property Address:
Springdale Road NE
Atlanta GA 30306

Date: 6/26/2012	Time: 12:25 PM	Report ID: 062612-2
Property: Springdale Road NE Atlanta GA 30306	Customer: Atlanta Home Inspection	Real Estate Professional:

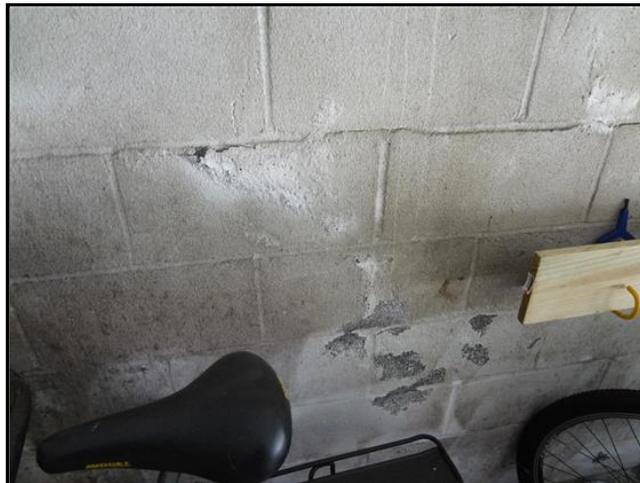
1.0 Item 2(Picture)

(1) Evidence of elevated moisture was noted in garage at rear foundation block wall. Recommend evaluate by qualified foundation contractor and correct issues as needed.

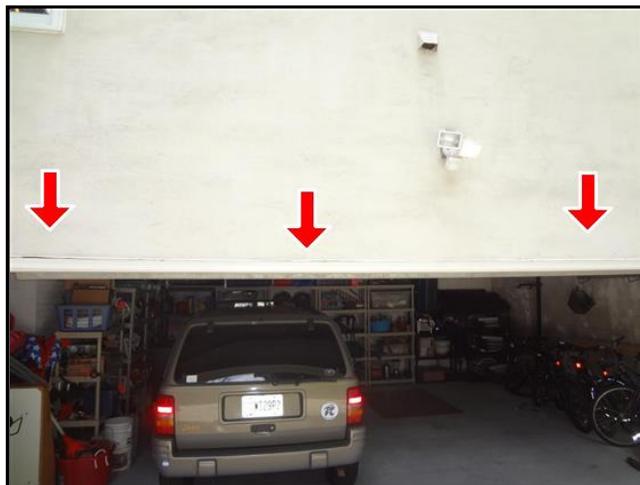
Garage header had evidence of sagging or deflection at header. Trim had gaps where it meets flashing. Further damage may occur if not corrected. Recommend further evaluation by qualified structural contractor and repair issues as needed.

1.1 Item 2(Picture) Evidence of deflection and sagging

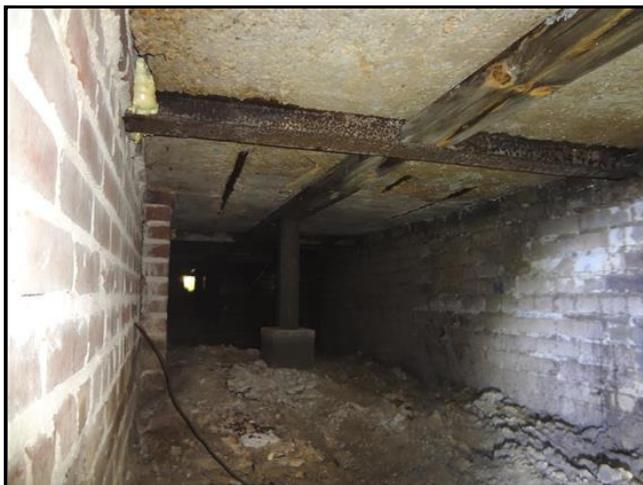
1.3 Item 2(Picture)

Front porch stoop had access through the basement crawlspace door. Evidence of wood structure deterioration and evidence of rusting at the steel floor beams (common due to age). Recommend evaluate by qualified foundation contractor and repair or reinforce as needed.

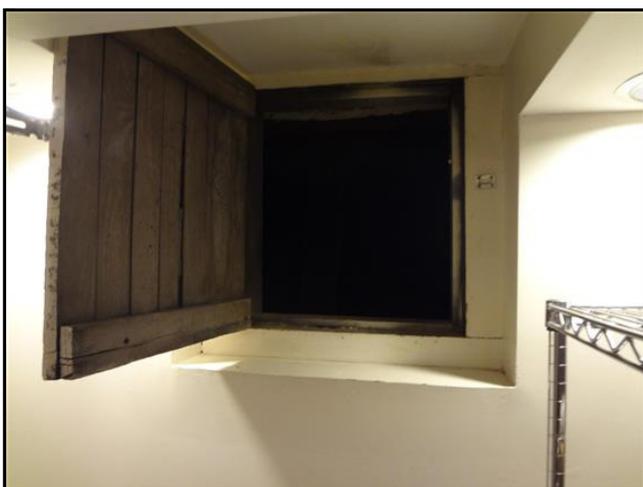
1.3 Item 5(Picture) Entry to porch stoop

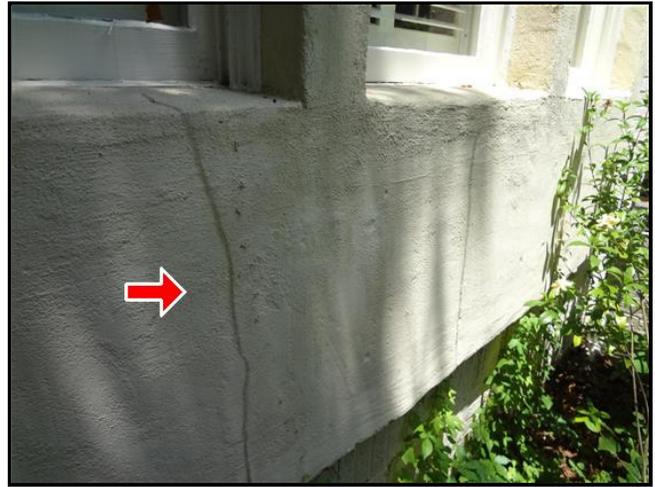
2.0 Item 2(Picture)

Several sections of cladding was hard coat stucco. At these areas, several cracks were noted. Further moisture issues may occur. Recommend repair by qualified stucco contractor.

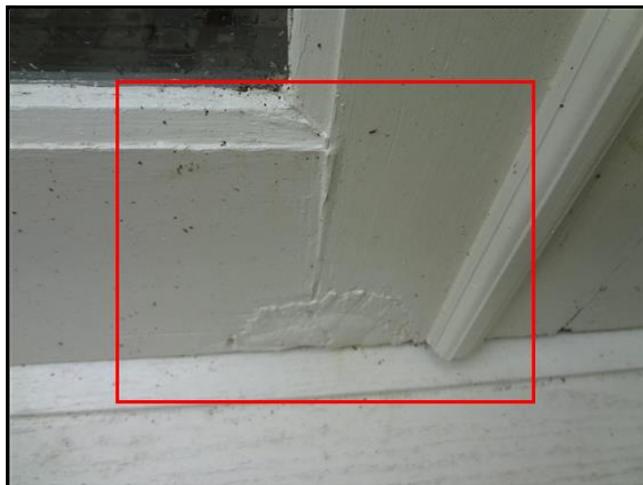
2.1 Item 2(Picture)

(1) Wood entry doors, trim, frames and thresholds had evidence of peeling paint, failing sealant, improper repairs, and small deterioration, several areas, most doors. Recommend repair issues as needed.

Recommend installing cap flashing over top of rear window/doors.

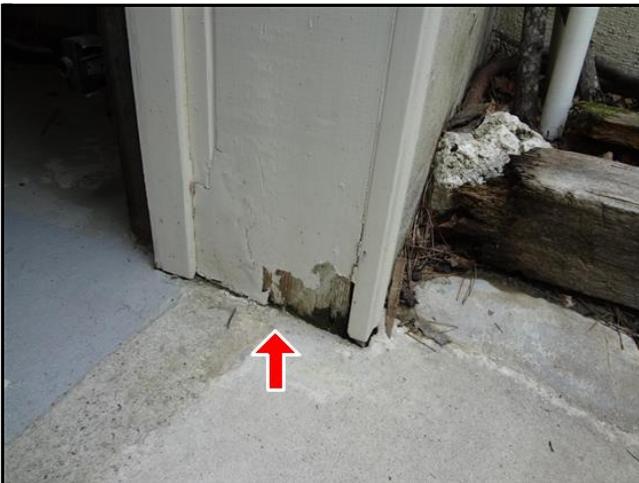
2.1 Item 10(Picture)

(2) Garage door wood frame had evidence of deterioration at bottom sections. Recommend repair by qualified contractor.

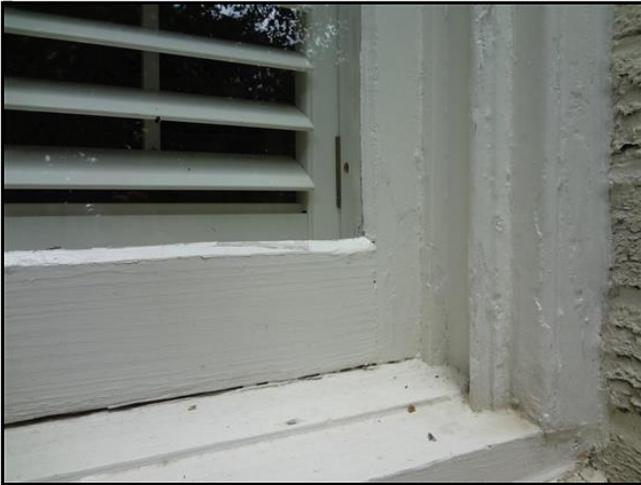
2.2 Item 3(Picture)

Multiple windows were painted shut. Peeling paint, failing sealant and minor deterioration noted at wood sashes, trim and frames. Recommend repair by qualified contractor.

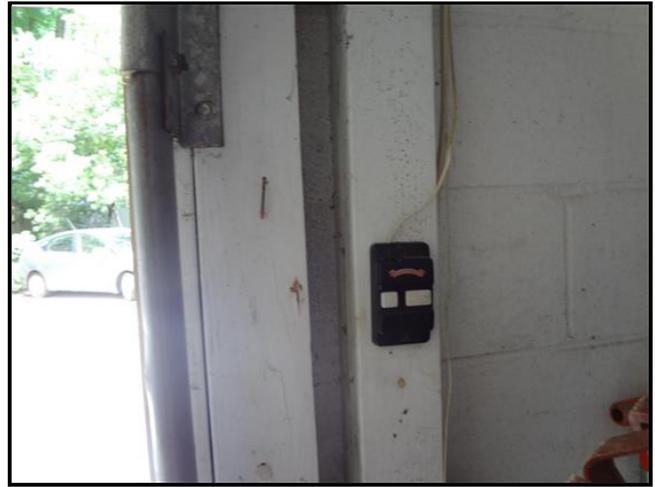
2.3 Item 2(Picture)

Garage door operator did not function properly when tested. Also bottom sweep was deteriorated. Recommend repair issues by qualified contractor.

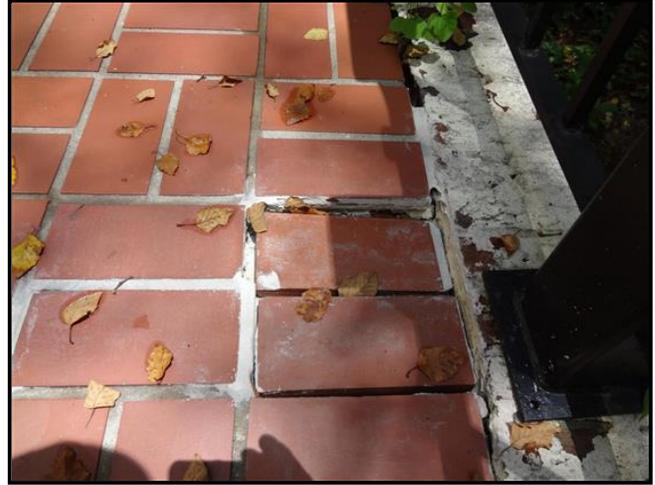
2.4 Item 2(Picture)

(1) Front porch steps were not level and evidence of settlement. Porch brick had multiple cracks. Metal guard railing was loose. Injury or further damage may occur. Recommend repair by qualified contractor.

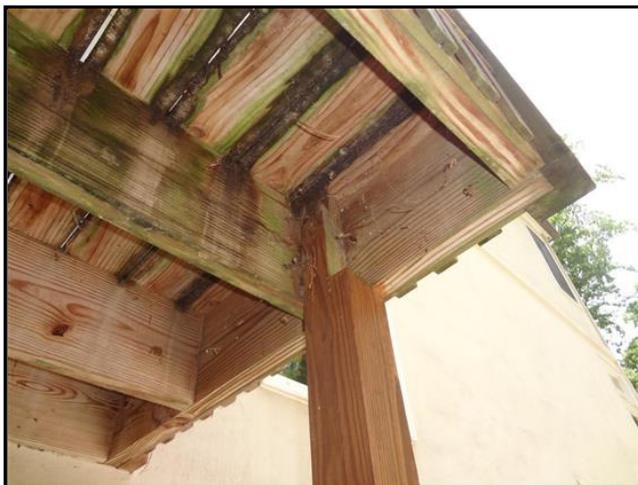
2.4 Item 6(Picture)

(2) Rear set of steps and landing to kitchen entry had issues noted such as: 1. Loose guard railing. 2. Improper support post. 3. Joists not properly secured. 4. Ledger board not properly secured to home. 5. Deterioration at bottom of support post. Injury or further damage may occur. Recommend repair by qualified contractor.

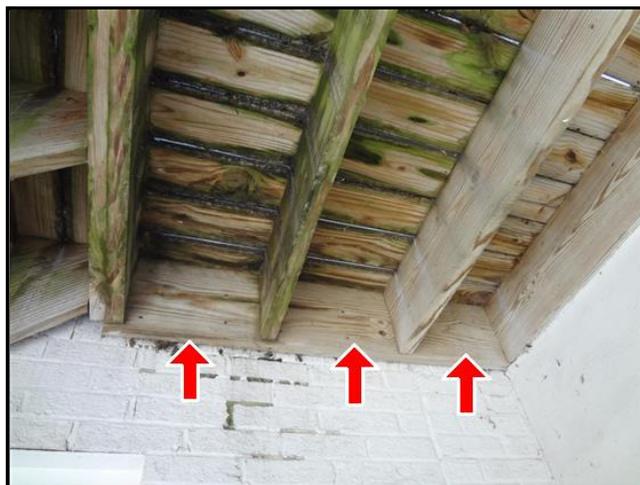
2.4 Item 10(Picture) Ledger board not properly secured

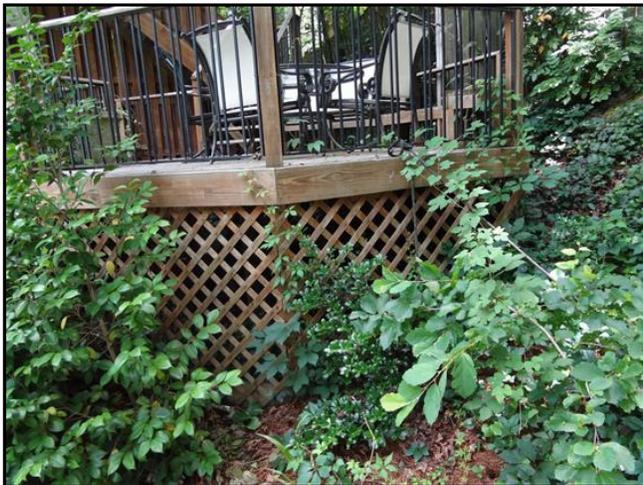
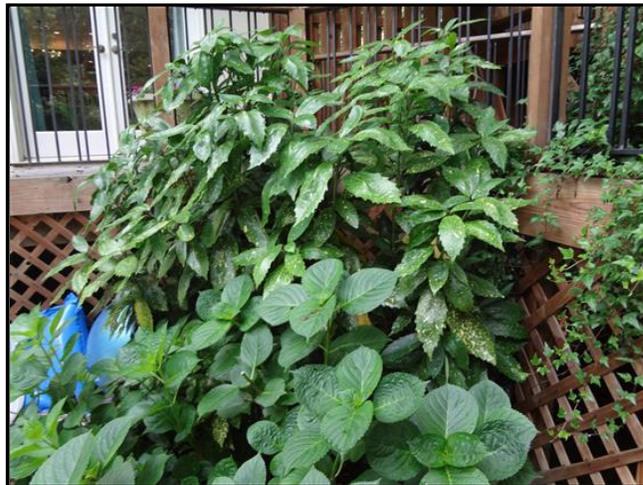
(3) I was not able to inspect several sections of the rear deck structures due to vegetation growth and lattice.

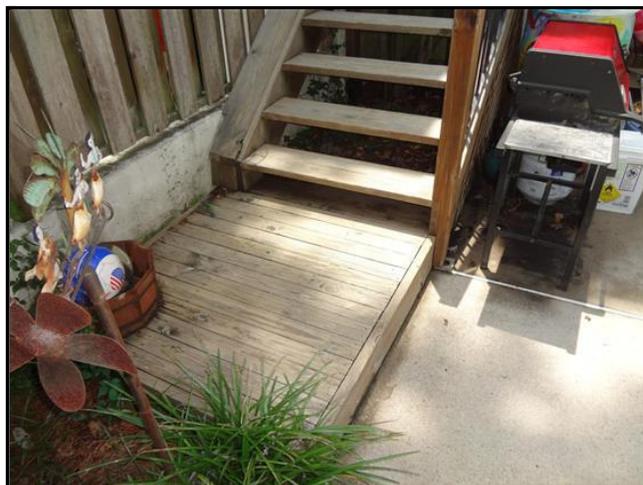
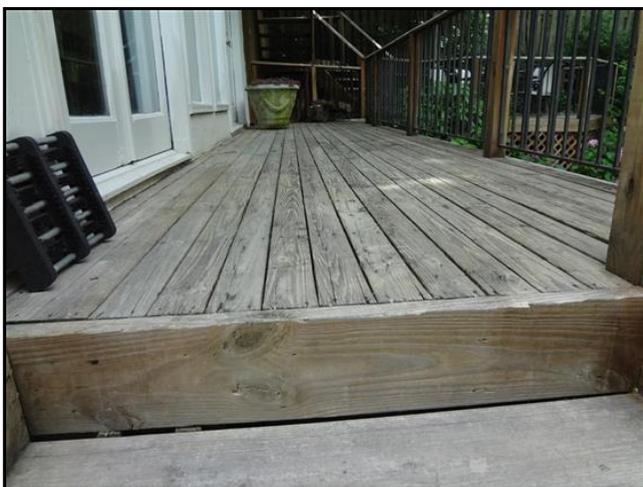
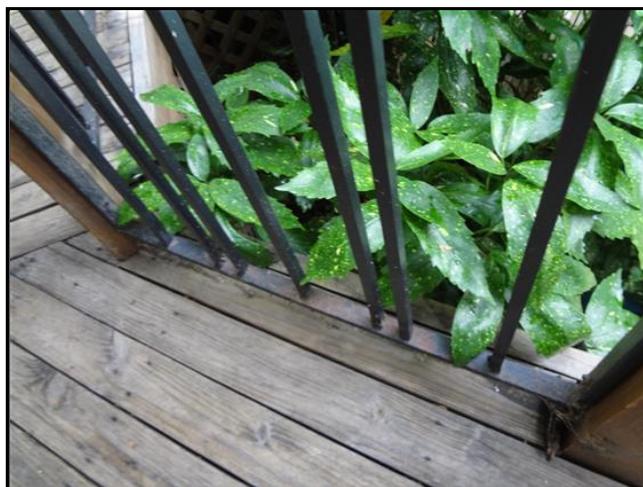
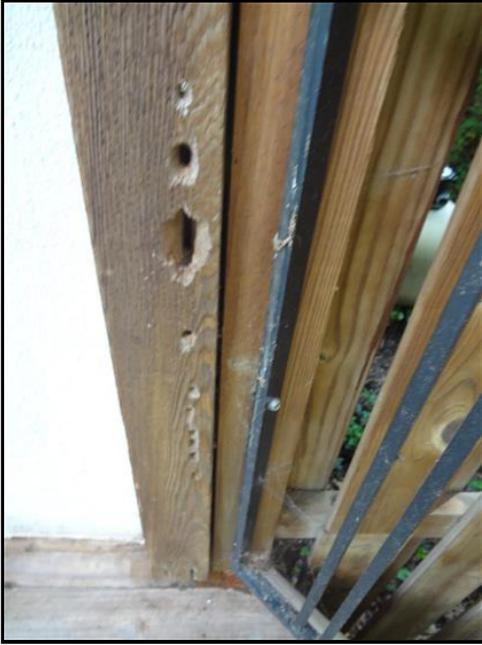
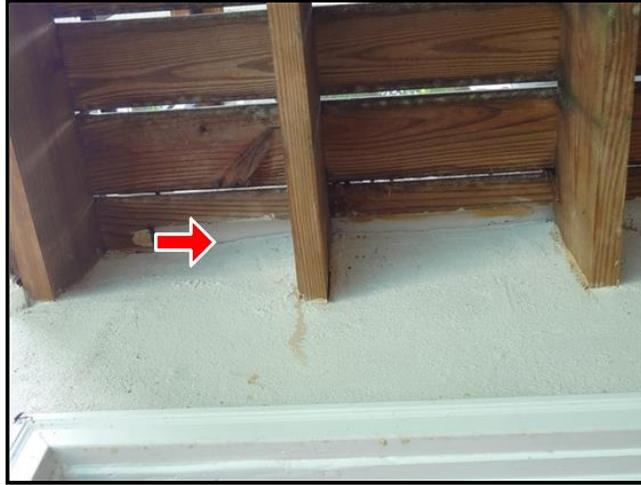
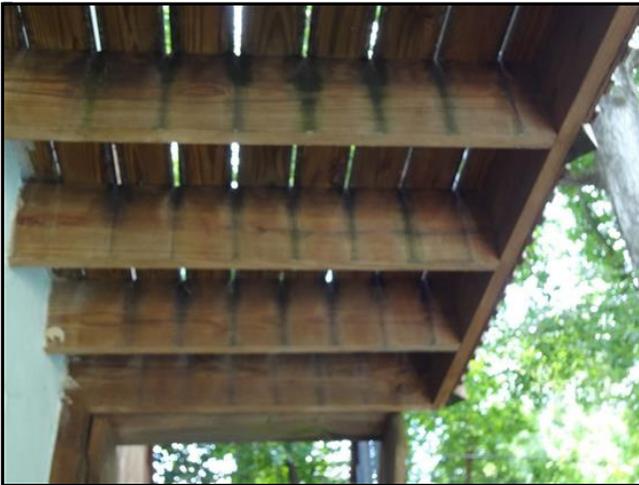
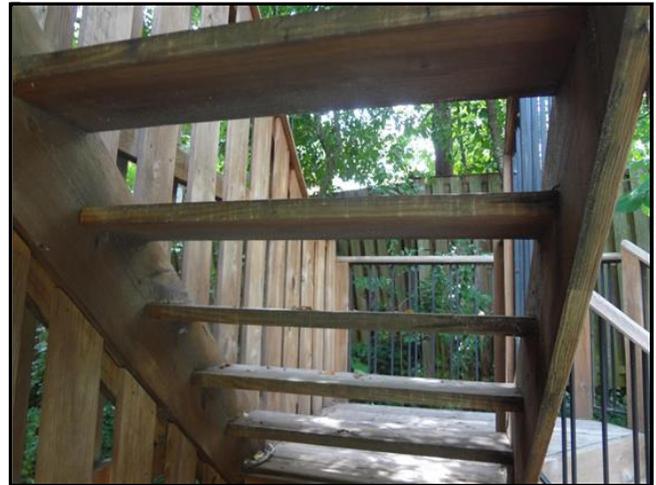
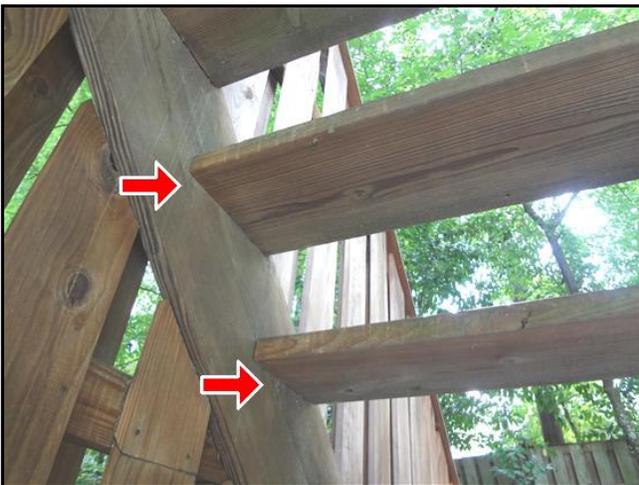
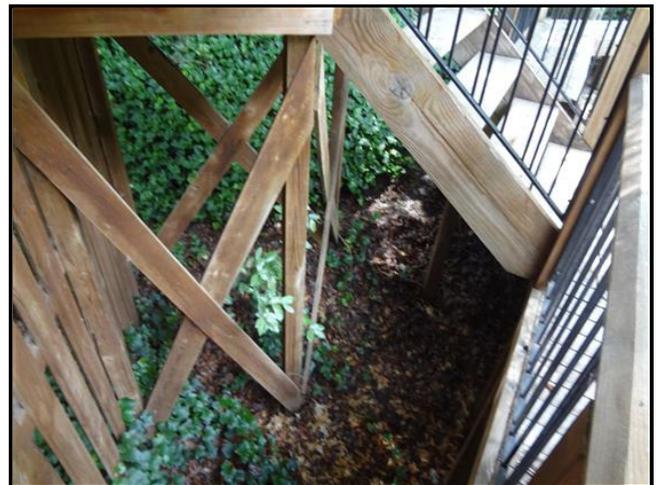
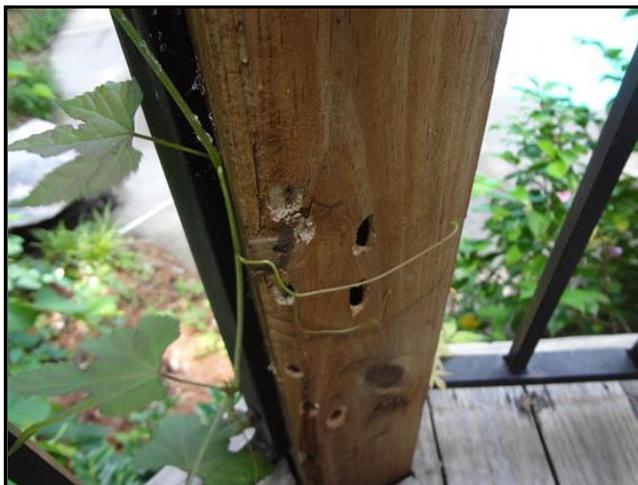
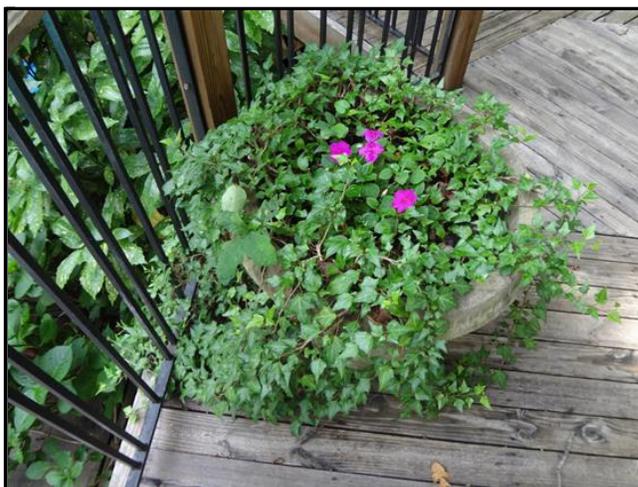
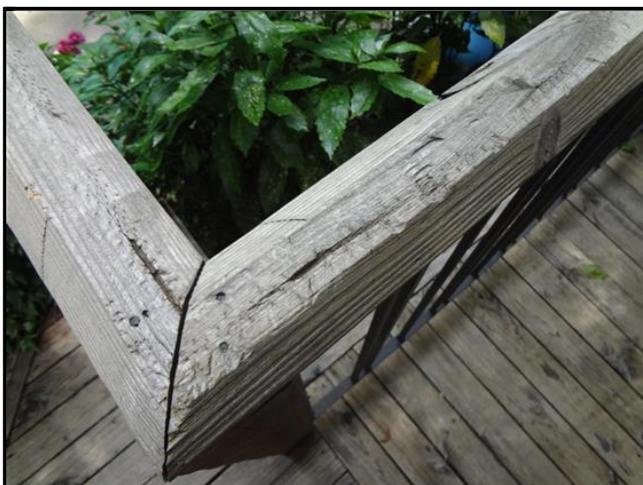
(4) Issues noted at rear decks, balcony and steps such as: 1. Several joists did not have proper support. 2. Wood in contact with ground (causes deterioration and termite coverage is excluded in these areas). 3. Carpenter bee damage. 4. Decking and railing material was aged (at the end of its expected useful life) and no sealant coat noted. Several pieces were deteriorating. 5. Metal railing was rusted. 6. Rusting at upper balcony flashing where it attaches to the home. 7. Stair treads had improper fasteners and improper support.

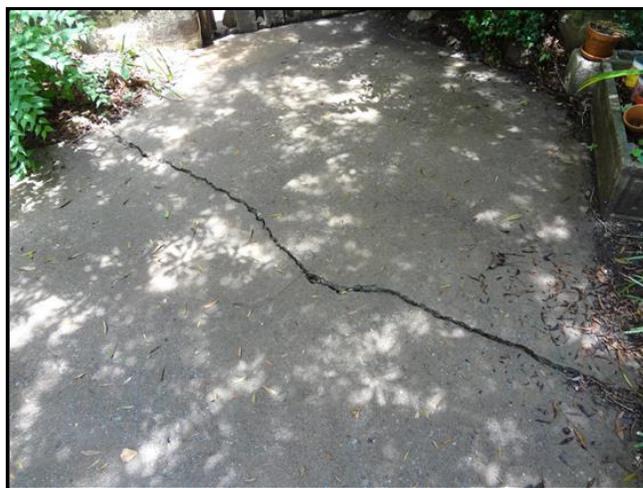
2.5 Item 3(Picture)

(2) Driveway had common settlement cracks. Repair as desired.

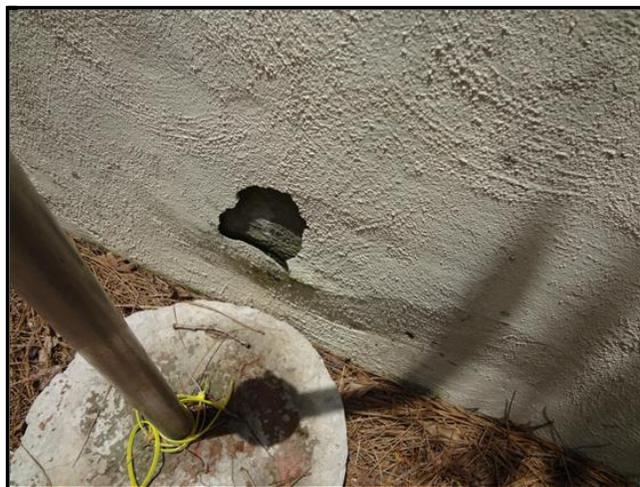
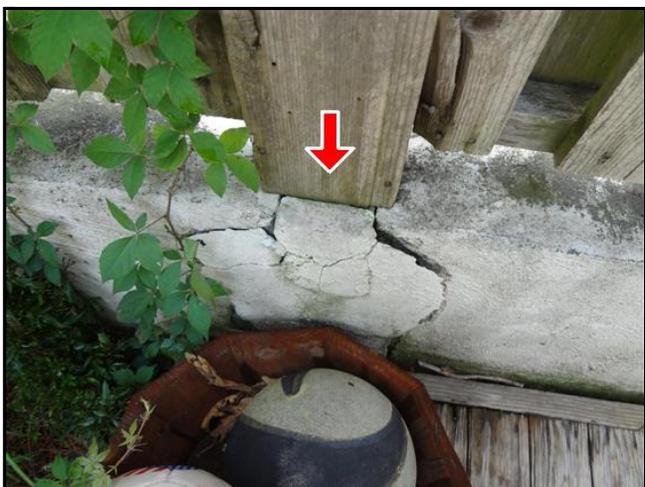
(4) Bottom driveway stucco retaining wall had several cracks and veneer was peeling. Recommend repair as needed.

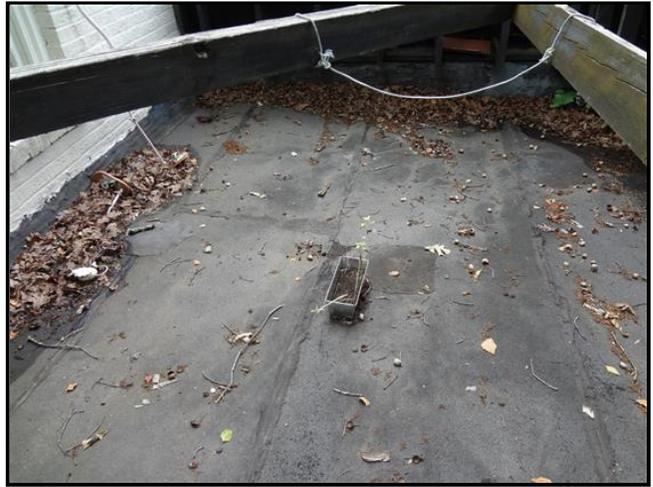
(1) One section of roof was flat at lower right side addition (office room) and several issues noted such as aged rolled roofing material, debris, and roof sealant repairs. Due to type of roof (flat) and the design along with issues noted, I recommend replacing roof material along with a better design (pitched roof) to prevent moisture damage. Roof structure material was aged and showing signs of deterioration. Clay tile were also not constructed or installed properly at this section. Exposed roof decking also present.

3.0 Item 2(Picture) Aged flat roof material

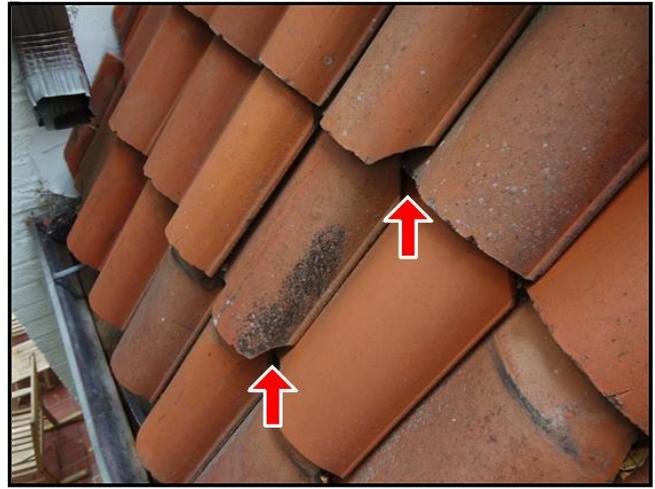
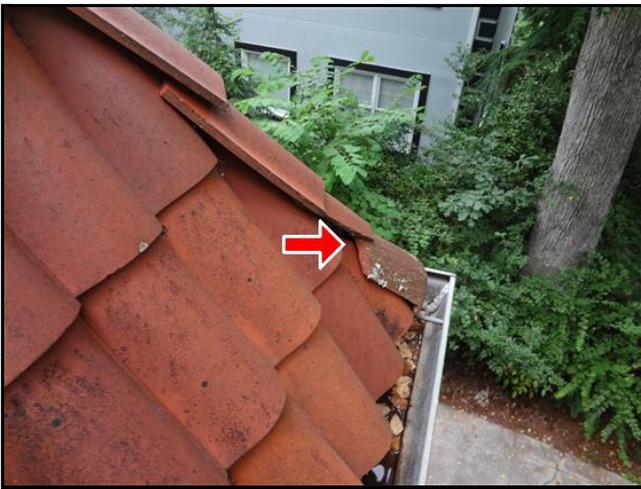
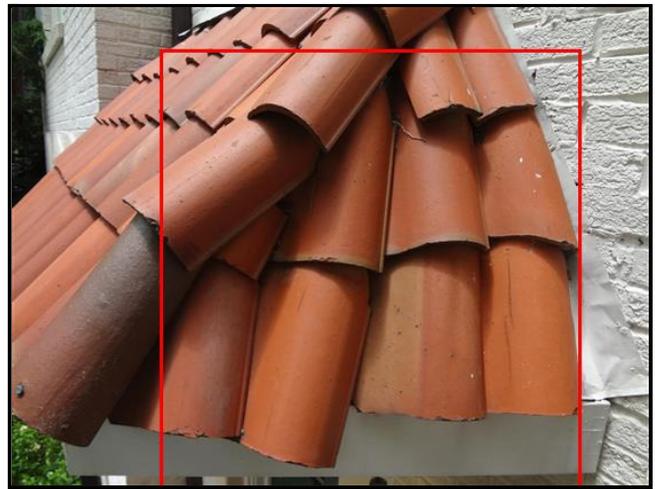
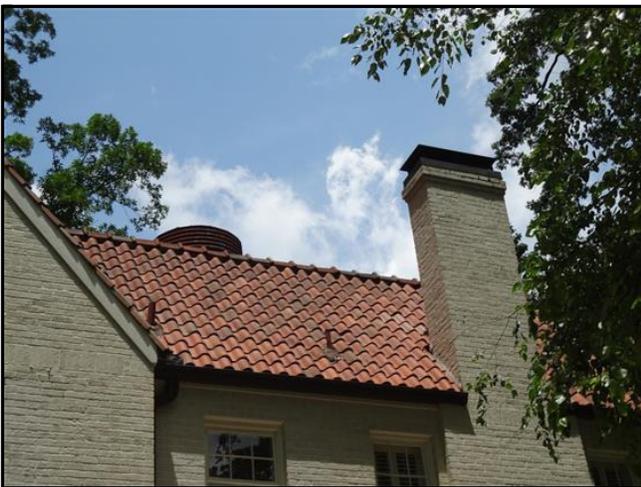
(2) Roof covering clay tiles were aged and nearing the end of their expected useful life. Determining life span can be difficult, usually it consists of 30-50 years. As the roof ages, issues arise such as damaged, cracked, loose or missing tiles. Approximately 20 tiles were cracked/damaged/loose. I recommend further evaluation by qualified roof contractor and repair tiles as needed.

I also recommend budget replacement of clay tile roof covering accordingly.

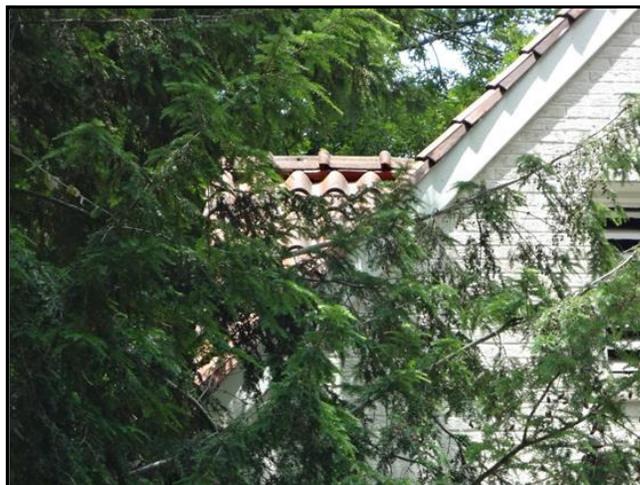
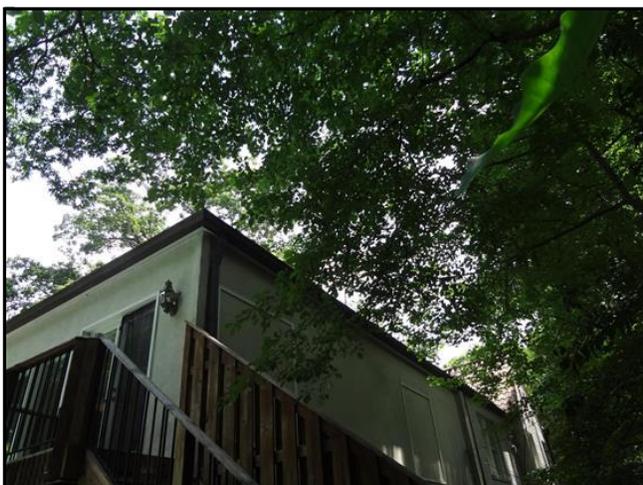
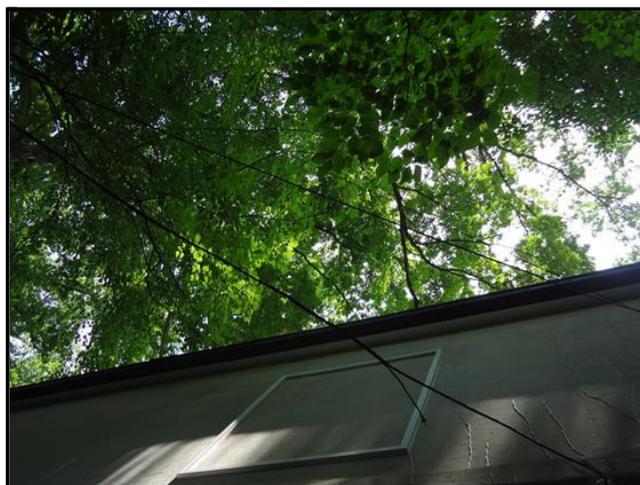
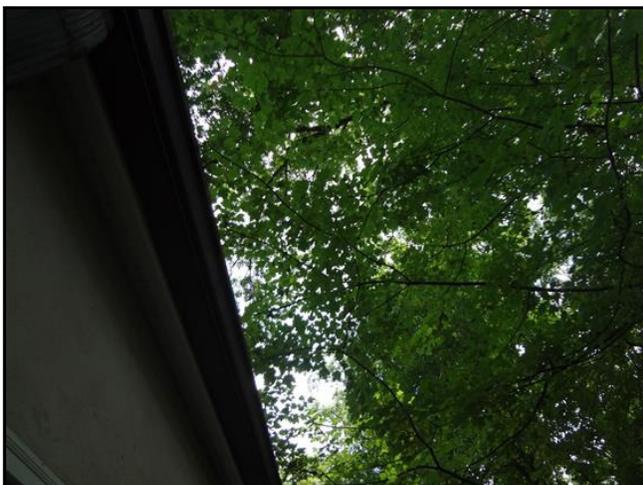
(3) Tree limbs that are in contact with home and over roofline should be removed/trimmed to prevent damage or pests.

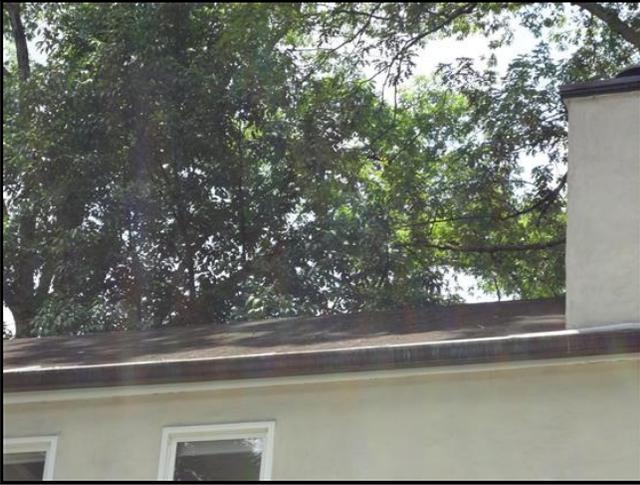
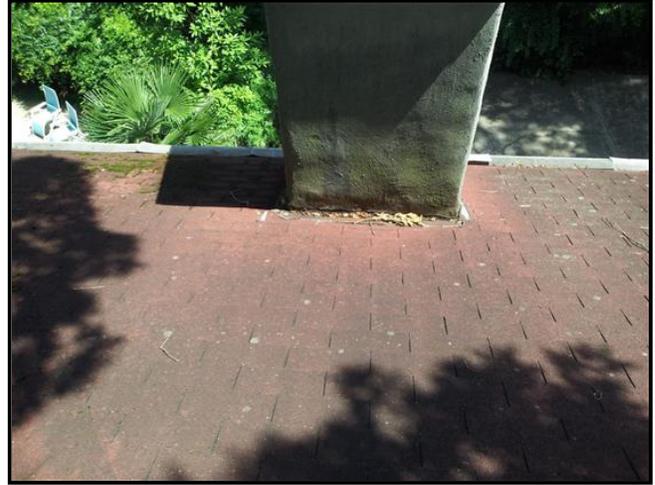
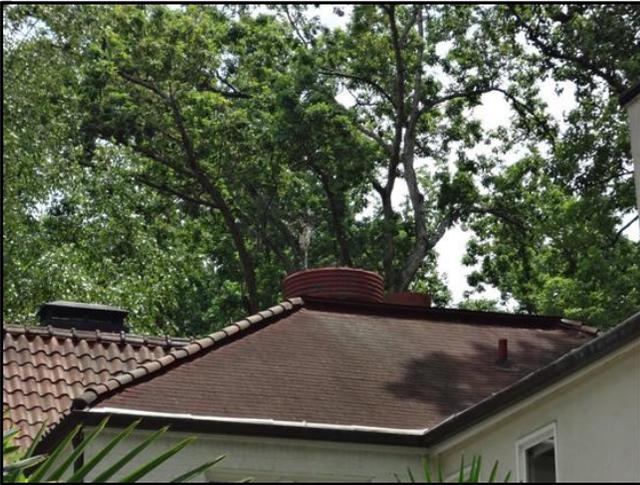
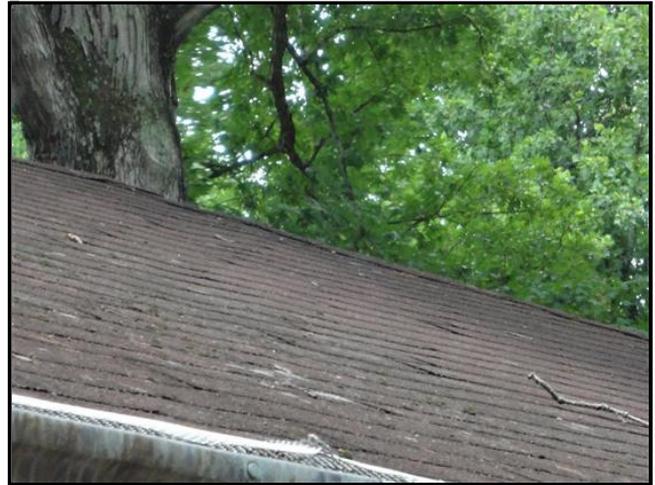
(4) Asphalt shingles at roof were aged and at the end of their expected useful life. Granule loss and cupping noted at multiple sections. Debris and moss growth also noted. While the roof could last a few more years, some issue such as moisture intrusion or damage may occur if not replaced. Recommend evaluate by qualified roof contractor.

Recommend budget on replacement of asphalt shingles.

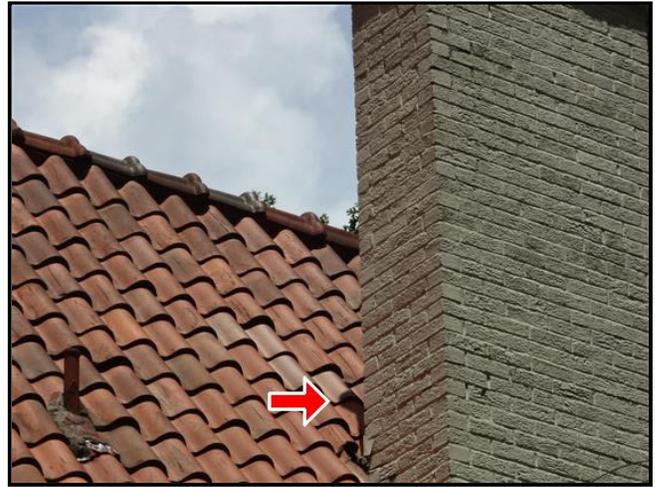
(1) Metal flashing sealant was not present, exposed fasteners as well. Recommend repair by qualified roof contractor.

3.1 Item 2(Picture) Proper flashing needed at chimney

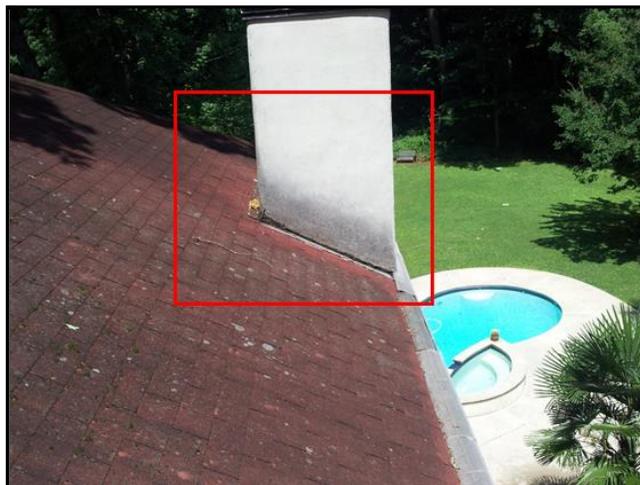
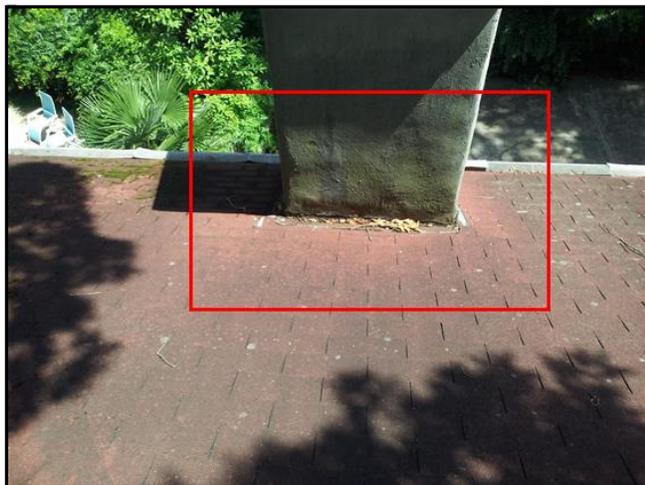
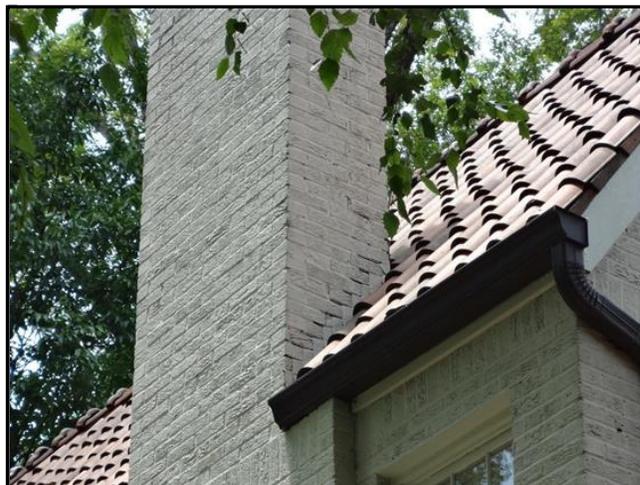
(2) Chimney chase flashings were aged, cracked, failing and showed signs of deterioration. Recommend replace all flashing at both chimney chases. Stucco chimney chase needs a saddle installed for proper drainage. Recommend repair by qualified roof contractor.

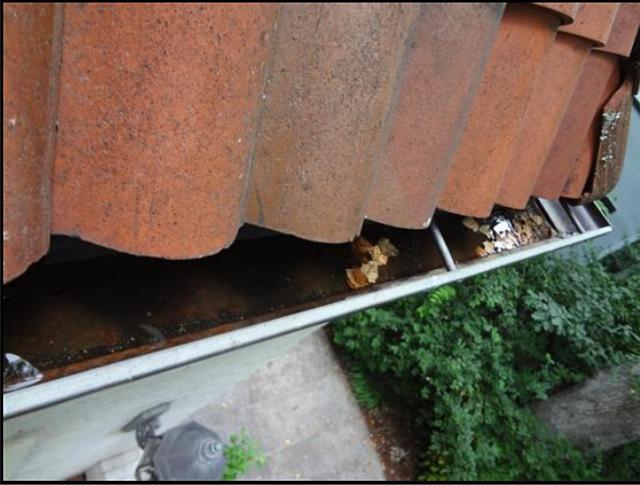
3.3 Item 1(Picture)

Gutters are clogged and need cleaning of debris. Gutters that drain poorly or clogged can lead to many costly problems such as deterioration of fascia, soffit or roof edge. It can also cause gutters to pull loose and lead to possible water intrusion. Recommend a qualified contractor inspect and repair as needed.

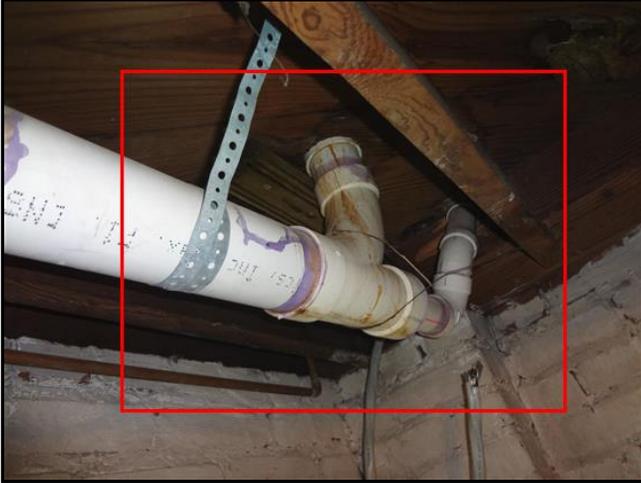
4.0 Item 1(Picture)

(1) Evidence of water stains from possible active plumbing drain pipe leak in basement under main floor guest bathroom area. Recommend evaluate by licensed plumber and repair as needed.

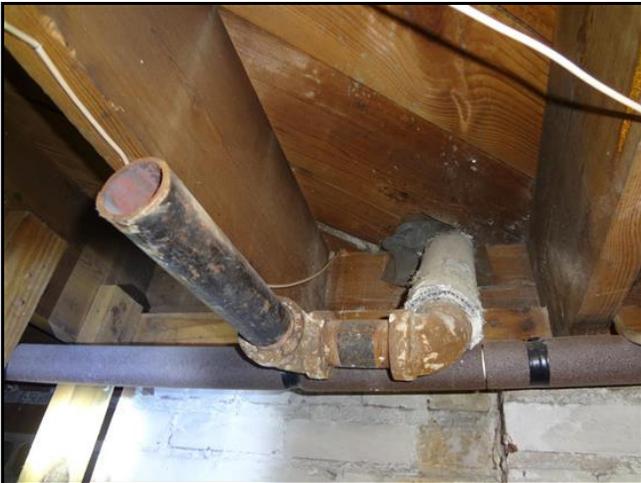
4.0 Item 2(Picture)

(2) Old piping noted in basement that may have asbestos liner still present. Recommend evaluate by qualified contractor to determine if it needs to be removed.

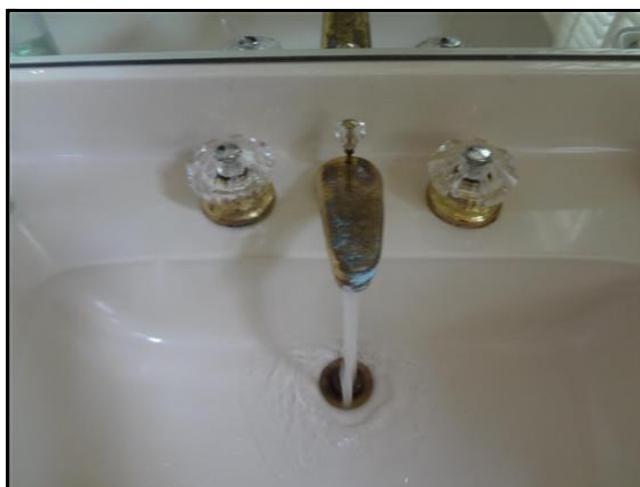
4.1 Item 3(Picture)

(2) Several plumbing fixtures were aged. Evidence of drips were noted when faucets are at off position. Recommend repair issues by qualified plumber and expect more with aged fixtures.

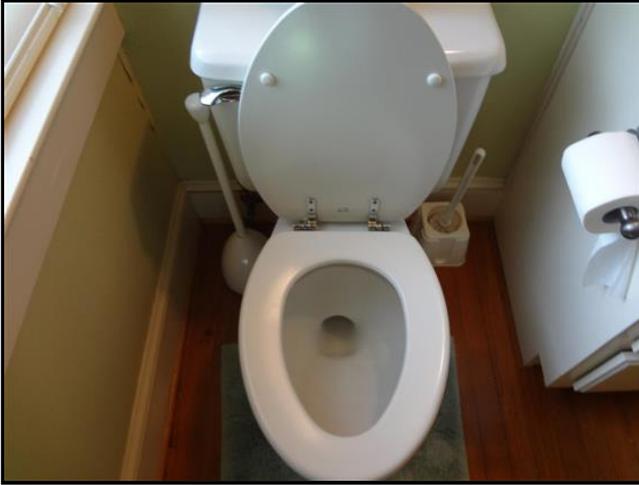
4.1 Item 4(Picture)

(3) Water pressure over-all is weak but did pass "functional flow." Which is determined by running water in sink and shower while toilet is flushed. If shower spray remains, it passes. A possible reason why this home has weak pressure could be aged water piping or plumbing fixtures.

Toilets upstairs did not have sufficient suction power when flushed/tested.

Recommend evaluate issues by qualified plumber and repair as needed.

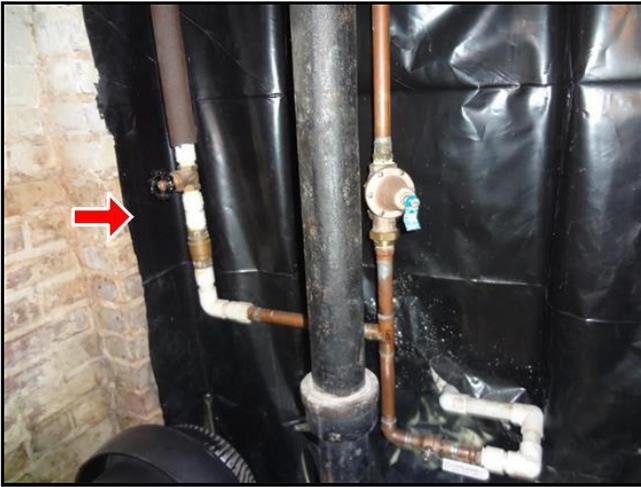
4.3 Item 1(Picture)

Black valve in basement.

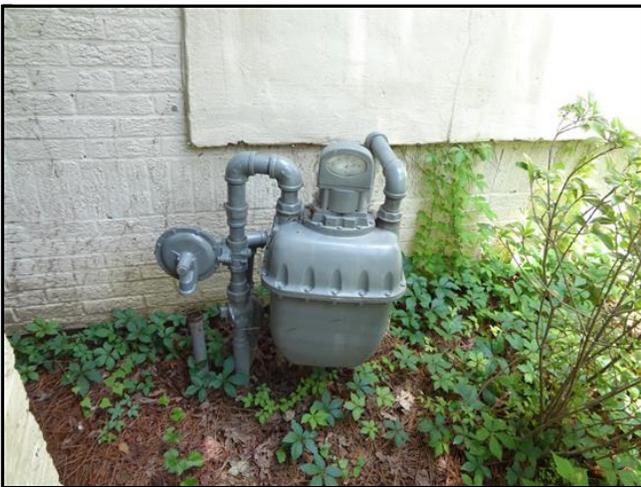
4.4 Item 1(Picture)

Front left of home.

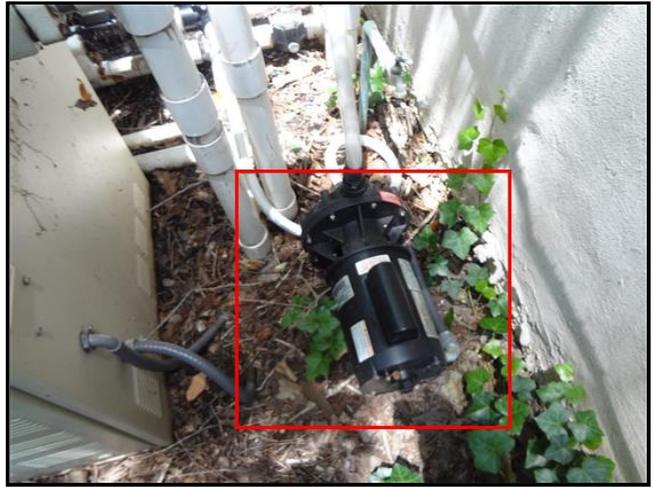
5.3 Item 2(Picture)

(1) Exposed electrical wiring left rear of home. Recommend repair by qualified electrician.

I do not inspect pools or their components, however I noted a safety issue. The motor bond/ground wire was not present. Recommend repair by qualified electrician.

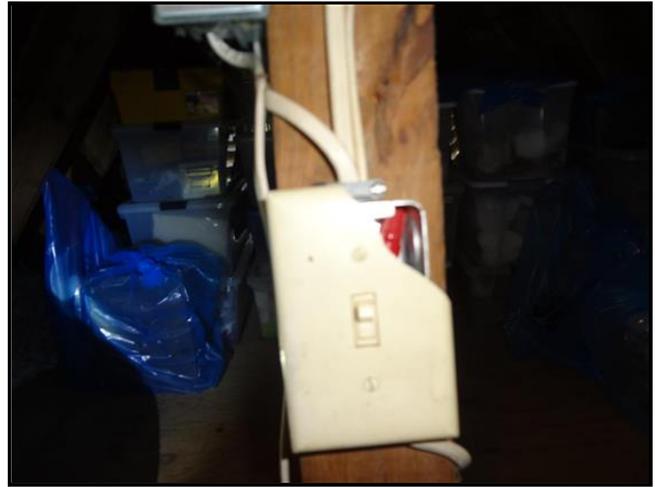
5.3 Item 5(Picture)

(2) Several plate covers were damaged or cracked. Recommend repair as needed.

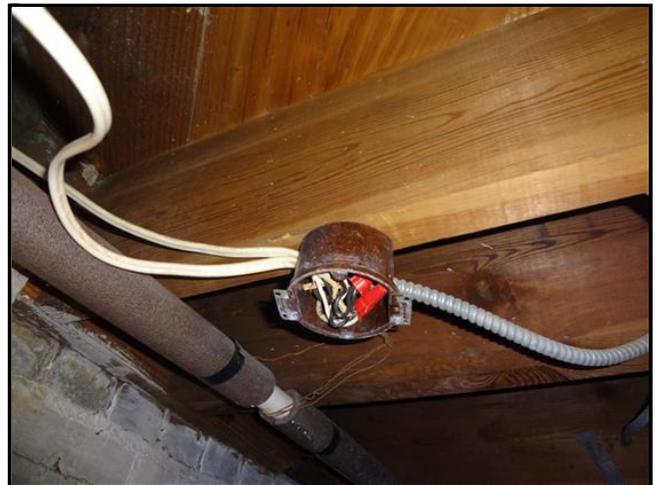
5.3 Item 8(Picture)

(3) Exposed non-terminated electric wiring at rear storage room. Open J-box noted. Recommend capping.

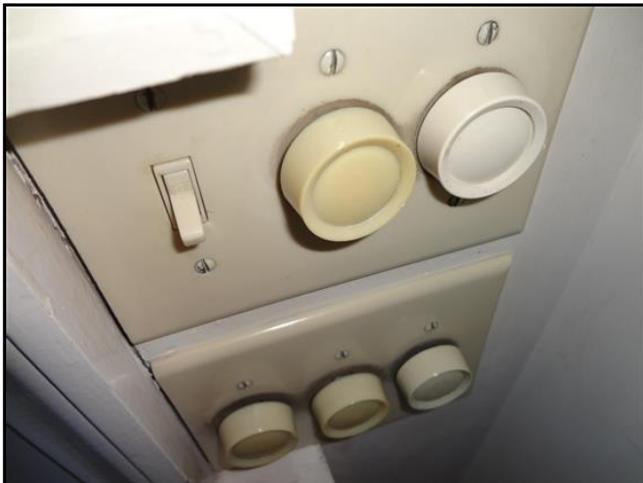
5.3 Item 9(Picture)

(4) Several light switch dimmers present, however dim function did not work on a few of them.

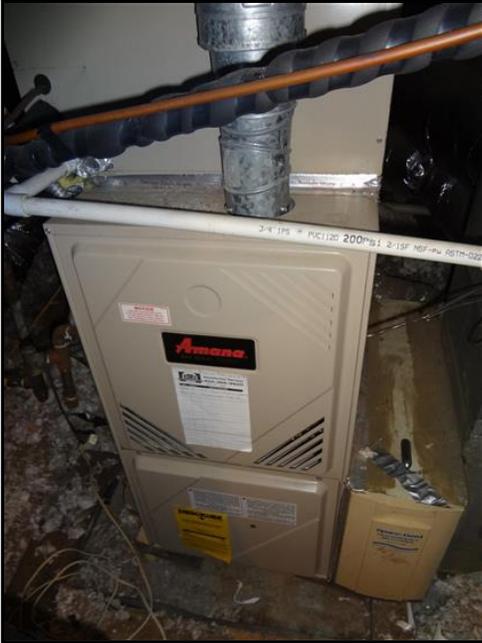
6.0 Item 1(Picture)

(1) Gas-fired appliances should be inspected at least annually. **If it cannot be proven that furnace has had a service/maintenance inspection within the last twelve months, recommend complete system evaluation by licensed HVAC contractor before close of escrow.** Such an inspection typically involves partial dismantling of the furnace to facilitate inspection of the heat exchanger, a task that is reserved to licensed heating and cooling technicians, of which I am not.

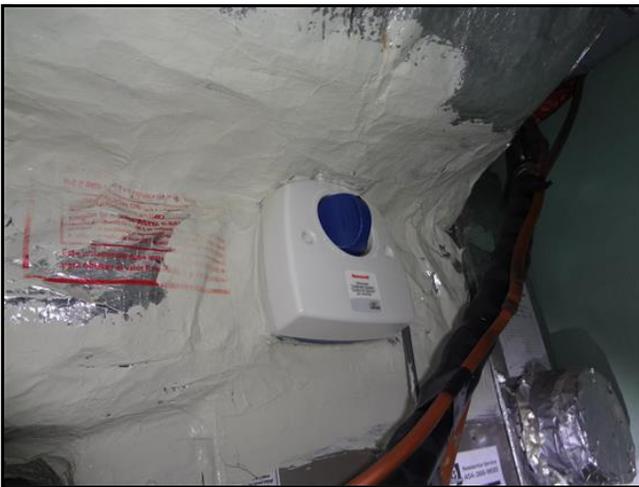
6.0 Item 3(Picture)

(2) Special accessory equipment was installed for HVAC unit in basement such as UV sanitizer. I do not inspect this type equipment. Recommend having a HVAC contractor or seller review with you prior to closing.

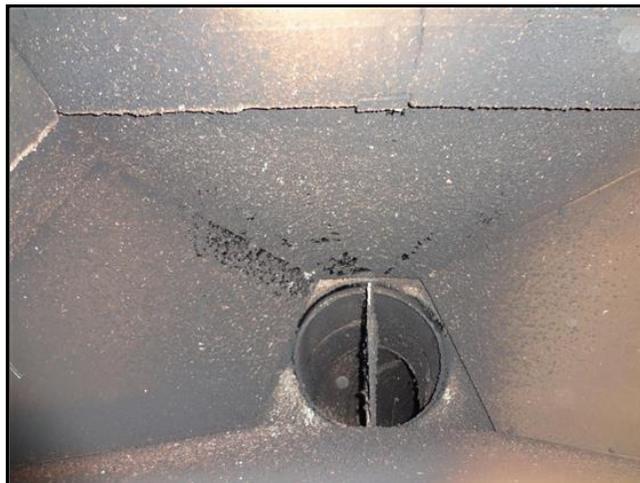
6.4 Item 2(Picture)

(1) Front fireplace was aged. It did not have a proper damper or throat, which is recommended for direct wood burning. Rear great room fireplace firebox liner was cracked and creosote build-up was noted. Fireplaces are not safe to use in current condition. Recommend evaluate by licensed chimney sweep and correct issues as needed.

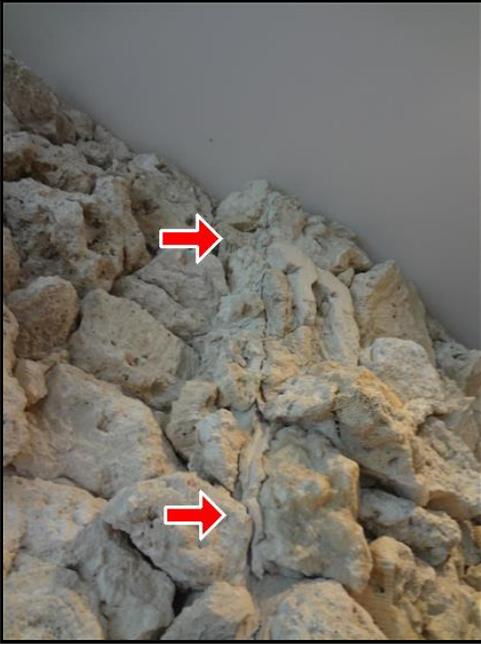
6.4 Item 4(Picture)

(2) Great room fireplace synthetic type stone wrap was cracked at left corner. Recommend repair as needed.

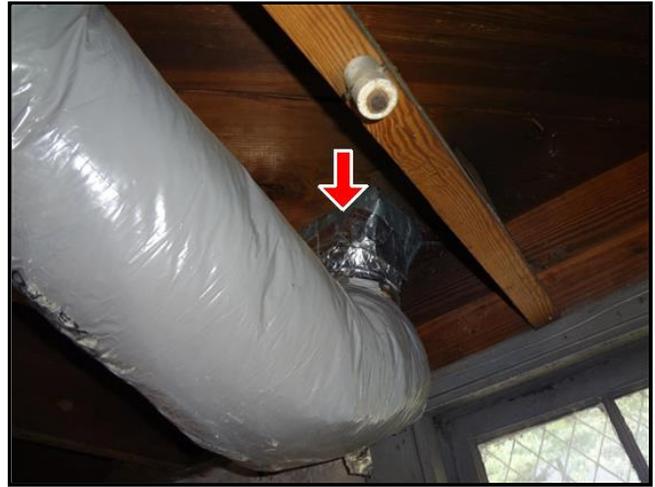
6.5 Item 2(Picture)

(1) HVAC duct piping in attic and basement had several sections that were aged/punctured/loose. Recommend sealing for better energy efficiency.

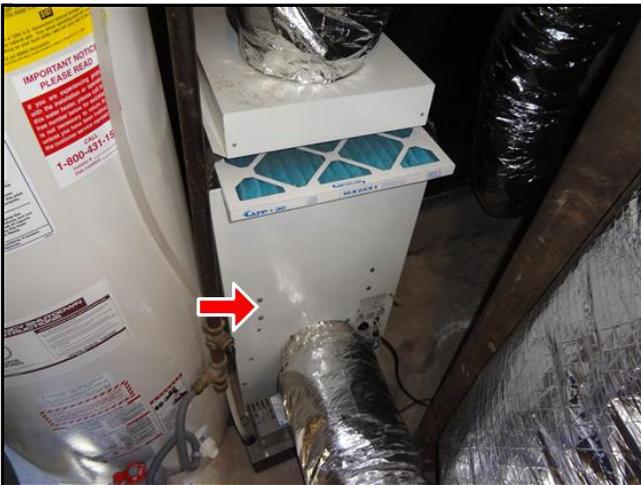
6.5 Item 4(Picture)

(2) Commercial grade dehumidification system was installed for this home. This is for your information. I do not inspect this type equipment.

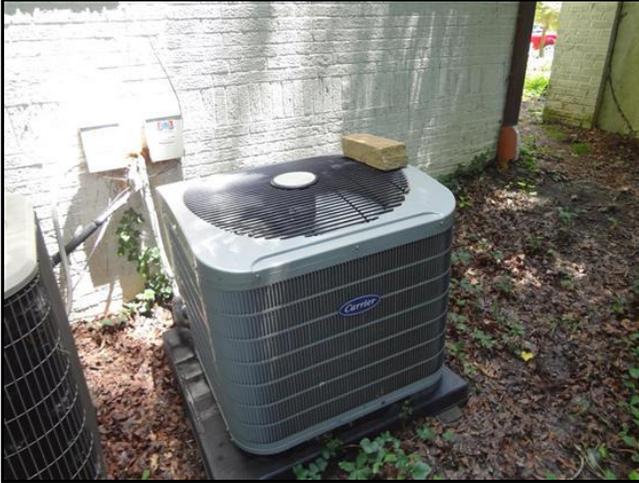
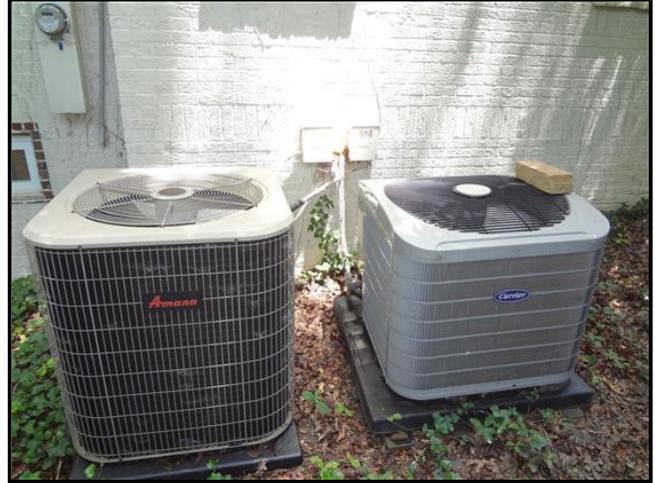
AC compressor units need to be serviced. Right unit had brick at top, placed to prevent rattling. Service by qualified AC contractor.
