Inspection Report

Atlanta Home Inspection

Property Address:
Springdale Road NE
Atlanta GA 30306

Date: 6/26/2012	Time: 12:25 PM	Report ID: 062612-2
Property: Springdale Road NE Atlanta GA 30306	Customer: Atlanta Home Inspection	Real Estate Professional:

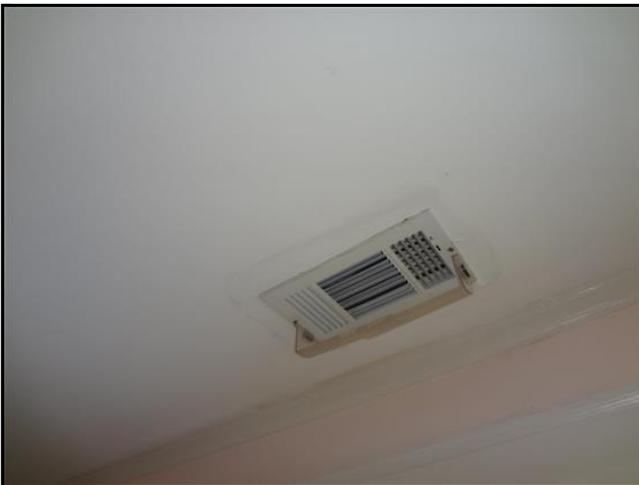
7.2 Item 1(Picture)

Evidence of condensation stains were noted around vents in ceiling. This is usually caused by insufficient insulation wrap.

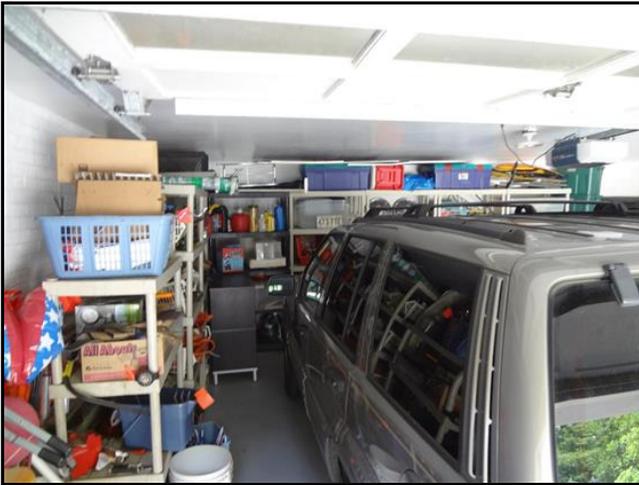
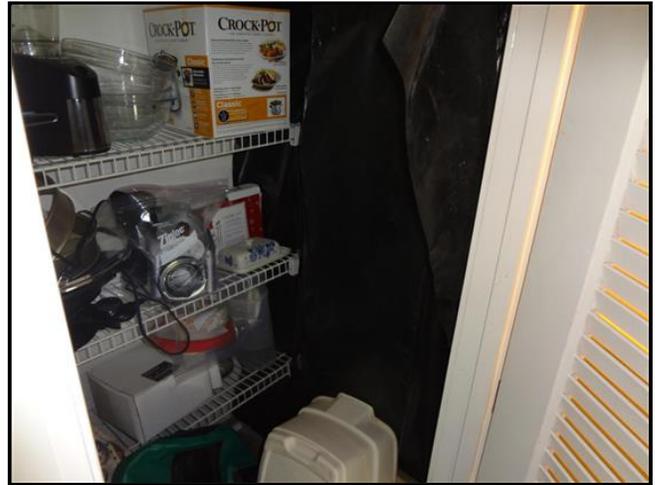
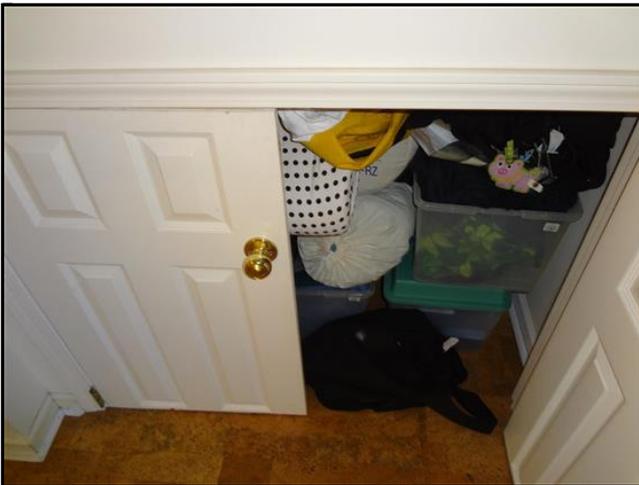
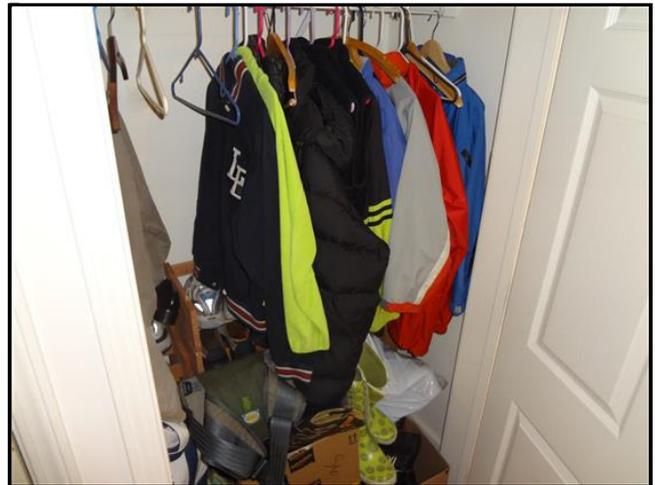
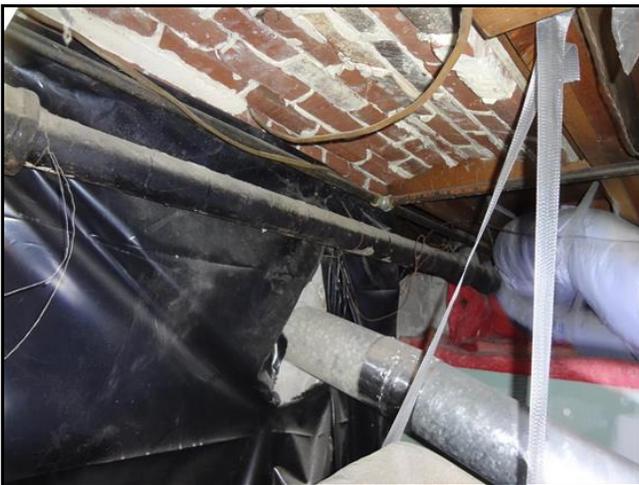
(1) I was not able to visually inspect multiple areas of the home due to stored items in multiple rooms. Also in basement portions of the foundation were covered with items or plastic sheathing. This is for your information.

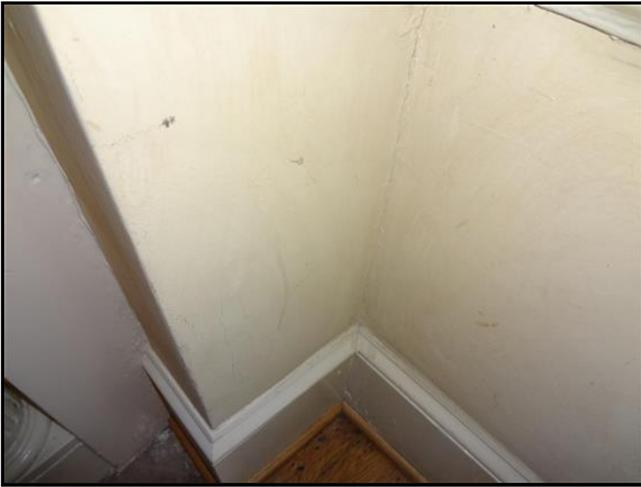
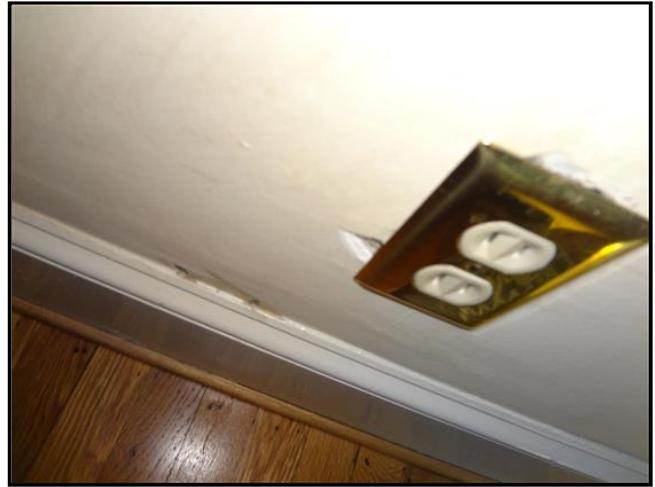
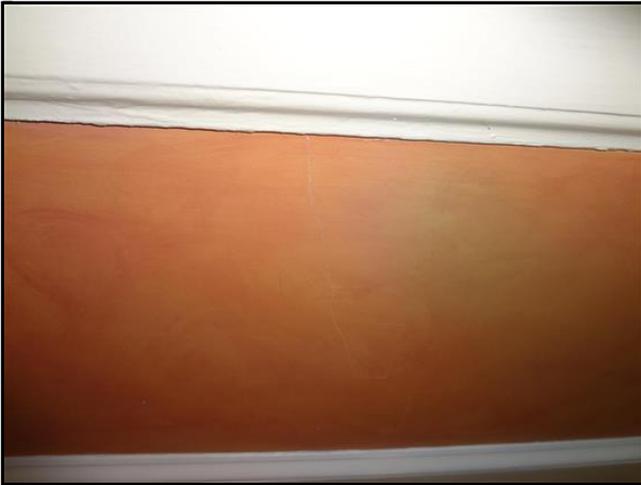
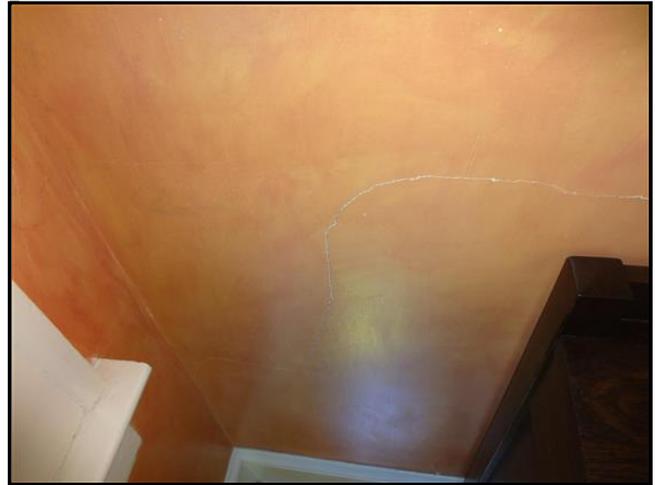
(2) Multiple settlement or shrinkage cracking was noted at plaster walls in several rooms, which is common for aged plaster. Recommend repair issues as needed.

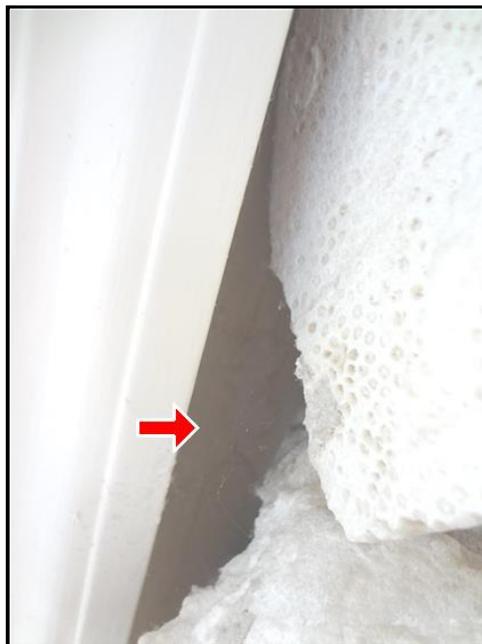
(3) Evidence of water stains was noted behind the fireplace left hand side at wall between covering and window. Recommend evaluate by qualified contractor and repair as needed (likely caused from failing flashing or roof).

8.1 Item 11(Picture) Water stains noted at walls

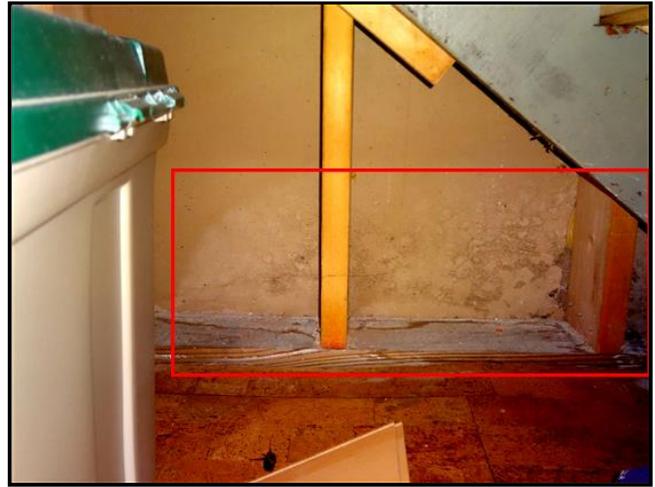
8.1 Item 14(Picture)

(4) Evidence of possible mold growth was noted in basement under stairwell at bottom walls. Recommend evaluate by mold remediation contractor and correct/sanitize as needed.

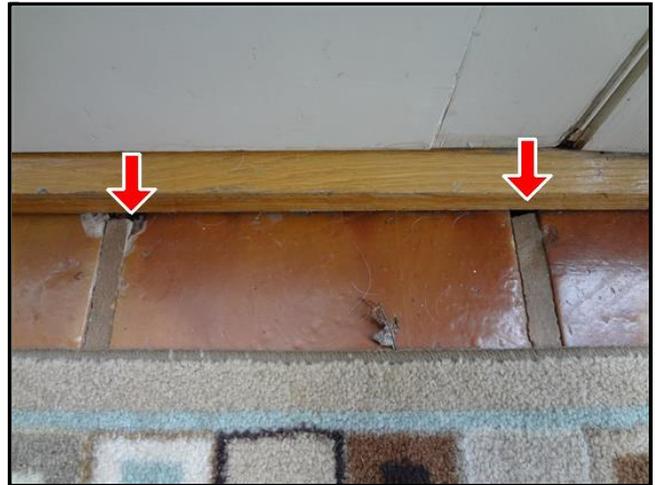
8.2 Item 2(Picture)

Tile flooring at kitchen and great room had cracked/loose mortar and loose/cracked tile in a few areas. Recommend repair as needed by qualified contractor.

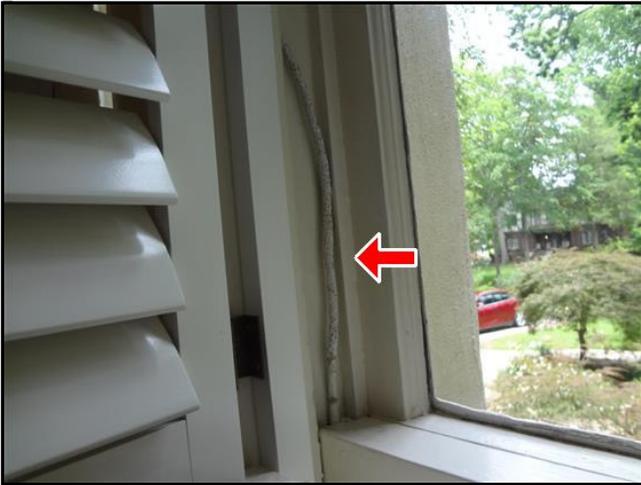
8.6 Item 3(Picture)

(2) Mildew was noted inside of a few windows. Recommend clean/sanitize.

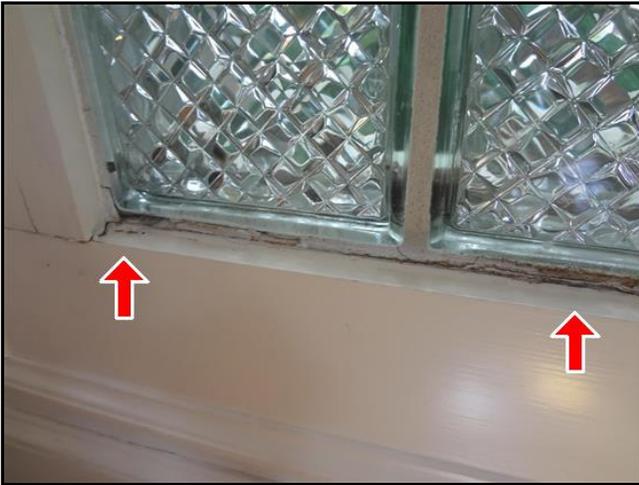
8.6 Item 5(Picture)

(3) Kitchen left side wall fixed glass block windows had evidence of moisture intrusion, loose block and failing sealant at multiple sections. Recommend repair issues by qualified contractor.

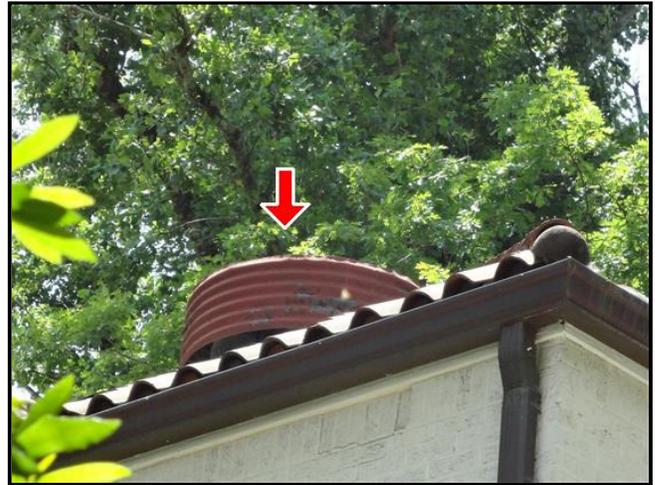
9.1 Item 2(Picture)

Roof venting was insufficient, rusting and dated. Recommend installing properly roof ventilation by qualified roof contractor.

Also soffit venting was painted over, which is reducing the air intake needed for the roof/attic. Recommend correct this is as well.

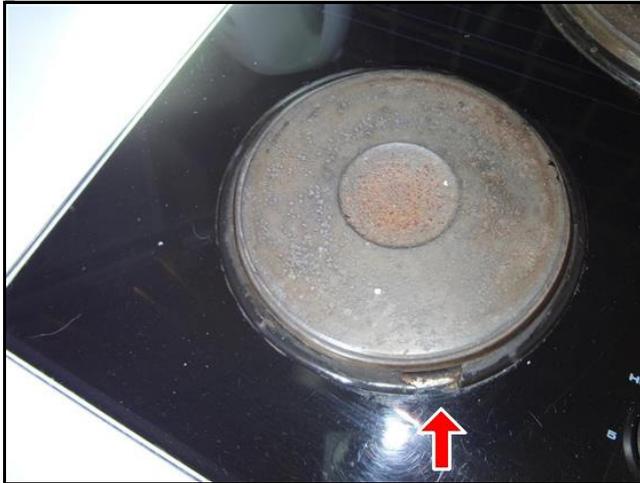
10.1 Item 1(Picture)

Electric cooktop left burner trim was damaged and control knob was damaged. Recommend repair as needed.
